Evaluating Stucco

David Tamny, ASHI Certified Inspector

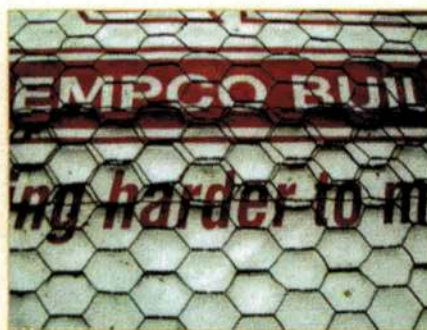
Galvanized chicken wire lath over Tyvek HomeWrap.

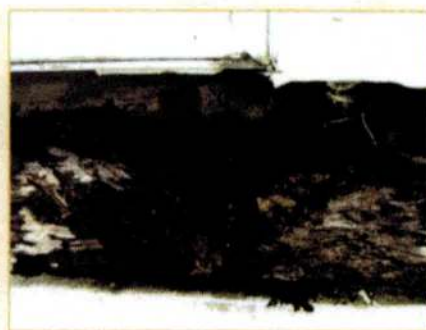
An example of the result of improper window flashing.

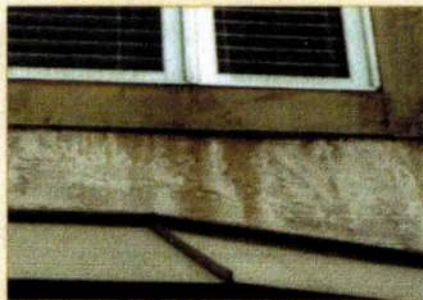
Unfortunately, it is nearly impossible to determine if the window is flashed properly after the stucco has been installed. Sometimes the only clues visible are stains at the stucco trim junctions (see photo, middle left).

Builders and stucco contractors who are not informed regarding stucco failures will often consider this to be normal. They do not understand that water running down the window frames is becoming trapped behind the trim. The trim, which is often not back-primed, allows water to rot not only the trim, but to degrade the water-resistive barrier behind it.

Stains at the stucco trim junctions indicate improper flashing.

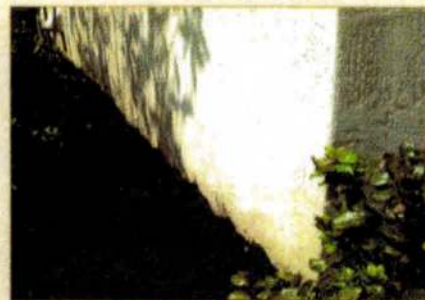
Mold growing along the rim joist due to a lack of weep screed.

In one example (see photo, middle right), the homeowner had been complaining about mold growing along the rim joist behind the insulation where the floor structure meets the foundation wall. The builder was called back and concluded that the problem was due to the colder temperature of the rim joist. He elected to spray foam insulation to keep warmer house air from coming in contact with the colder wood.

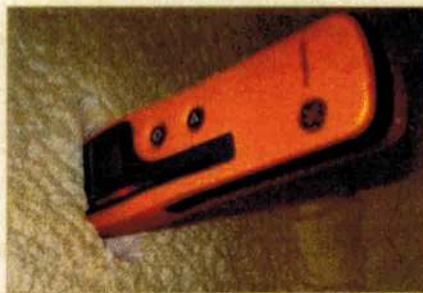
A pin-type moisture meter detected a moisture content over 20 percent, indicating a lack of weep screed.

When a pin-type moisture meter was inserted into the wood (see photo, bottom left), it registered moisture content well above 20 percent. The insulation was

merely concealing the true problem, which was the lack of a weep screed and the dirt-to-stucco contact.

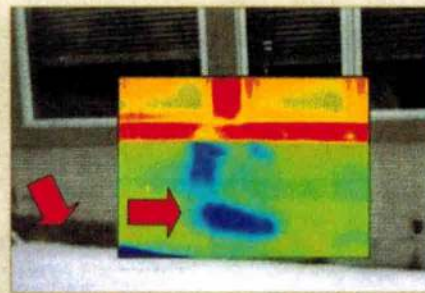
An infrared view of leaking windows.

In the case illustrated in the bottom-right photo, the windows were leaking. One also can see how the stucco has absorbed moisture from the ground due to the lack of a weep screed and required clearance from the concrete patio. While infrared can be a useful tool, conditions must be right for its use.

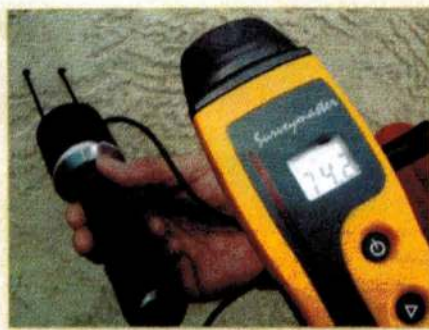
A moisture reading of 74.2 percent indicates a serious problem.

Ultimately, the areas that have been identified in the infrared scan must be investigated further, either with a moisture meter or by removing stucco. In this case, moisture contents in the

OSB sheathing were measured at 74.2 percent. Sustained levels of moisture above 20 percent will result in rot and deterioration.
