Inspecting ROOF TRUSSES

Garet Denise, PE, ASHI Certified Inspector

This article discusses wood roof trusses, including problems with manufacturing, damage, installation, bracing, alterations and partition separation. Much of this information also applies to open-web floor trusses, although floor trusses have other unique issues not discussed here.

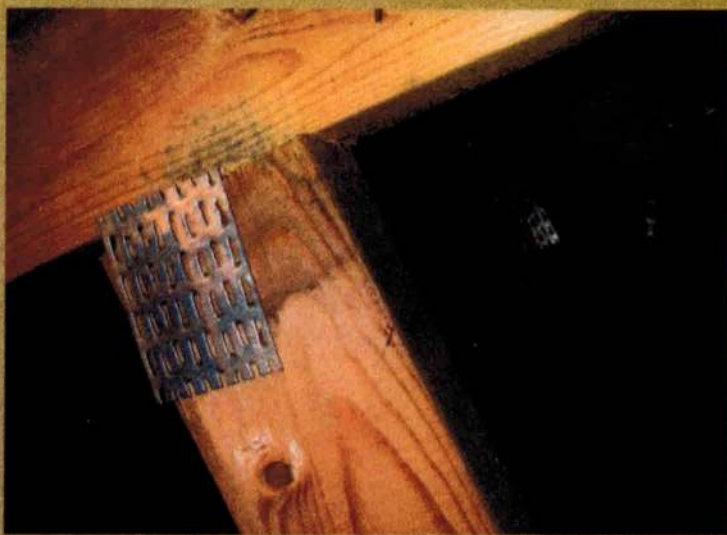
For simple joints, the plate should be centered, although this isn't always true for larger joints with multiple members coming together. Misaligned plates are not as strong as the designer intended (see *Figure 2*).

Figure 2: This metal connector plate was misaligned at the factory.

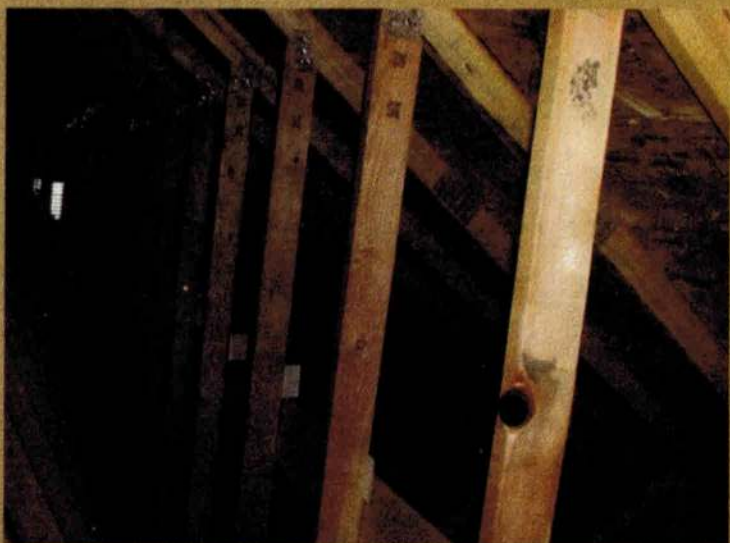
Since wood is a natural product, some knots are inevitable. But large knots weaken the member (see *Figure 3*), particularly if a metal connector plate is pressed into one. Acceptable knot size for metal connector plates should be listed in the manufacturer's evaluation report – which isn't likely to be available to you as a home inspector. If in doubt, refer the issue to a licensed structural engineer.

Figure 3: Knotholes weaken web members.

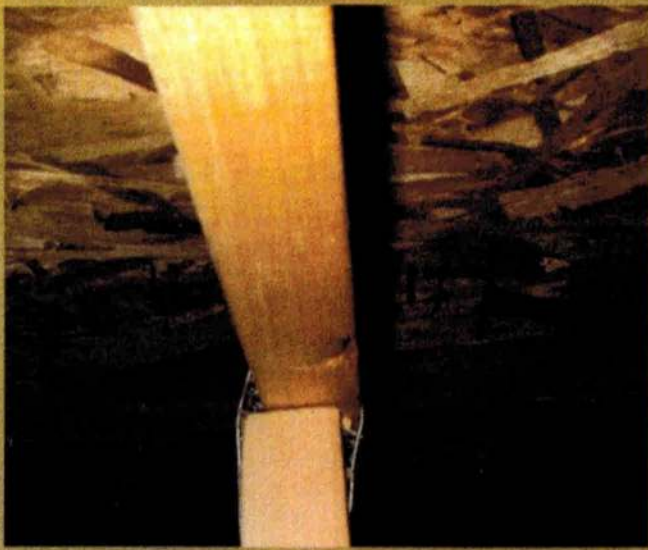
Damaged metal connector plates are one of the most common forms of damage. Obviously, a plate that's pulled completely out of the wood has no strength. But a plate that's pulled partway out no longer has full strength (see Figure 4). The Truss Plate Institute (TPI) publication QST-88, *Quality Standard For Metal Plate Connected Wood Trusses*, says that the gap under a plate should not exceed 10 percent of the tooth length or 1/16," whichever is greater. It also says that such a gap should not exceed 1/3 of the plate contact area on each member in the joint. Repair is not as simple as hammering the plate back in because the fingers on the plate are designed to be pressed one time into undisturbed wood. The normal repair is to install a plywood or OSB gusset plate, nailed in place. These are usually much larger than the metal plate being replaced. The size and nailing pattern will be specified by the engineer. Sometimes an engineer will specify a metal replacement plate with nails.

Figure 4: Metal connector plates lose strength even when pulled only part way out.

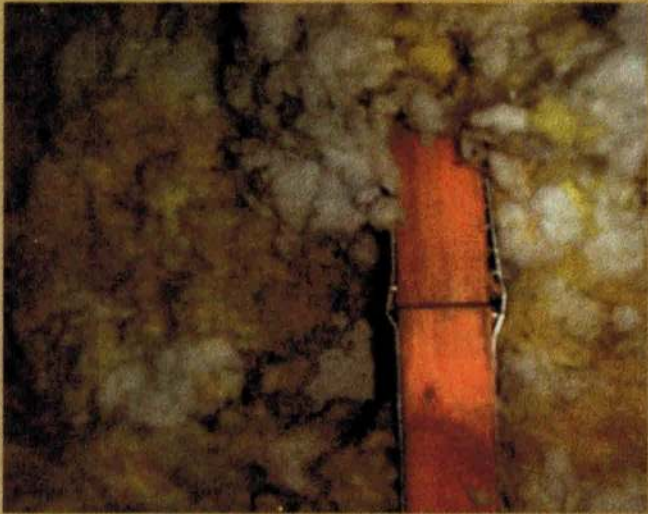
As a truss is bent sideways, the metal plates on the outside of the curve are stretched or pulled out (as described above), but the plates on the inside of the curve are compressed and can buckle. This damage is not as obvious (see Figure 5). If you find signs of damage in the accessible parts of the truss, you should also pull aside insulation to look for more damage to the lower chord.

Figure 5: Compression buckling of connector plate on truss that was bent during installation (left).

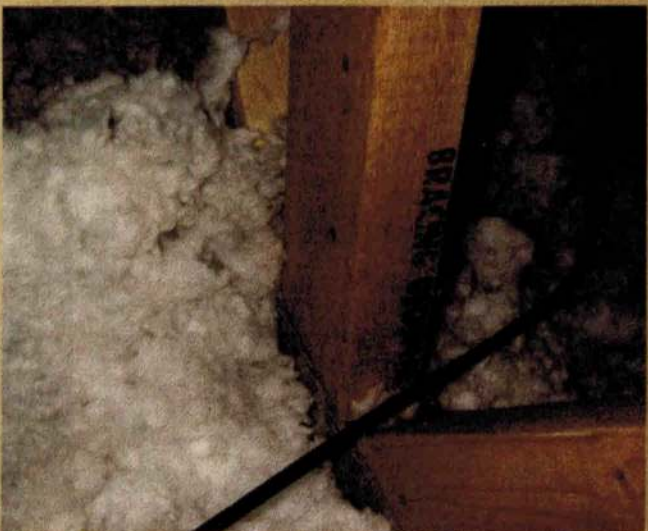
Figure 6: Ink stamp reads "BRACING REQUIRED".

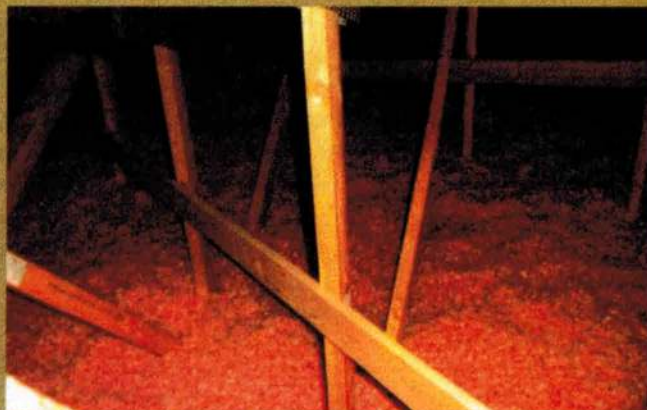
Figure 8: CLR is not effective when applied to trusses that do not have similar web patterns.

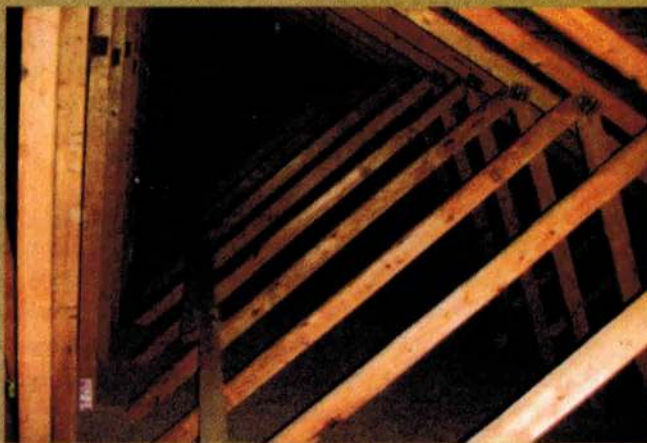
Figure 9: CLR should be roughly centered in span of web member.

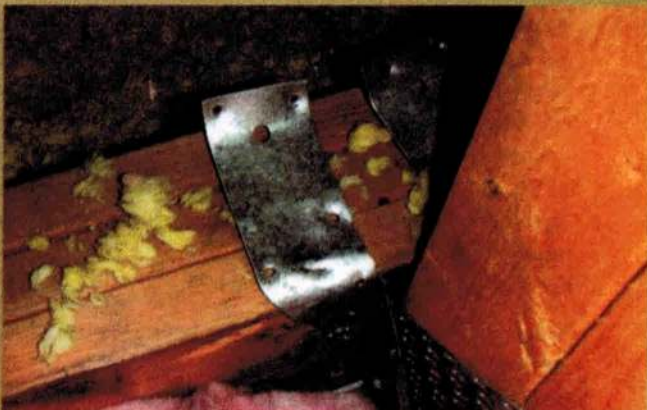
Figure 10: All nail holes should be filled in metal hanger brackets.

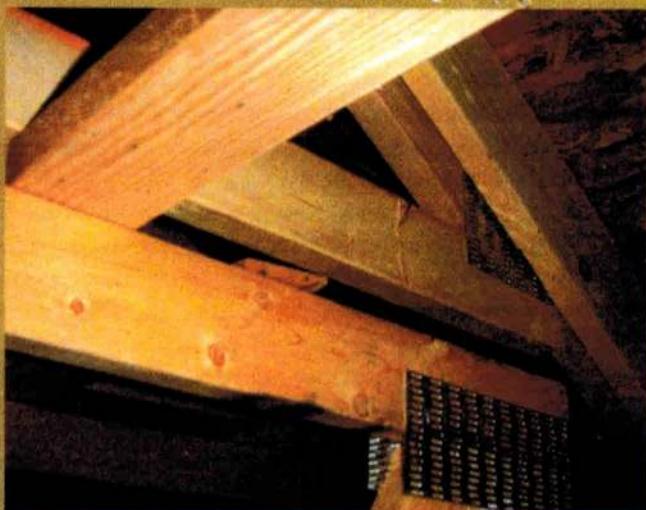
Figure 11: These piggyback trusses are not supported at the bearing point.

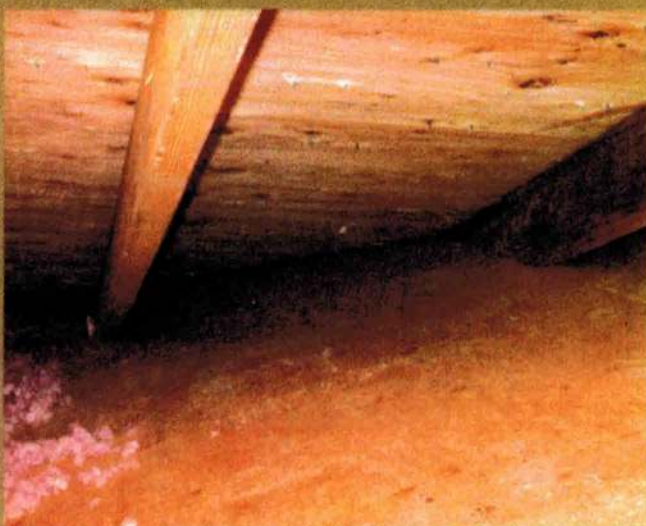
Figure 12: These rafters bear only on roof sheathing in between trusses.

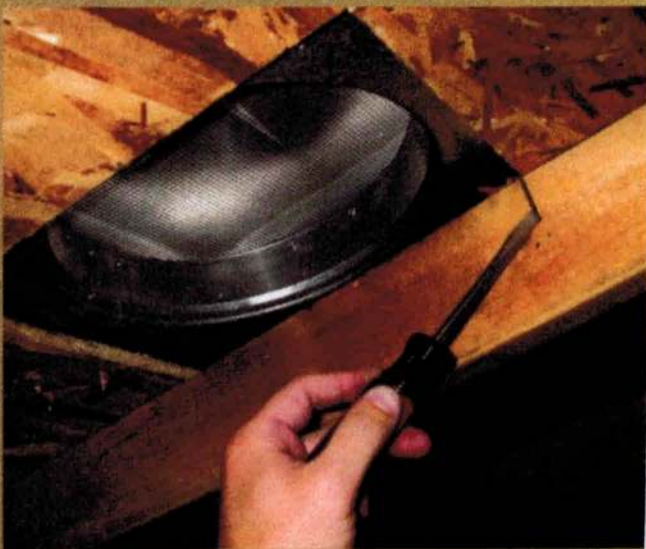
A major advantage of lumber as a building product is that it can easily be cut and nailed in the field, but this also makes it easy to make improper modifications. As previously discussed, any alterations to a truss must be backed up by engineering designs. Truss members commonly get cut during installation of whole-house fans, drop-down stairs, fireplace chimneys and recessed light fixtures. Truss members also get cut during installation of rooftop vents (see Figure 13) or when installing mechanical and plumbing systems.

Figure 13: Truss members should not be altered in the field.

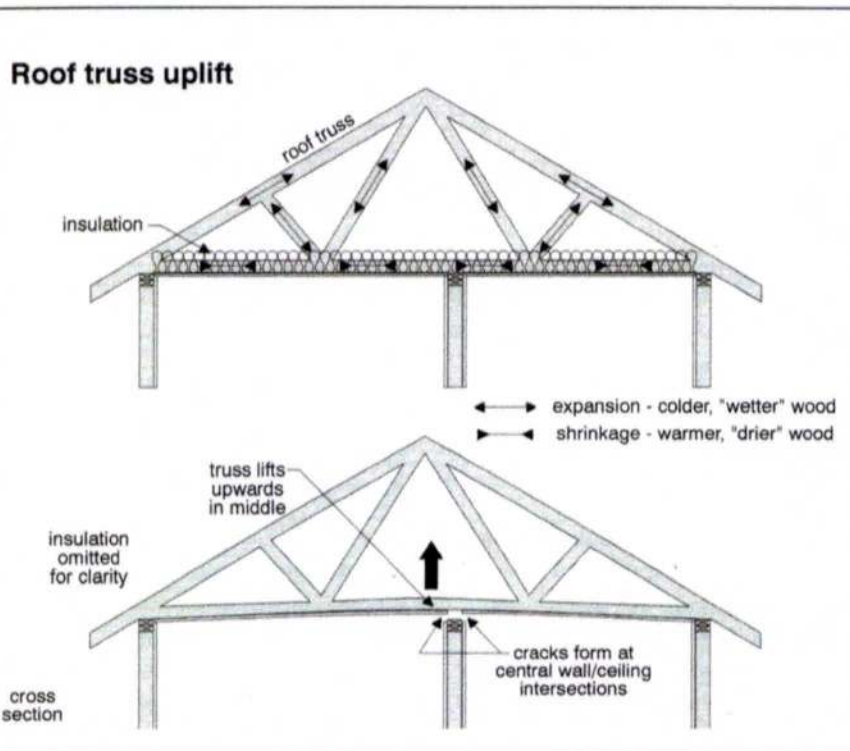
Because interior partition walls are typically not load bearing, a unique problem can develop where those walls meet the bottom of trusses, resulting in dry-wall cracks near the wall/ceiling joint. In areas where the relative humidity changes significantly from summer to winter, the truss lumber will expand and contract as its moisture content changes. As a result, the bottom chord of the truss will rise and fall seasonally as it bows up and flattens back out. This is called 'partition separation' or 'truss uplift' (see Figure 14). Other factors that can also cause partition separation include building settlement and deflection from snow or wind loads. You can read more about ways to avoid this problem in *Partition Separation Prevention and Solutions*, part of the Truss Technology in Building series published by The Wood Truss Council of America (www.sbcindustry.com). ■

Figure 14: Partition separation (from Carson Dunlop Illustrated Home, #0438 in 1st edition).
