September 1, 2019

On 5/19/2018, Cities' Inspection Service, Inc. completed a building inspection of the property located at XXXXXXX, XXXXXX, Minnesota for you. Doug Hastings did all the fieldwork related to this project. Doug used the commercial inspection protocol; the Standard Guide for Property Condition Assessment – ASTM Standard E2018-01.

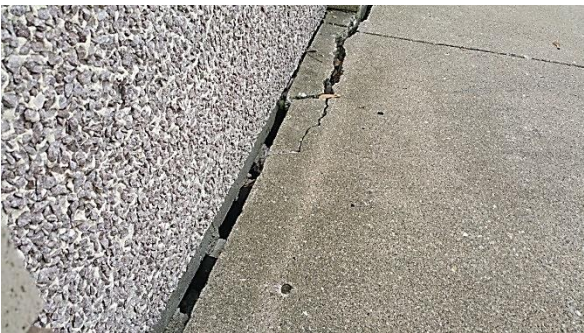
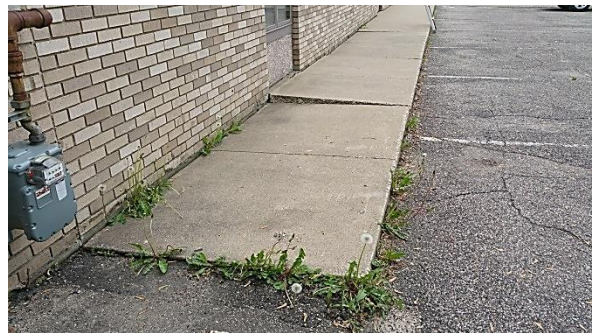
Walk (north side)

walks _____ ✗.... settled & uneven concrete / pulled away from building (replace)
 handicap ramp _____ ✗.... none
 retaining wall _____ ✗.... cracked and bowed dock wall
 fence _____ ✗.... tipped posts
 trash enclosure _____ ✗.... none

- ✓ Settled and uneven concrete walks; no handicap ramp.
- ✓ Cracked and bowed loading dock retaining wall.
- ✓ Uneven and deteriorated concrete parking lot curbs. Cracked and uneven concrete street curb entrance. No gas meter bollard.
- ✓ Cracked, patched, and deteriorated asphalt parking lot and driveways. Faded parking space lines, no handicap space and sign.
- ✓ Sagged, rusted, and lifted brick wall steel lintels.
- ✓ Cracked window frames; damaged window sashes (west side).
- ✓ Damaged side door (west side).
- ✓ Interior dock and storage room doors to finished rooms are not fire rated.
- ✓ Roof is ponding water (moisture intrusion); recommend adding an additional internal drain(s).
- ✓ Worn perimeter roof and equipment vertical curb membrane, seams and corners (moisture intrusion). Wind scoured sections of the roof gravel. Roof system will require annual maintenance and repair.

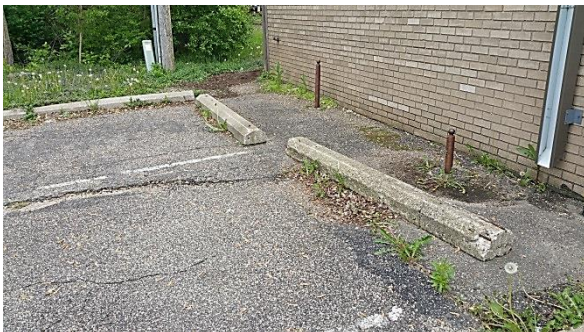
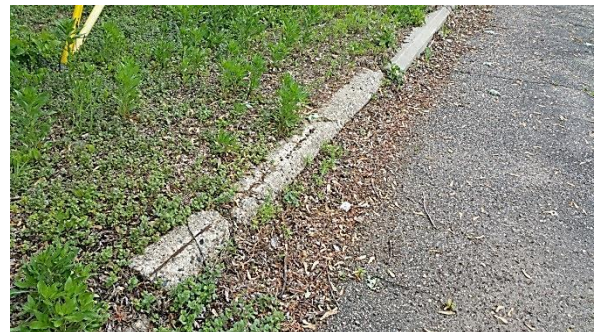
Curbs

- curbs _____ ☒.... uneven & deteriorated curbs (repair) / damaged street entrance curb cut (replace) / no gas meter bollard
- surface _____ ☒.... deteriorated, cracked, and missing asphalt & concrete (replace) / 2 layers
- stripe lines _____ ☒.... faded lines
- handicap space _____ ☒.... none
- sign _____ ☒.... none

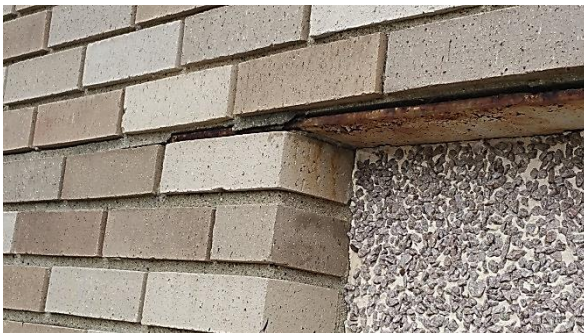
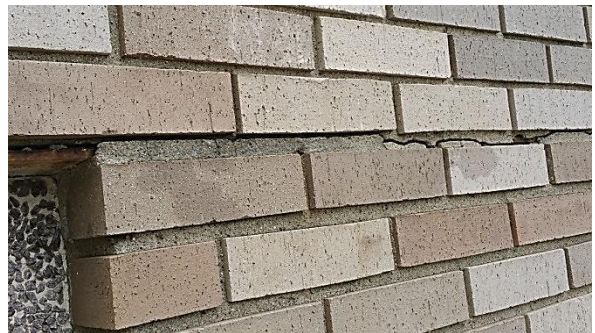
Lintels

- bricks_____ ❌.... rusted, sagged, & lifted steel lintels / no brick weep holes
- flashing/caulking_ ❌.... no window, control joint, & door caulking
- windows_____ ❌.... cracked & faded frames / damaged sashes (west side)

Rusting lintels

the expansion of
rusting steel lintels
can cause horizontal
cracks above
windows

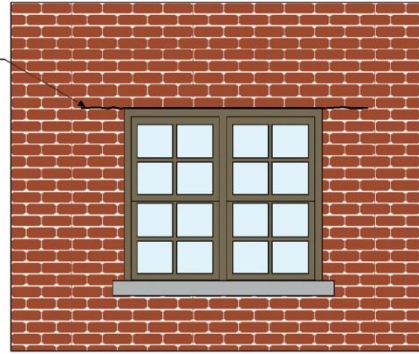
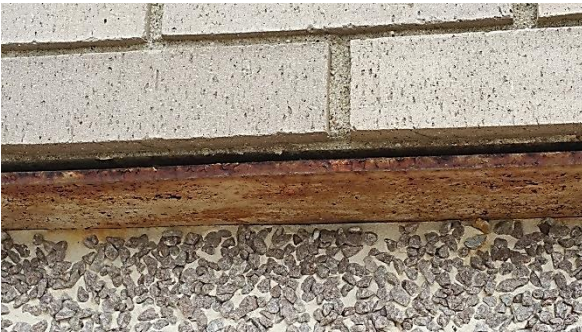
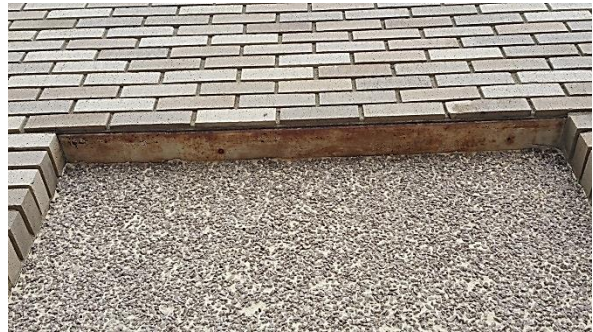
Rusted & sagged lintel

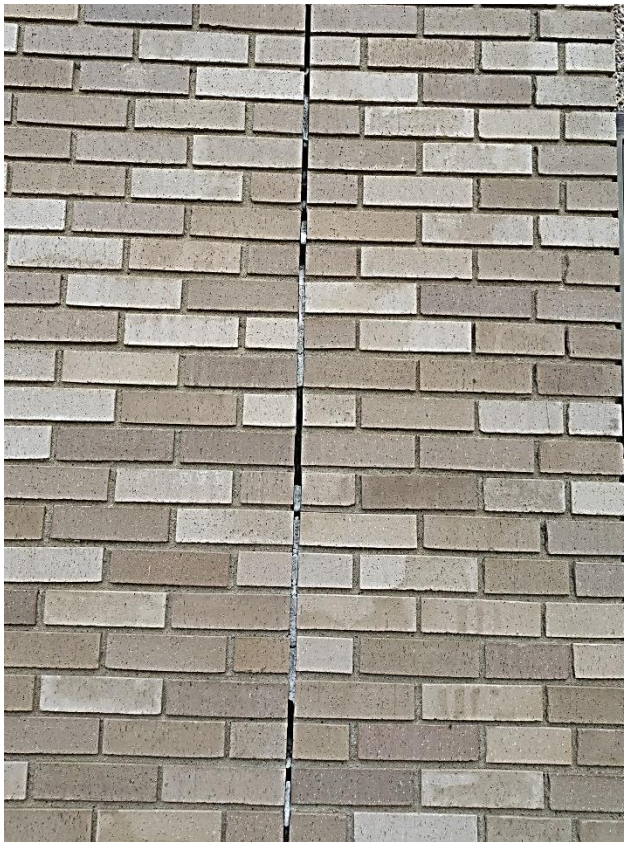
Control joint

- ✓ Tipped fence posts; no trash enclosure.
- ✓ No brick wall veneer weep holes.
- ✓ Missing window, door, and brick control joint caulking.
- ✓ No dock service door weather-stripping; door needs to be painted.
- ✓ Drive-in overhead door and automatic opener are out of adjustment. Dented metal panels.
- ✓ Abandoned and unused roof equipment (moisture intrusion).
- ✓ Interior and exterior rodent bait stations (pest management).

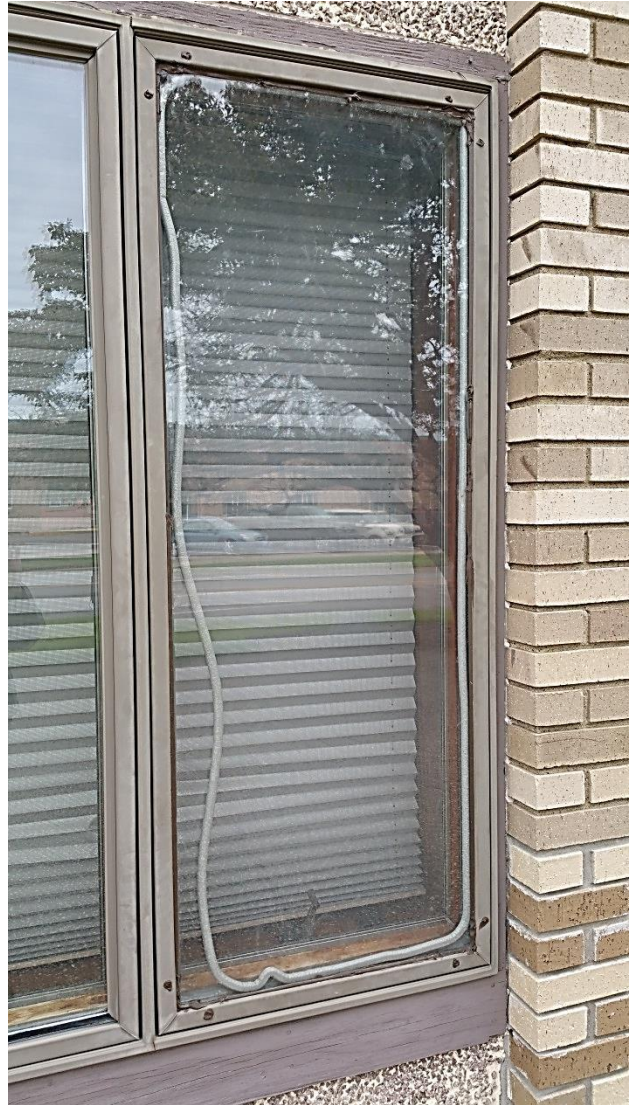
Damaged sashes

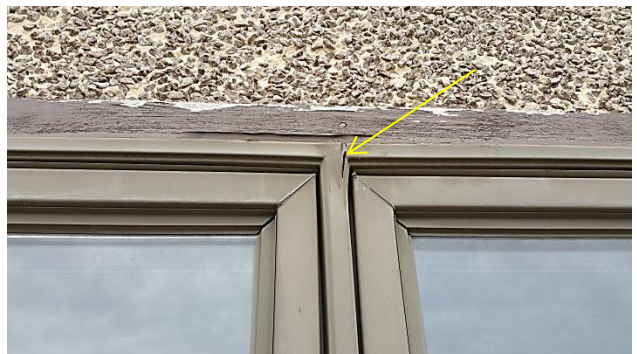
Cracked frame

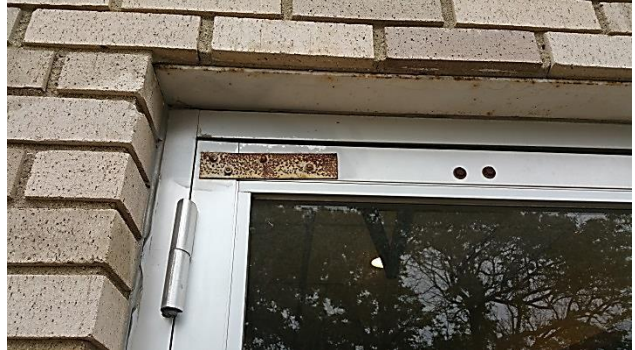
Side door

- main entry_____●
- side entry_____⊗.... damaged & sagged door / bent metal
- dock door_____●.... lacks paint / no weather-stripping
- overhead doors__●.... dented metal / door & opener out of adjustment
- dock bumpers____●
- fire doors_____⊗.... interior dock & storage area doors not fire rated

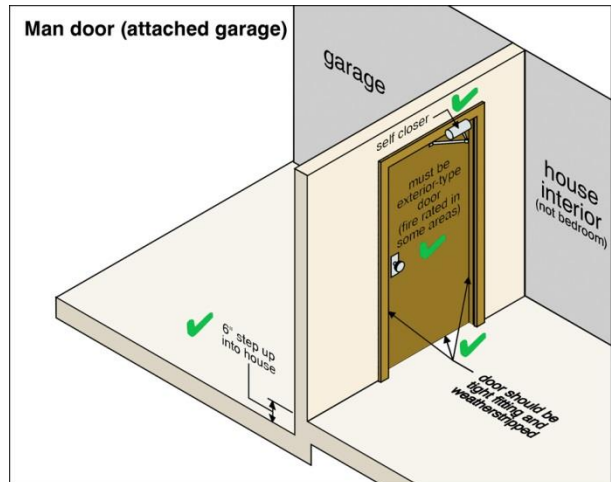
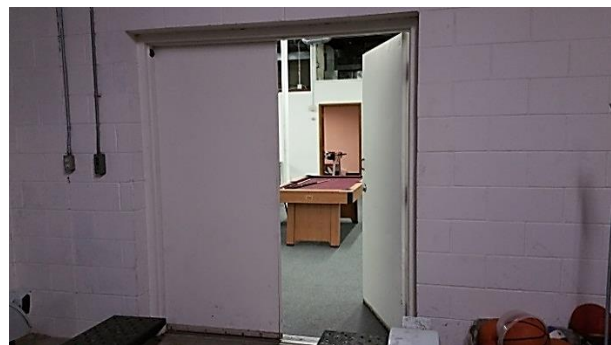
Not fire rated

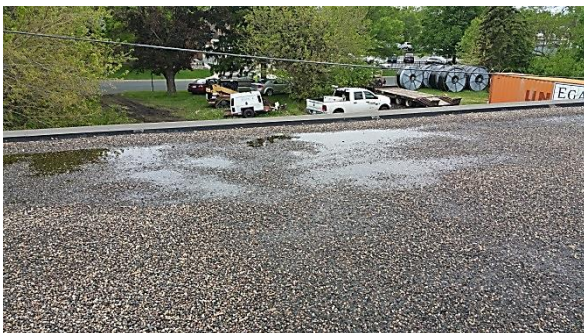
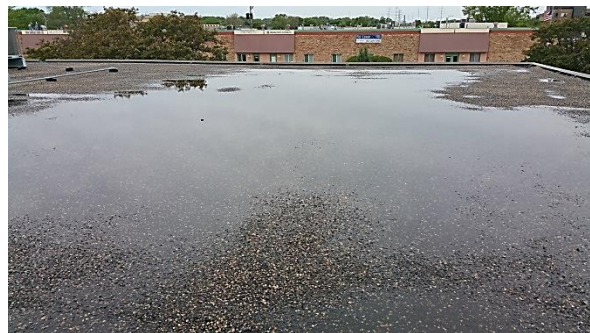
- low slope _____ ☒ major ponding water
- membrane _____ ☒ wind scoured
- flashing _____ ☒ worn vertical curb membrane, seams, and corners
- flue pipes _____ ☒
- equipment _____ ☒ abandoned equipment
- internal drains _____ ☒
- scuppers _____ ☒

Ponding water

- ✓ grounds___low
- ✓ walls___low
- ✓ roof___medium (ponding water)

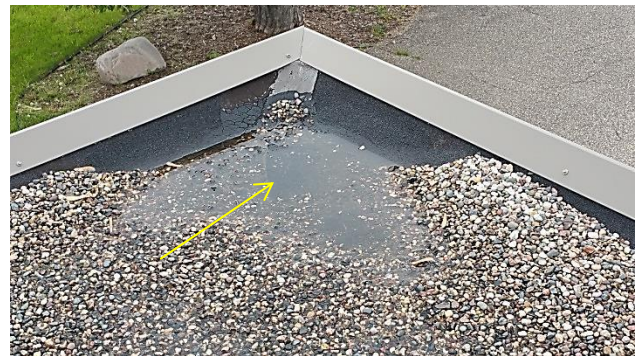
Wind scoured

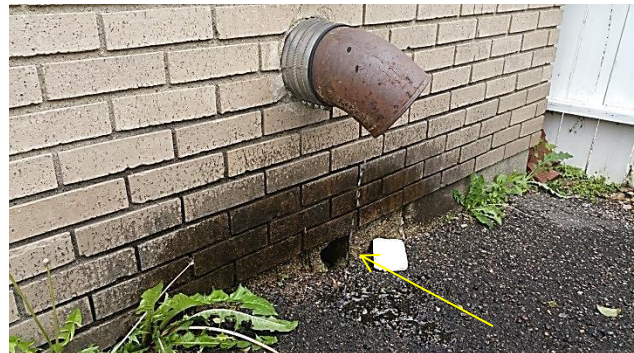
Foundation

walls _____ ✗.... damaged foundation at roof drain

- ✓ Damaged foundation at roof drain exterior discharge location.

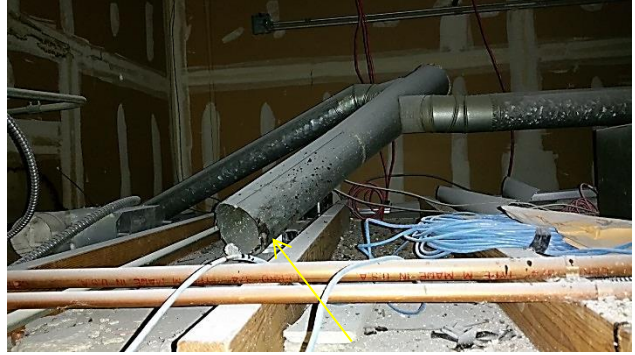
Bath vents

vent pipes _____ ✗.... disconnected restroom exhaust fans

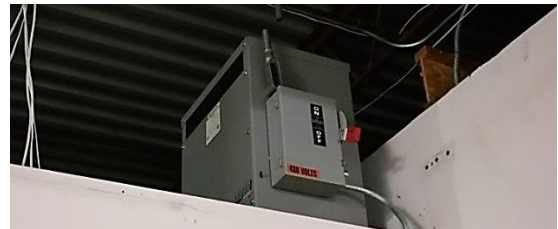
Transformer

Transformer_____⊗.... disconnected / inoperable

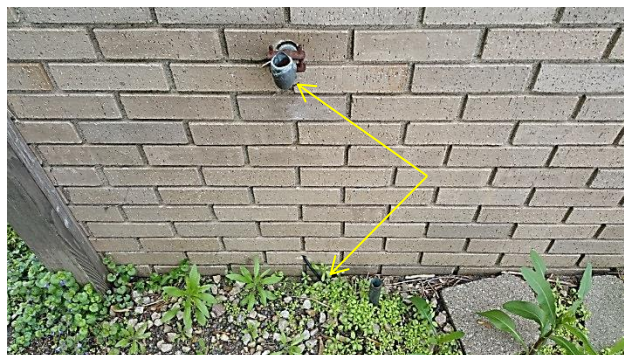
- main pipe _____ ●
- interior pipes _____ ●
- water heater _____ ○.... leaking flue pipe / water stained ceiling
- exterior spigots _____ ⚠.... no spigot handle & not viewed operating
- yard sprinkler _____ ✗.... disconnected / inoperable

Disconnected sprinkler

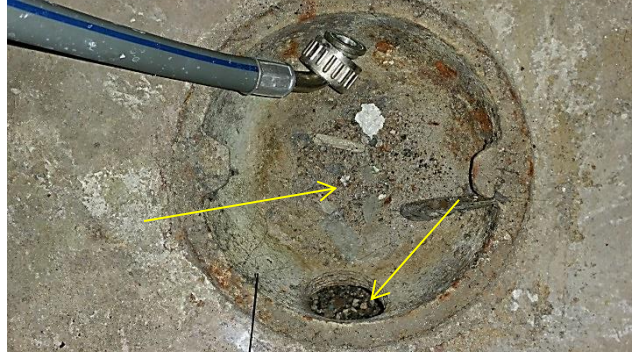
Floor drain

- sewer _____ ⚠.... not visible
- soil stack _____ ●
- drain/vent pipes _____ ●
- floor drain _____ ✗.... plugged drain / missing cleanout plug
- slop sink _____ ○.... abandoned standpipe

- ✓ Disconnected (inoperable) yard sprinkler.
- ✓ Plugged mechanical room floor drain and missing cleanout plug.
- ✓ Uncapped and abandoned mechanical room standpipe (unless clothes washer installed).
- ✓ Flexible lunchroom sink drain pipe.
- ✓ Corroded restroom #1 sink drain pipe and inadequate toilet space.
- ✓ Loose restroom #2 toilet. Corroded sink drain pipe.

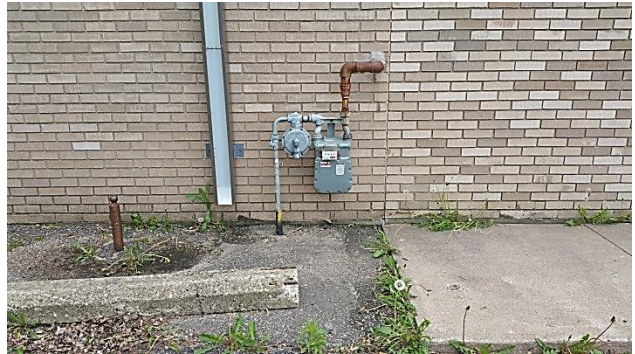
no parking lot bollard

No bollard

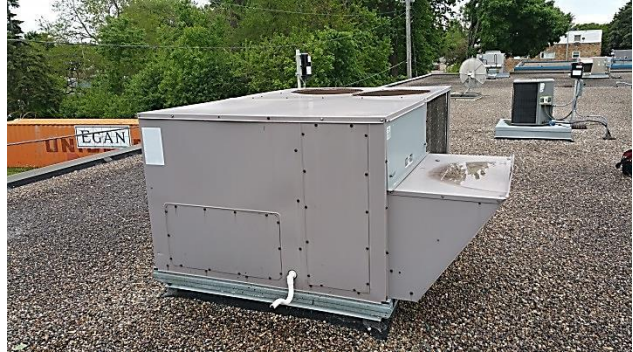
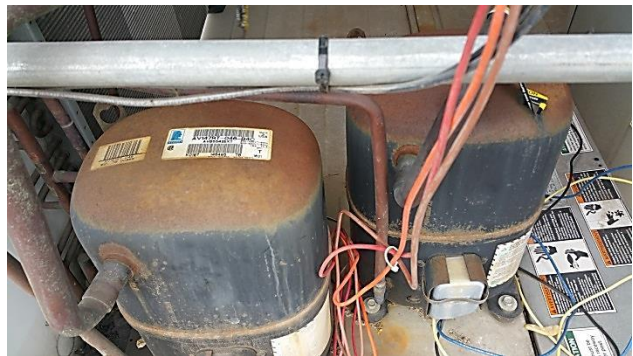
Compressors

- jacket_____●
- heat exchanger____●
- distribution_____●
- vent_____●
- condenser_____●
- compressors_____⚠.... rusted compressors / too cold & not viewed operating
- wiring_____●

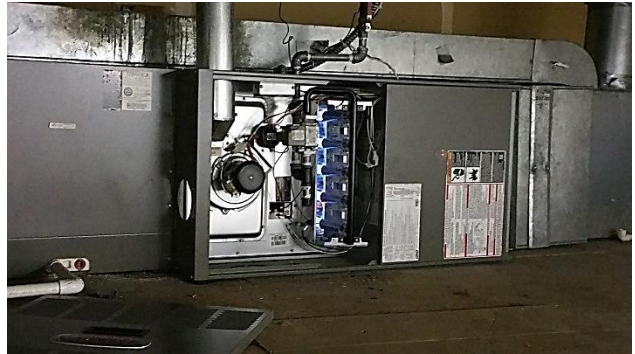
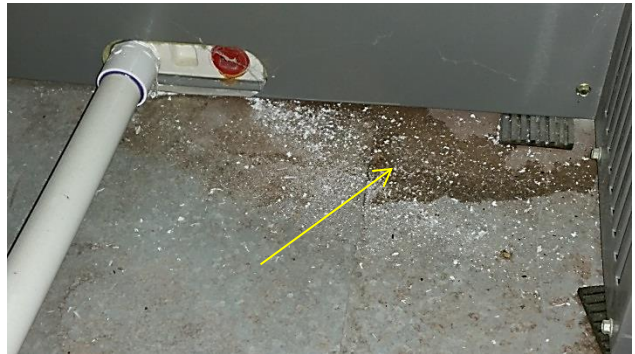
Leaking condensate tray

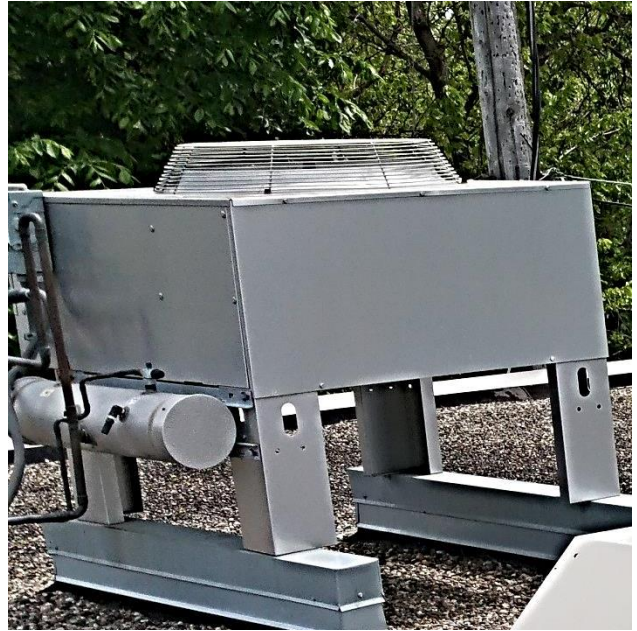
Liebert

Rooftop AC (Liebert)_____ ⚠️.... disconnected & not in use

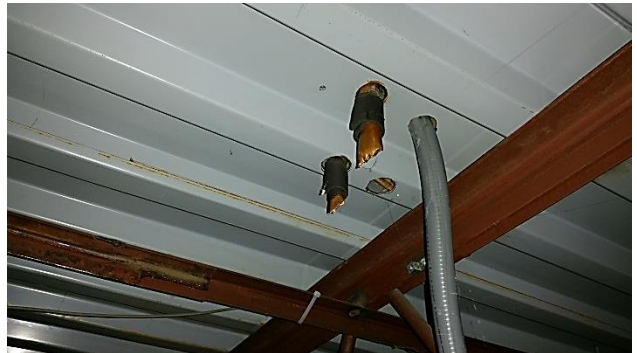
Disconnected refrigerant pipes

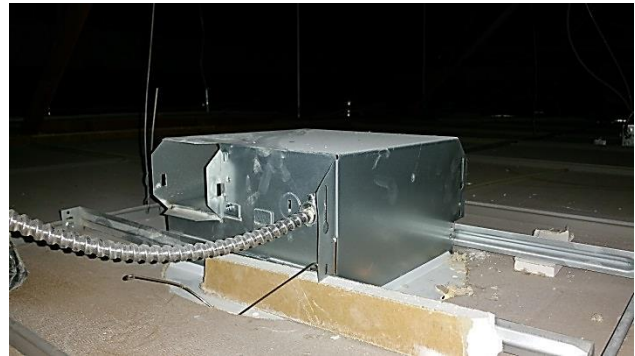
Bath fan

- wall, ceiling, floor___●
- fan and door___☒.... disconnected vent pipe / undersized door width
- outlet and fixture___●
- plumbing_____●
- handicap bars_____●
- cabinet and top_____●

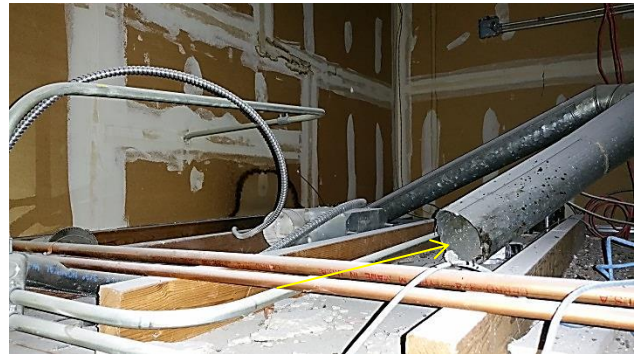
- wall, ceiling, floor___●
- fan and door___☒.... worn fan bearings / unvented fan
- outlet and fixture___☒.... no outlet
- heat___●
- plumbing___☒.... loose toilet / corroded sink drain pipe
- cabinet and top___●

Unvented fan

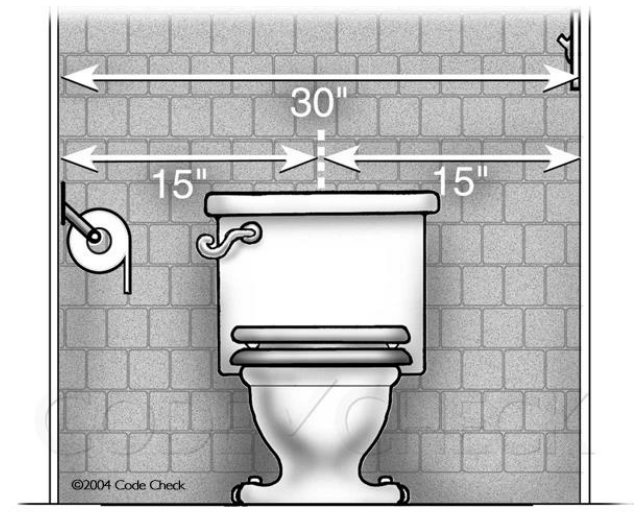
- wall, ceiling, floor___●
- fan and door___☒.... disconnected vent pipe
- outlet and fixture___☒.... no outlet
- heat_____●
- plumbing___☒.... corroded sink drain pipe / inadequate width
- cabinet and top_____●

Toilet Clearances
