On 7/30/2018, Cities' Inspection Service, Inc. completed a building inspection of the property located at XXXXXX, XXXXXXXXXX, Minnesota for you. Doug Hastings did all the fieldwork related to this project. Doug used the commercial inspection protocol; the Standard Guide for Property Condition Assessment – ASTM Standard E2018-01.

Exterior

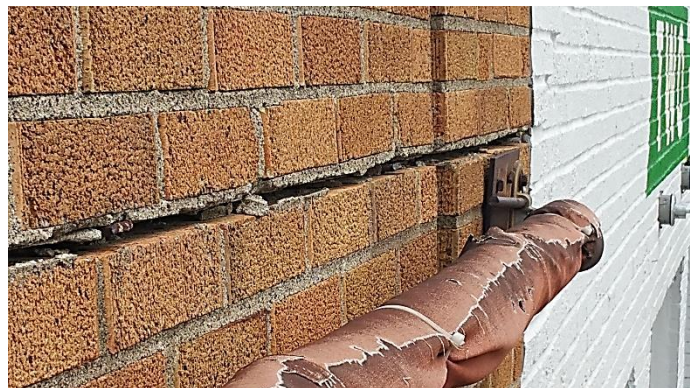
covering _____ ⊗.... loose & bowed bricks / rusted steel lintels

Bowed bricks

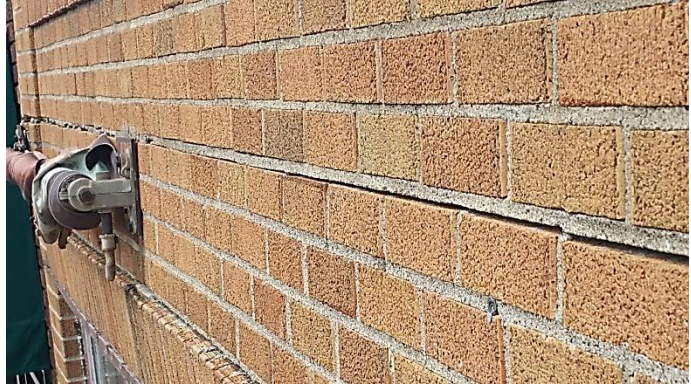
Bowed bricks

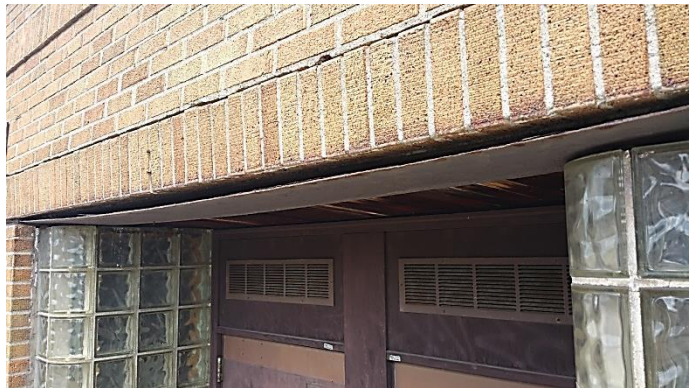
Rusted & sagged steel lintel

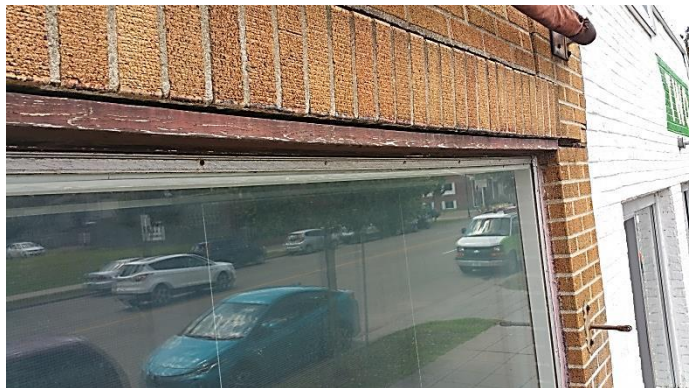
Rusted & lifted steel lintel

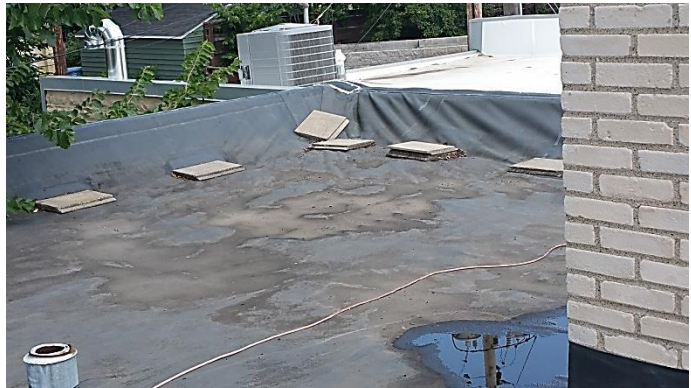
Loose & stretched membrane

- ✓ Re-roofing to include removing old materials and adding additional insulation. Anticipate replacing sections of roof boards.

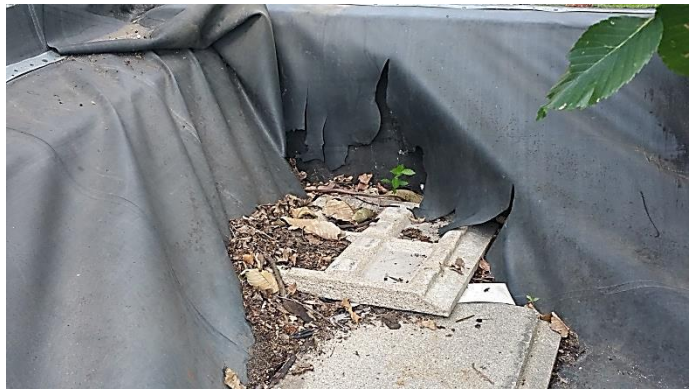
Torn membrane

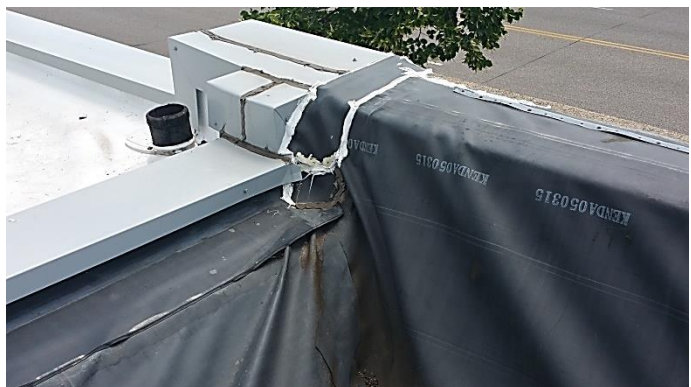
Loose, wrinkled, & caulked membrane

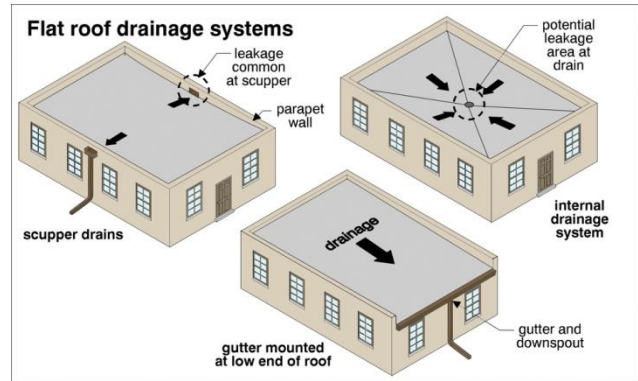
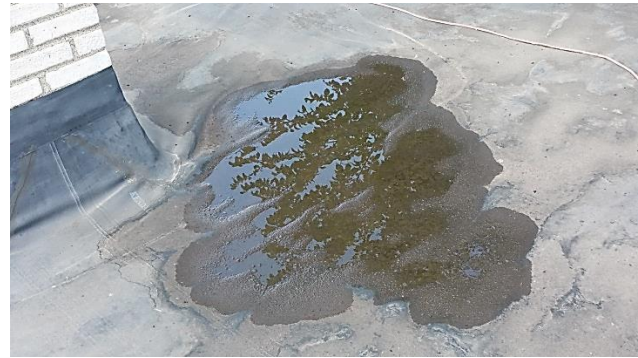
Ponding water

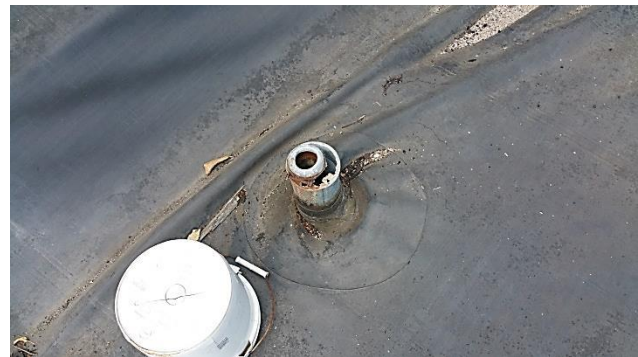
Vent flashing

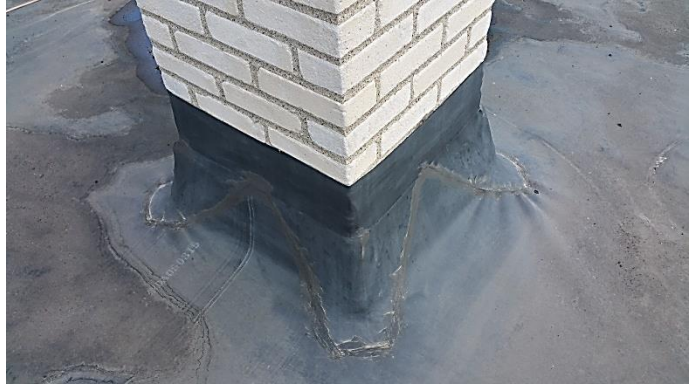
No flashing bar

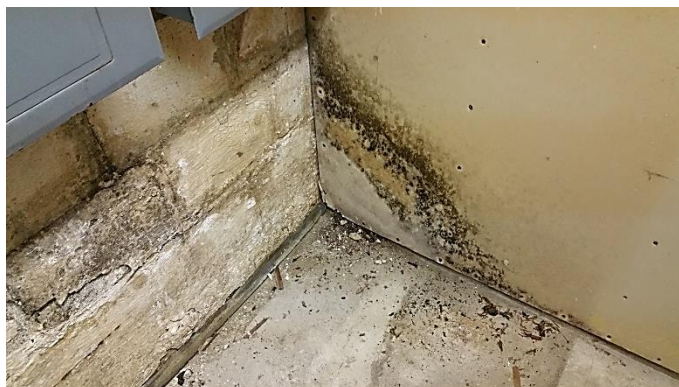
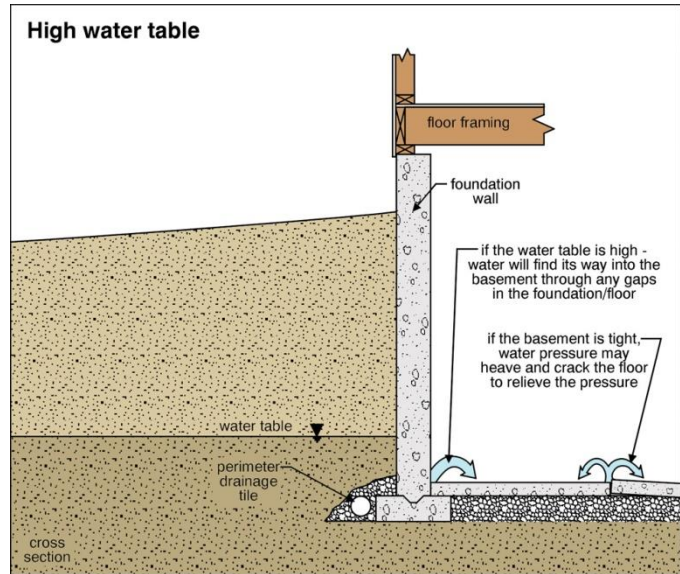
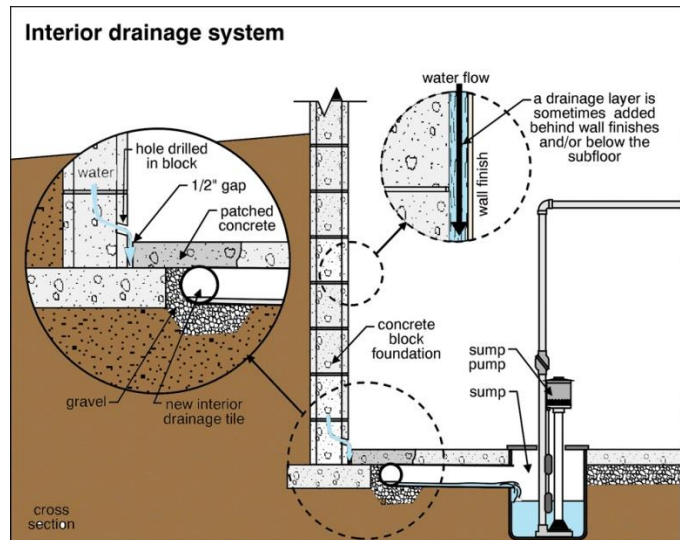
- walls _____ ✗.... wall & floor water stains (all sides) / high water table
- floor slab _____ ●
- sump/drain tile ___ ⚠.... sump not accessible (behind built in steps) / pump & drain tiles not visible / discharged into city sewer

- ✓ High water table; foundation drain tile, sump and pump must operate to keep the basement dry; recommend adding a battery backup pump.
- ✓ Old buildings have various environmental concerns; prior to disturbing you should test the building materials so that you handle them properly. This includes, but is not limited to, asbestos and lead paint.

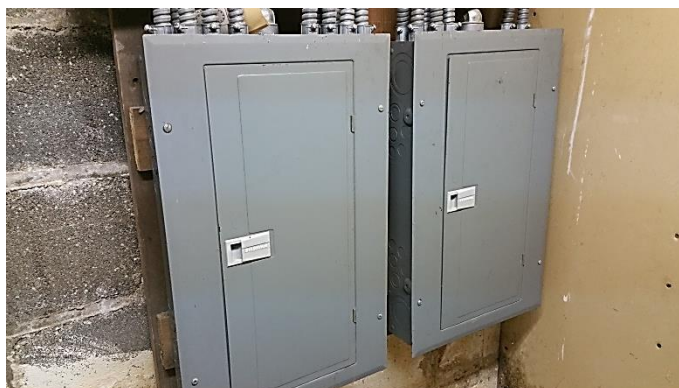
Utility service_____ ✗.... improperly located utility meter panels / undersized service entrance wires

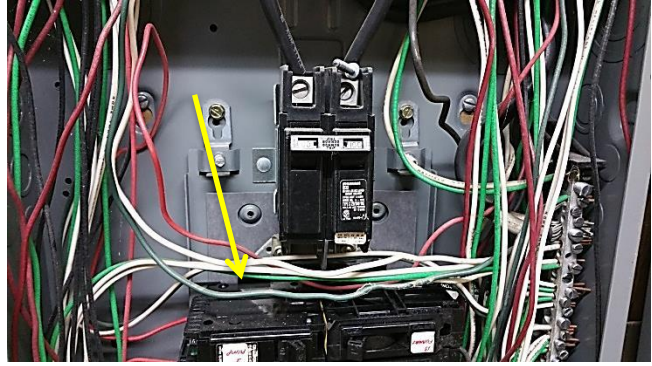
Wires crossing bus bar

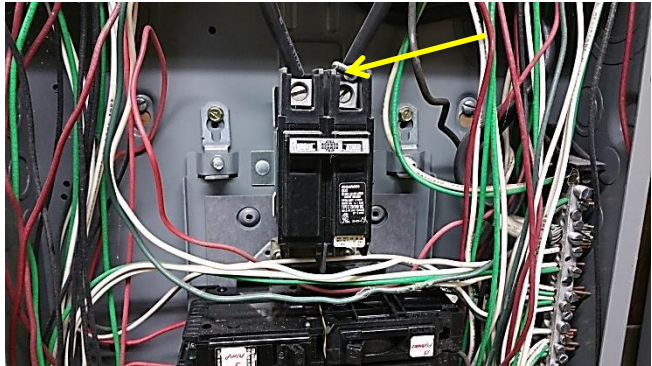
Loose screw on main disconnect

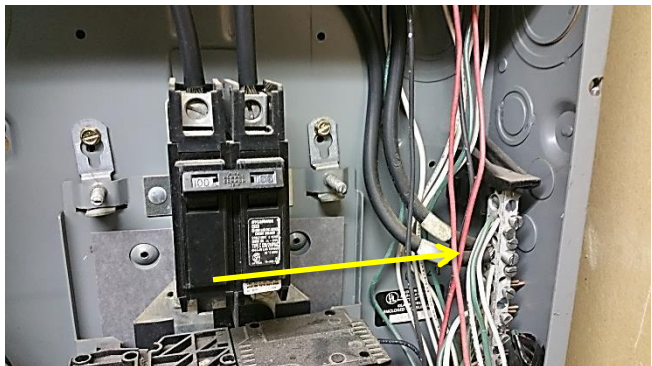
wiring _____ ☒ both panel neutral bars are bonded / ungrounded panel
