September 1, 2019

On 8/27/2019, Cities' Inspection Service, Inc. completed a home inspection of the property located at XXXXX, XXXXXXXX, Minnesota for you. Doug Hastings did all the fieldwork related to this project. Doug used the national home inspection protocol; the American Society of Home Inspectors (ASHI) Standards of Practice.

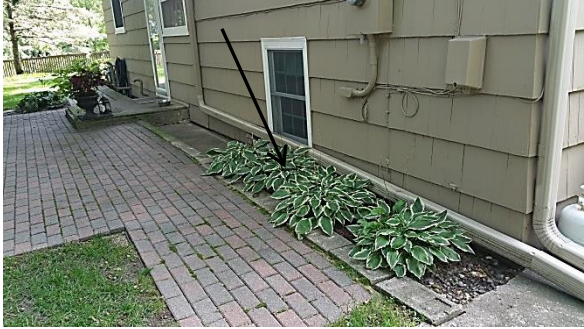
- front \_\_\_\_\_ ●
- left side \_\_\_\_\_ ⊗ .... negative slope
- right side \_\_\_\_\_ ●
- rear \_\_\_\_\_ ⊗ .... ponding water on foundation

Rear – ponding water

- ✓ Earth grade does not slope away from and is ponding water on the foundation (basement, lower level, and garage moisture intrusion). Only the portions adjacent to the lower level bedroom and garage can be corrected.
- ✓ Loose, tipped and bowed retaining walls.

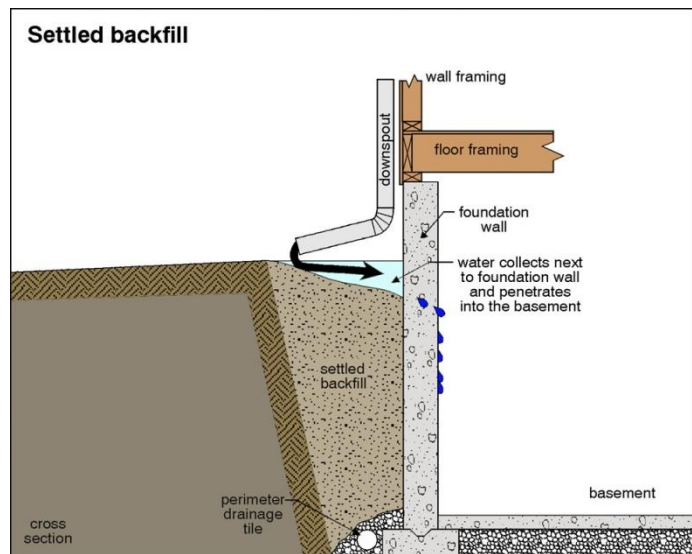
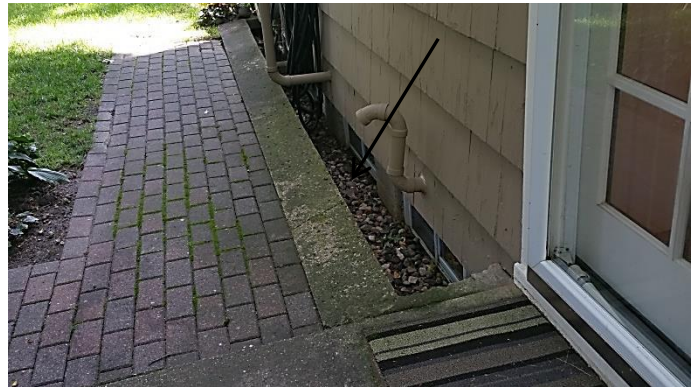
Rear – ponding water

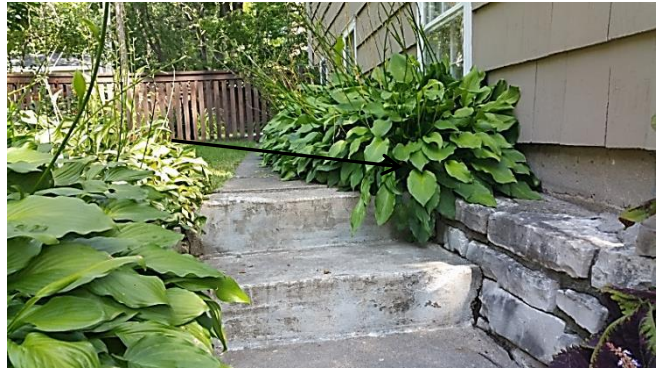
- steps \_\_\_\_\_ (O).... no handrails
- walks \_\_\_\_\_ (X).... negative slope (left side)
- patio \_\_\_\_\_ (O)
- retaining walls \_\_\_\_\_ (X).... loose, tipped, & bowed stones
- driveway \_\_\_\_\_ (O).... cracked concrete apron

Walk – negative slope

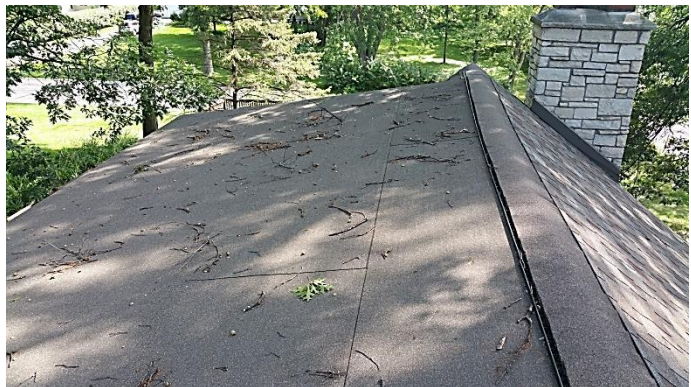
Low slope roof – no problems

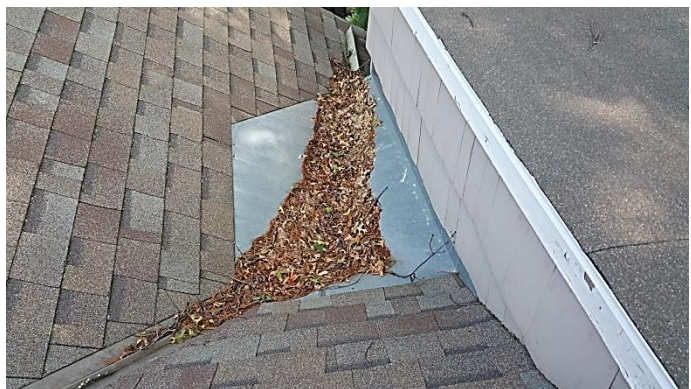
flashing\_\_\_\_\_⚠️... restricted rear valley drainage

Restricted drainage – ice dams

- ✓ No front entry and garage step handrails.
- ✓ Cracked driveway apron.
- ✓ Decayed fence posts and boards.
- ✓ Deteriorated shed roof shingles.
- ✓ Cracked paint and weathered wood wall shakes and trim (high maintenance).
- ✓ Missing roof gutter guards; plugged gutters.
- ✓ Restricted rear roof valley drainage (ice dams); this is a built in design deficiency and cannot be corrected.

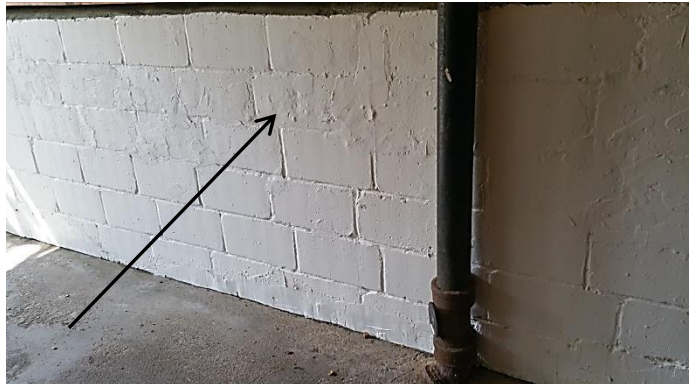
Patched blocks (water damaged)

- ✓ Water damaged foundation blocks and water stained wood paneling.
- ✓ Unprotected heat duct (not fire rated). Wood wall paneling is not fire rated.
- ✓ Water stained ceiling below upper bath.

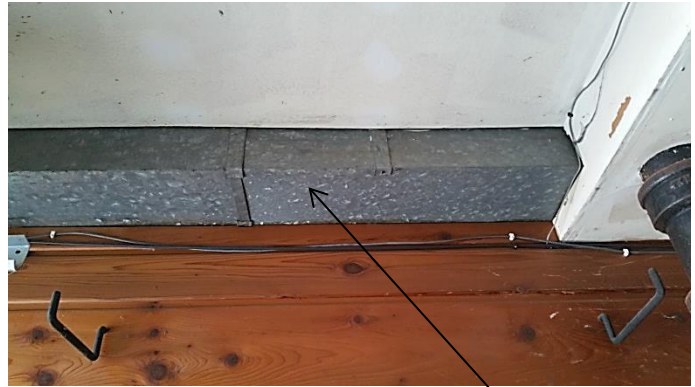
Unprotected duct

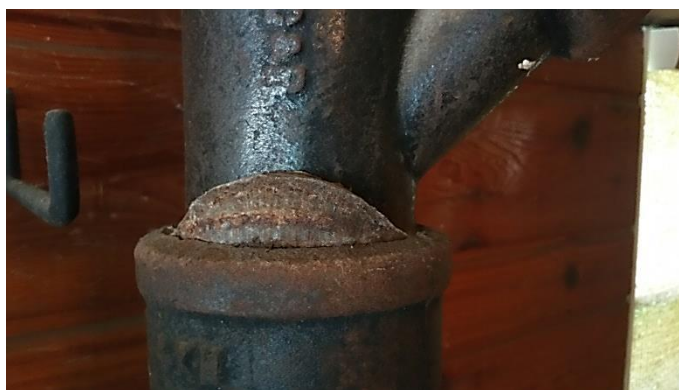
Loose lead connection

- ✓ Loose garage soil stack cast iron lead connection.
- ✓ Roof vent stacks too close to windows.
- ✓ Leaking basement copper waste pipe connection.
- ✓ Basement standpipe is too tall and improperly wet vented.
- ✓ Main level dishwasher improperly discharges into basement standpipe.
- ✓ Inoperable water softener (water tested hard).

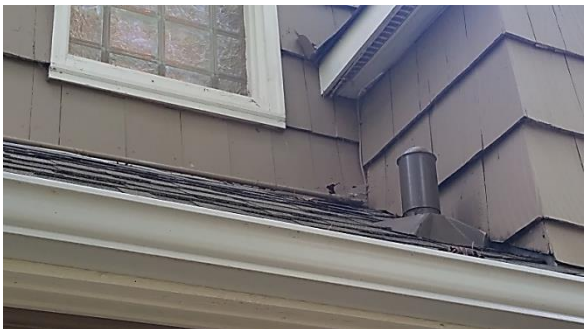
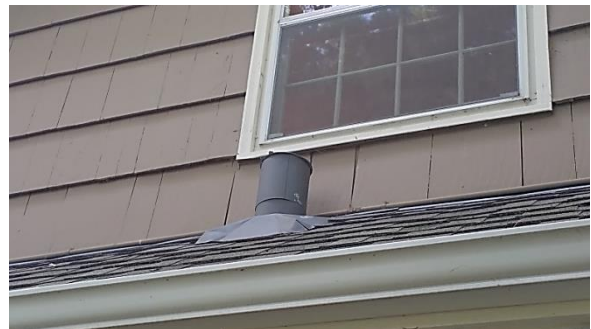
Too close to window

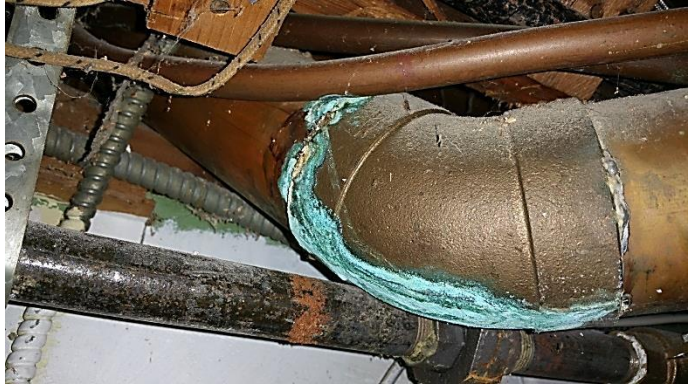
Leaking pipe

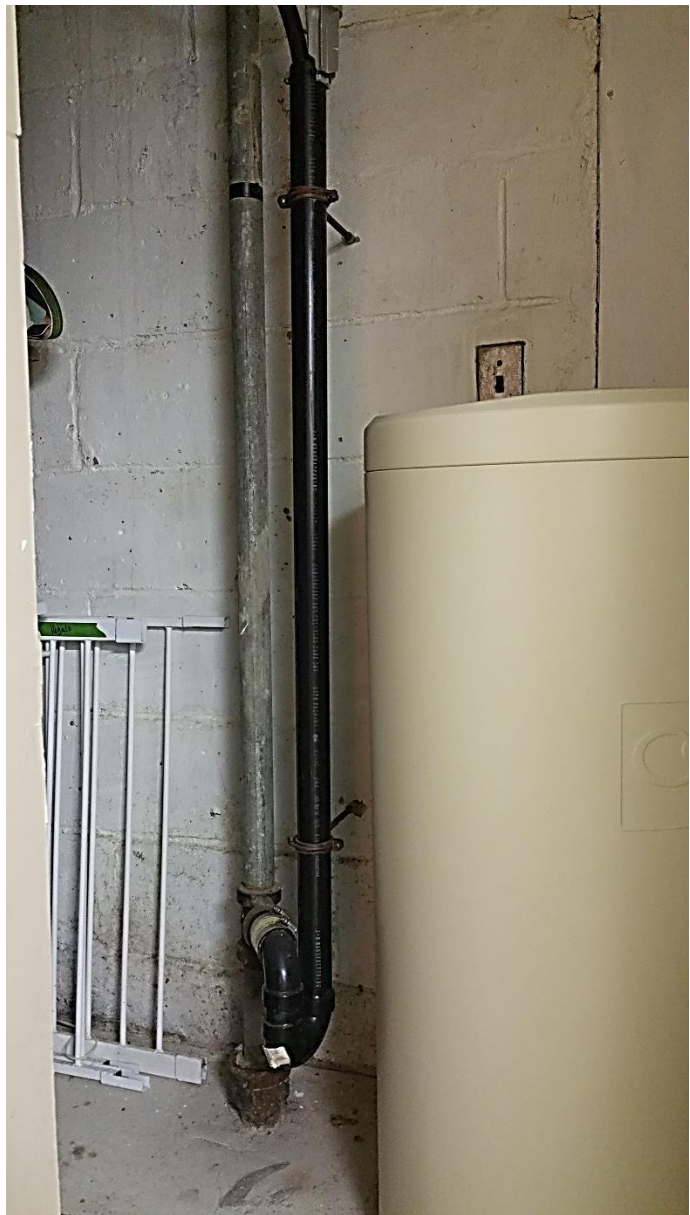
Standpipe too high

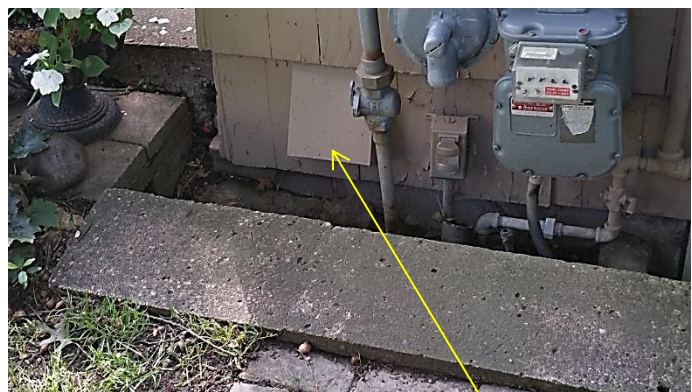
Too close to ground

- ✓ Furnace outside air supply exterior vent cover is too close to grade (snow will block).
- ✓ No lower level bedroom supply and return air registers. Inadequate amount upper top level supply registers and no return air register. No upper level top bath supply air register.
- ✓ One basement rec room supply register has no air flow. No rec room return air register.
- ✓ Old air conditioner; short useful life.

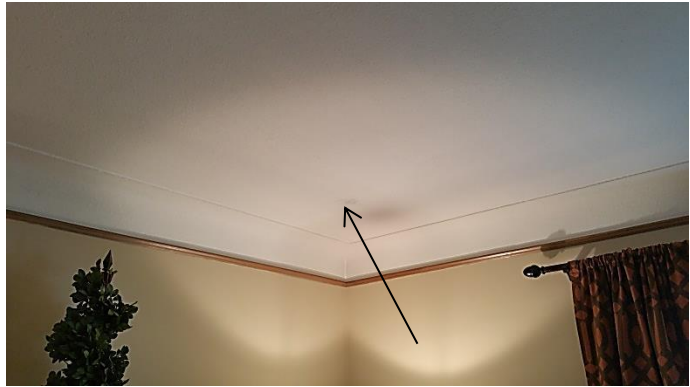
- wall, ceiling, floor ☒ .... water stained ceiling (ice dam)
- window and door ☒ .... inoperable storm window cranks
- outlet and fixture ☒
- heat ☒ .... no supply register at patio door
- wood fireplace ☒ .... flue tiles not visible / gas log ignitor not viewed operating (no handle)

Water stained ceiling

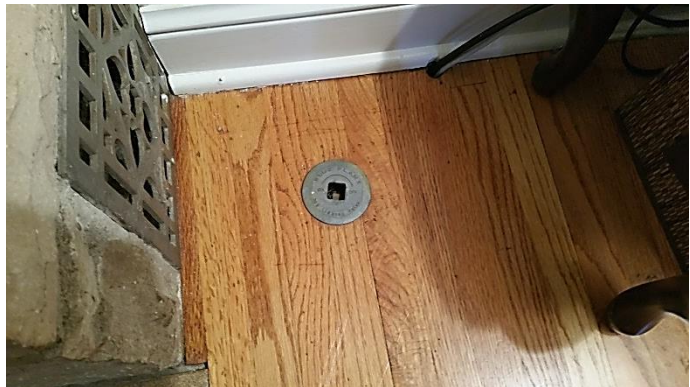
most gas igniters have few safety features and may not be permitted in some areas - find out if they are allowed in your area

Fireplace gas shutoff
