On 8/19/2019, Cities' Inspection Service, Inc. completed a partial home inspection of the property located at XXXXX,XXXXXX, Minnesota for you. Doug Hastings did all the fieldwork related to this project. Doug used the national home inspection protocol; the American Society of Home Inspectors (ASHI) Standards of Practice.

Major System Inspection

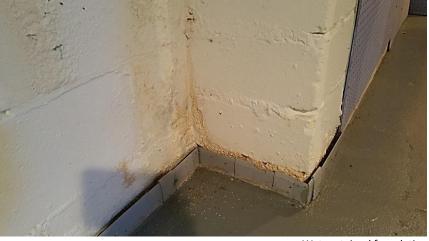
Water stained foundation

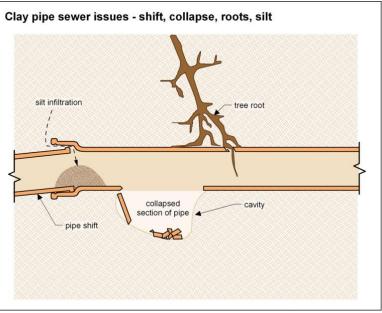
Sewer concern
