September 1, 2019

On 10/15/2018, Cities' Inspection Service, Inc. completed a second stage new construction inspection of the property located at XXXXXXXX, XXXXXX, Minnesota for you. Doug Hastings did all the fieldwork related to this project. Doug used the 2015 Minnesota State Building Code as the minimum construction standard.

Structure, Mechanical, Plumbing, and Electrical Rough-In Inspection

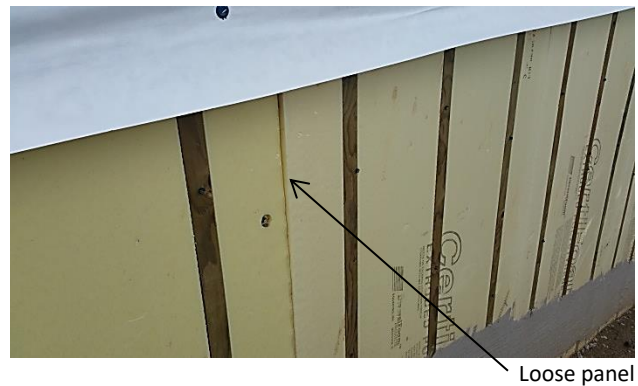
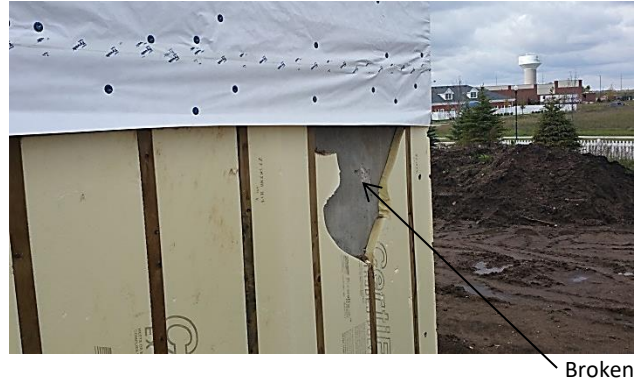
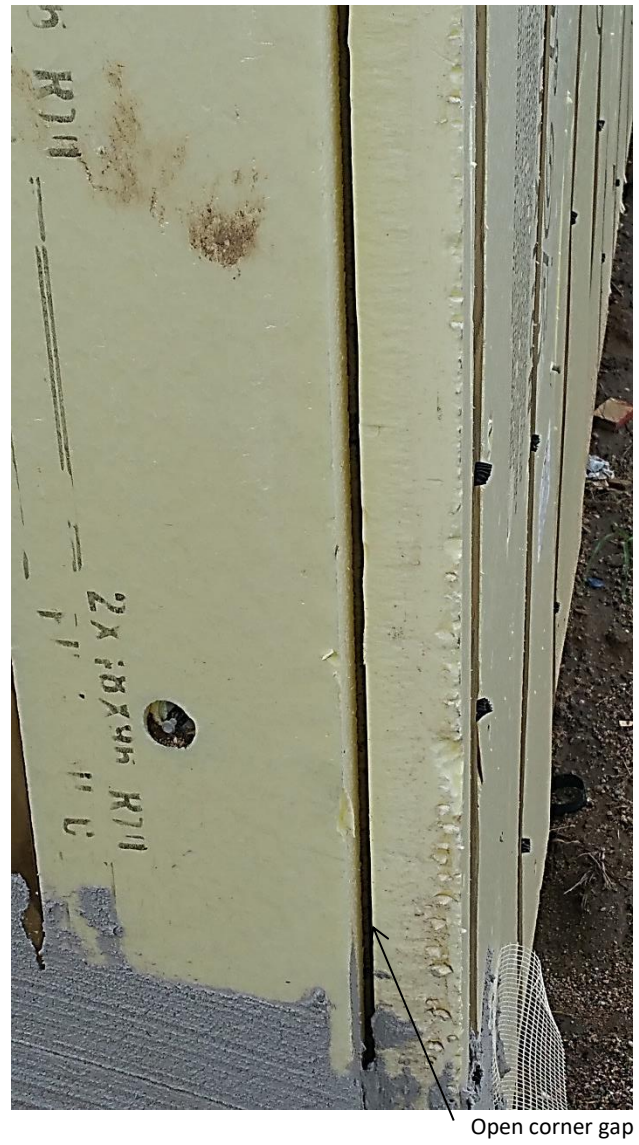
Insulation_____⊗.... loose & broken styrofoam panels / large corner gap

- ✓ Loose and broken foundation exterior styrofoam insulation panels.
- ✓ Garage floor will be installed on unstable backfill. Steel rods do not eliminate hollows and settled concrete.

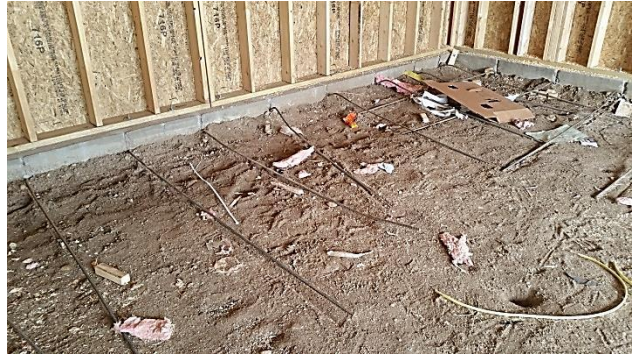
Floor slabs_____⊗.... basement and garage slabs supported on unstable backfill

Uncompleted garage floor

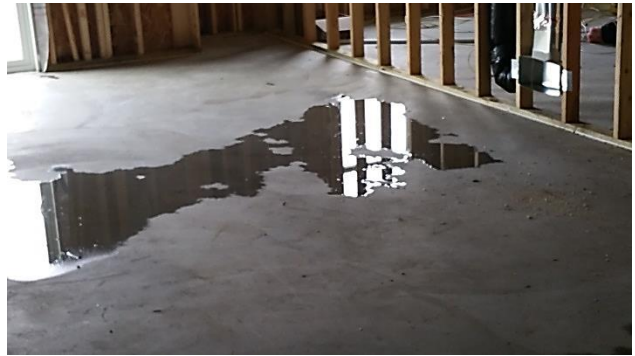
Completed basement slab

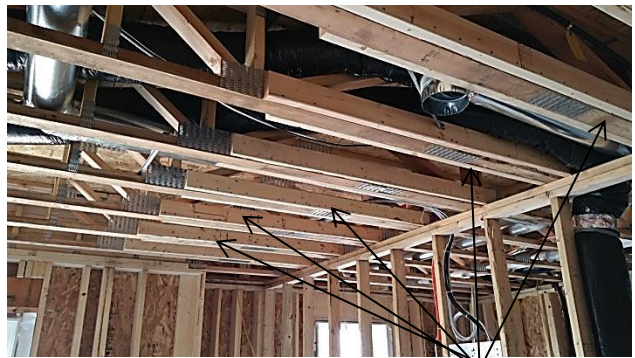
Trusses and subfloor_ ❌.... broken & field modified basement trusses / unfinished main level metal hanger nailing & incomplete truss beam end bearing

Broken trusses

- ✓ Damaged floor and roof trusses require truss manufacturer or structural engineer certification as to the field repairs. You should retain a copy of this document.

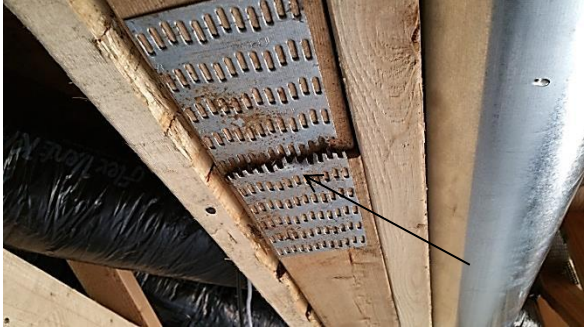
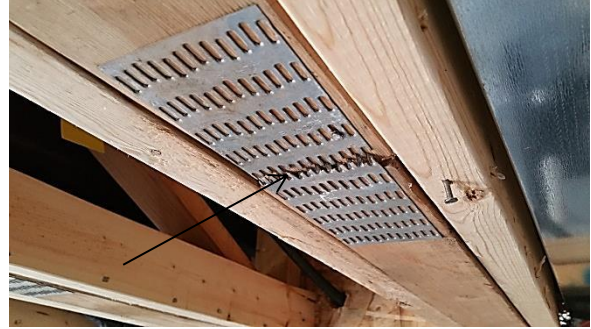
Damaged gusset plates

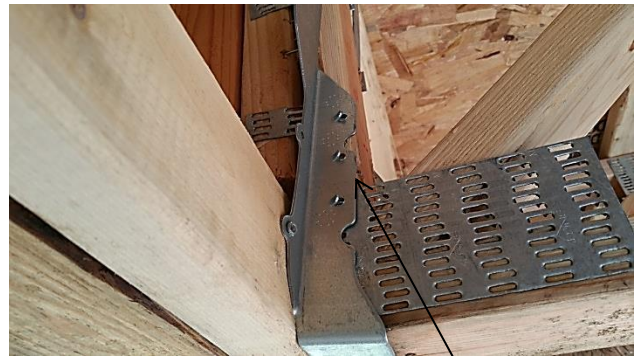
Joist hanger nails

- ✓ Dining room floor truss metal joist hanger nailing is incomplete. Verify wall bearing points on double floor truss (at cantilever) are per manufacturer specs.

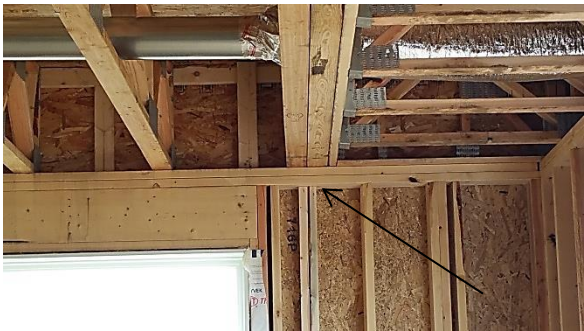
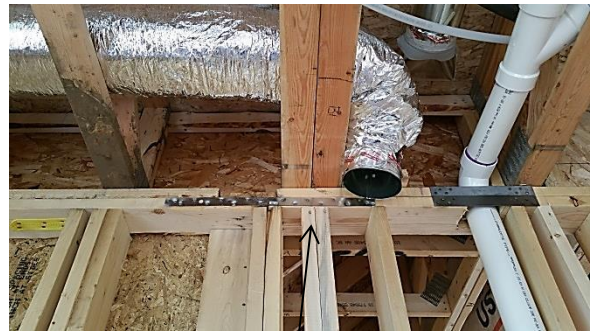
Main level beam end bearing

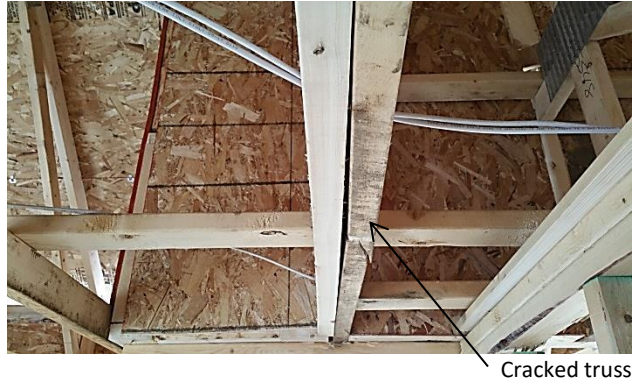
Trusses and boards _____ (⊗....) damaged trusses
 Overhangs _____ (●....) not completed

Cracked truss

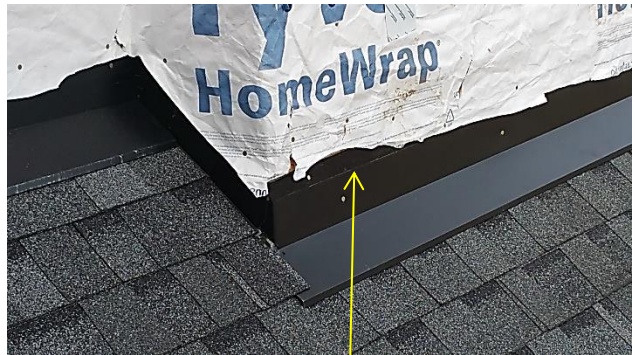
Short housewrap & no tape

- ✓ Loose housewrap and not seam taped at foundation and roof flashing.
- ✓ Gathering room awning windows not tempered glass (not marked).
- ✓ Upper front bedroom broken top sash window glass stop.

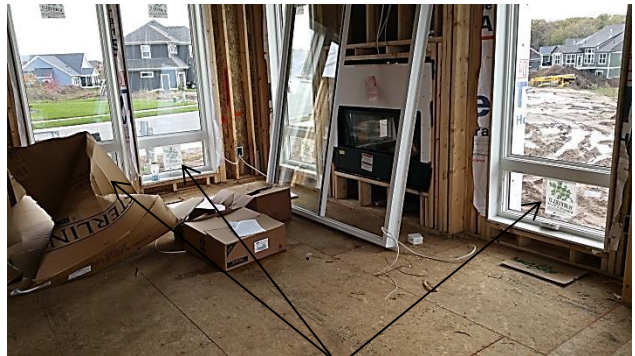
Windows glass not tempered

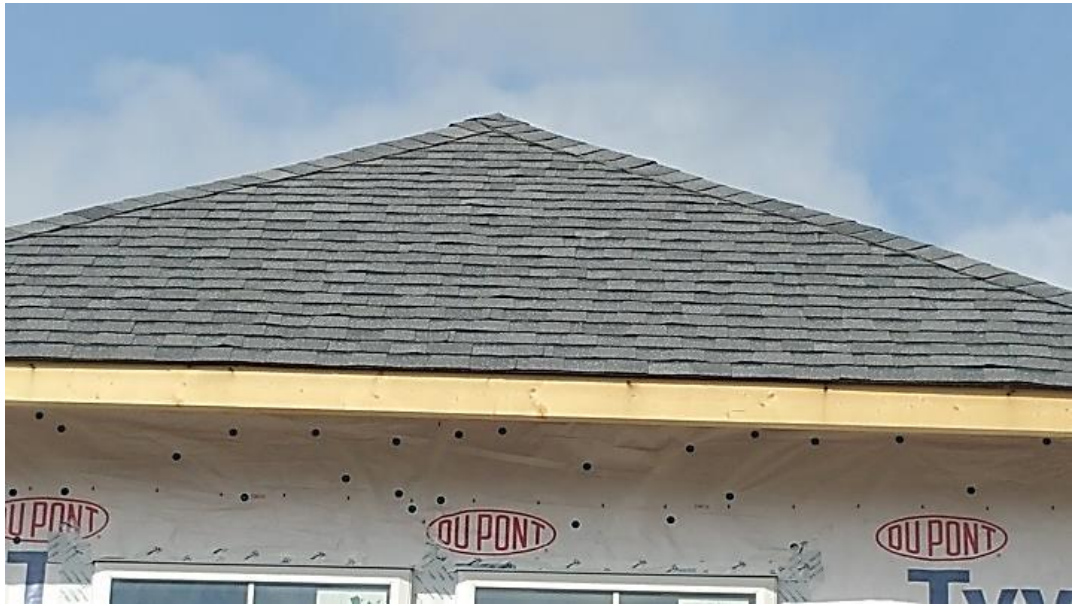
Shingles _____ ✗.... uneven, buckled, ridged, & lifted shingles & underlayment / crooked hip ridge shingles / poorly installed front valley shingles

Buckled, lifted, & uneven shingles

- ✓ Roof shingles are not flat on the roof. Shingles on front valley are poorly installed. Hip ridge shingles are crooked.
- ✓ Upper level bathtub water pipes appear to be located on exterior wall in unheated cavity.

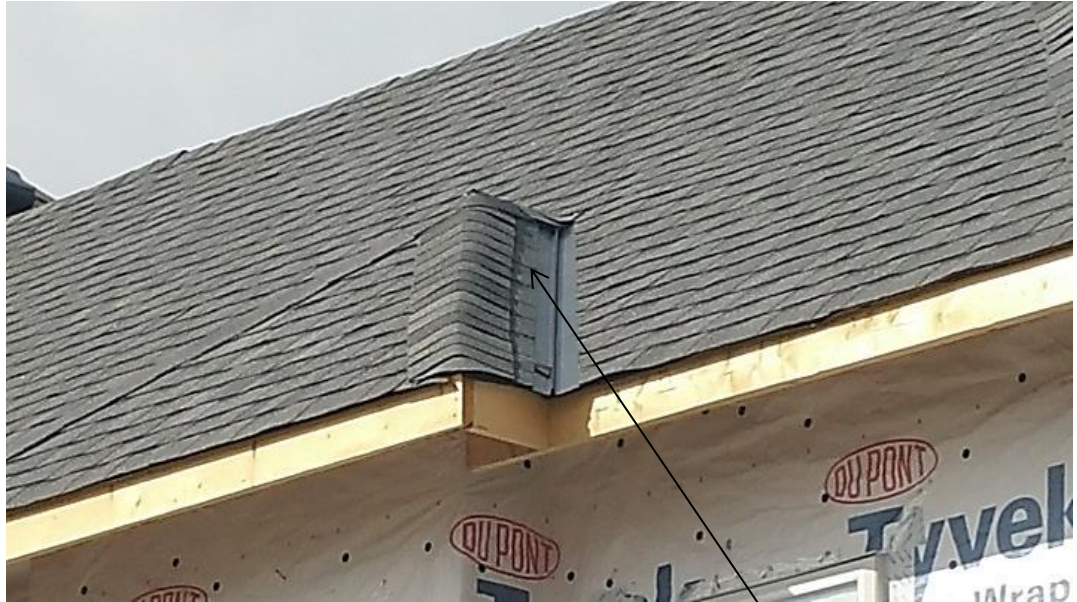
Poorly installed valley shingles
