On 12/13/2018, Cities' Inspection Service, Inc. completed the final stage new construction inspection of the property located at XXXXXXX, XXXXXXX, Minnesota for you. Doug Hastings did all the fieldwork related to this project. Doug used the 2015 Minnesota State Building Code as the minimum construction standard.

## Final Inspection

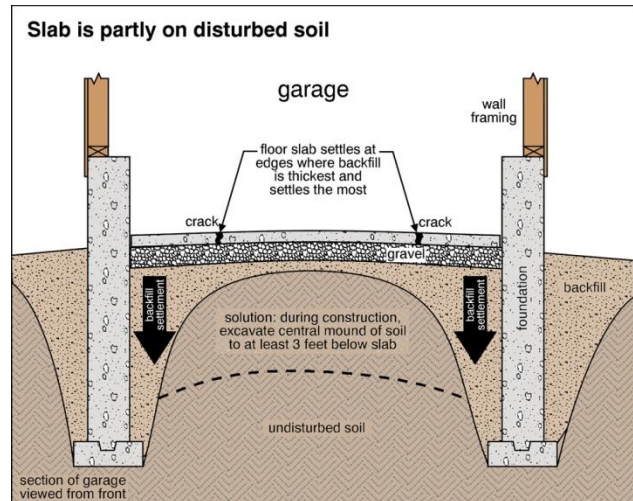
Soils and fill \_\_\_\_\_ (⊗).... unstable exterior & interior backfill (not compacted)

- Unstable (not compacted) exterior, interior, and garage soil backfill material (recommend making floor slabs and hardscaping a part of 10 year structural warranty).

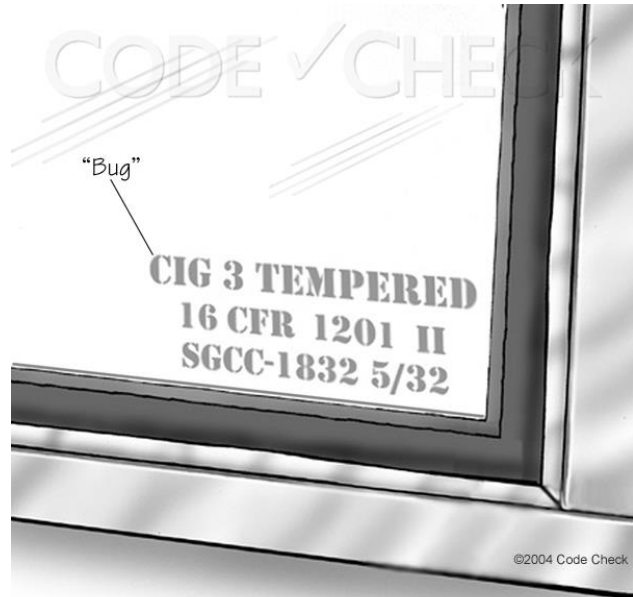
- Barriers and flashing\_\_\_\_\_●  
Siding and trim\_\_\_\_\_●  
Doors\_\_\_\_\_●  
Windows\_\_\_\_\_⊗.... gathering room windows not tempered (no document or bug)

Tempered Safety Glass

- Gathering room awning window tempered glass (manufacture document required).
- Buckled, ridged, and lifted roof shingles.
- Roof kickout flashing (front).

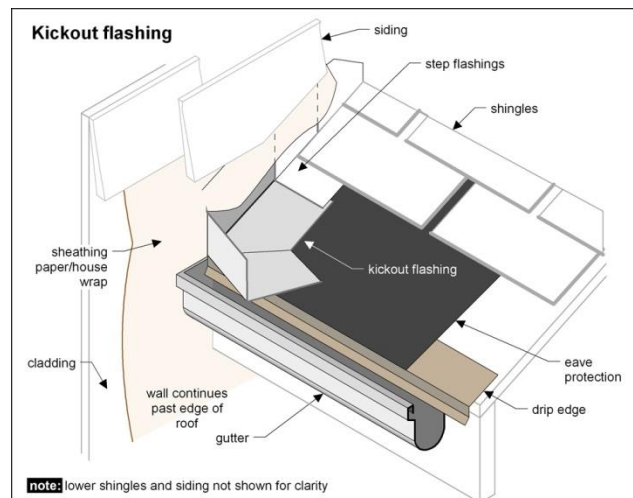
- Shingles\_\_\_\_\_ ☒.... uneven, buckled, ridged, lifted shingles
- Flashing\_\_\_\_\_ ☒.... missing kickout flashing
- Gutters\_\_\_\_\_ ☉.... incomplete (winter escrow)

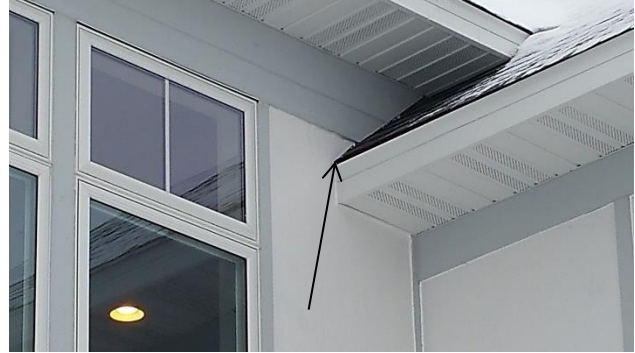
No kickout flashing

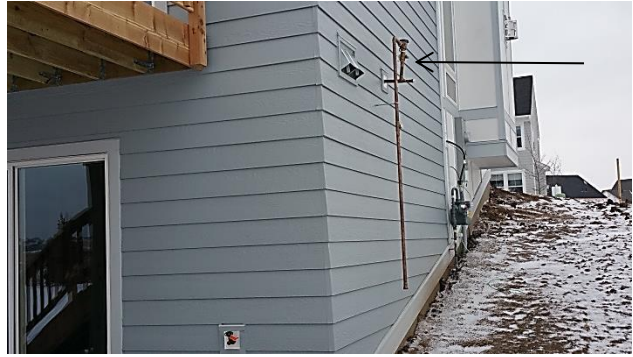
- Water supply\_\_\_\_\_●
- Interior water pipes\_\_\_☒.... UL bathtub located on exterior wall (no ventilation)
- Water heater (50g)\_\_\_●
- Waste pipes\_\_\_\_\_●
- Drain and vent pipes\_●
- Floor drain\_\_\_\_\_●
- Kitchen fixtures\_\_\_\_\_☒.... unsupported & poorly finished sink water piping
- Laundry fixtures\_\_\_\_\_☒.... unsupported & poorly finished sink water piping
- Bath fixtures\_\_\_\_\_☒.... unsupported & poorly finished sink & toilet water piping
- Bath rough in\_\_\_\_\_●
- Yard sprinkler\_\_\_\_\_☒.... incomplete (winter escrow) / poorly located vacuum breaker)
- Gas pipes\_\_\_\_\_●

Vacuum breaker

- Poorly located and extended yard sprinkler vacuum breaker.
- Missing furnace humidifier damper knob.
- Noisy ML bath exhaust fan.
- Unvented (should be vented) kitchen exhaust fan.

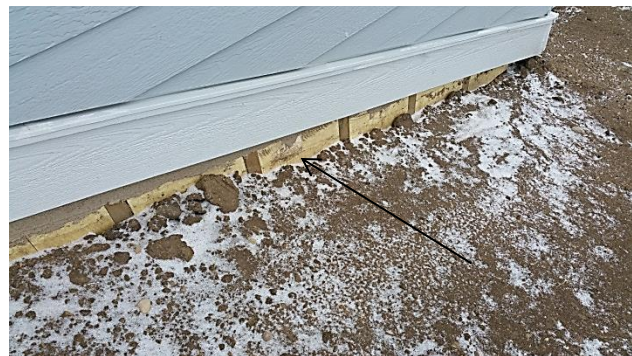
Foundation \_\_\_\_\_ ⊗.... incomplete styrofoam parging (winter escrow) / exposed, damaged & missing garage styrofoam  
 Rim Joist \_\_\_\_\_ ⊙.... not visible  
 Ground walls \_\_\_\_\_ ⊙.... not visible  
 Attic \_\_\_\_\_ ⊙.... not visible  
 Attic ventilation \_\_\_\_\_ ⊙.... not visible  
 Vapor retarders \_\_\_\_\_ ⊙.... not visible

Exposed styrofoam

- Exposed and missing pieces of garage foundation insulation.
- Disconnected UL window fall protection hardware.
- Garage fire door deadbolt lock out of adjustment.

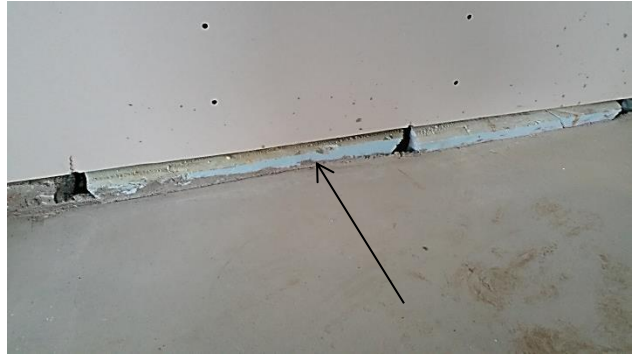
Damaged garage

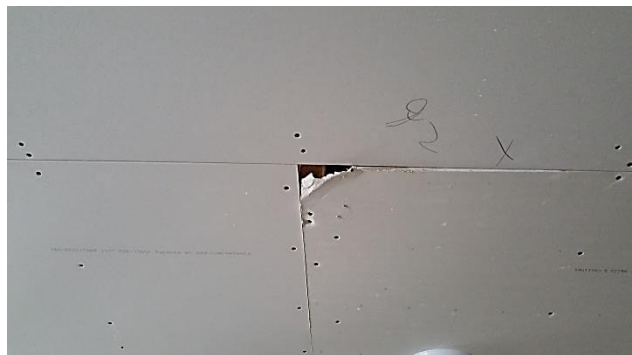
- Walls\_\_\_\_\_ ☒
- Ceilings\_\_\_\_\_ ☒
- Fire barriers\_\_\_\_\_ ☒.... hole in basement ceiling plaster

- No garage window trim (wall is finished).
- Hole in basement ceiling fire barrier.
- Paint on dining room floor register cover.
- Various UL doors top and bottom edges not painted.

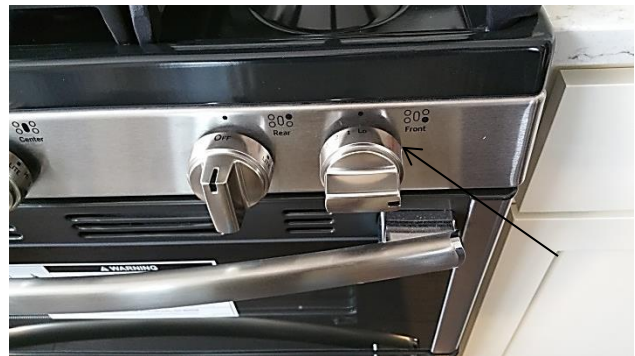
- Kitchen\_\_\_\_\_ ☒.... no refrigerator / inoperable burner knob / debris in disposal  
Laundry\_\_\_\_\_ ☒  
Water softener\_\_\_\_\_ ☒.... none (hard water)

Inoperable burner

- No refrigerator.
- Inoperable stove burner knob.
- Debris in disposal.
- No water softener.
- Dirty furnace and ducts.
- Final cleaning not completed.
