September 1, 2019

On 7/30/2019, Cities' Inspection Service, Inc. completed a home inspection of the property located at XXXXXXXX, XXXXXXXXXXXXX, Minnesota for you. Doug Hastings did all the fieldwork related to this project. Doug used the national home inspection protocol; the American Society of Home Inspectors (ASHI) Standards of Practice.

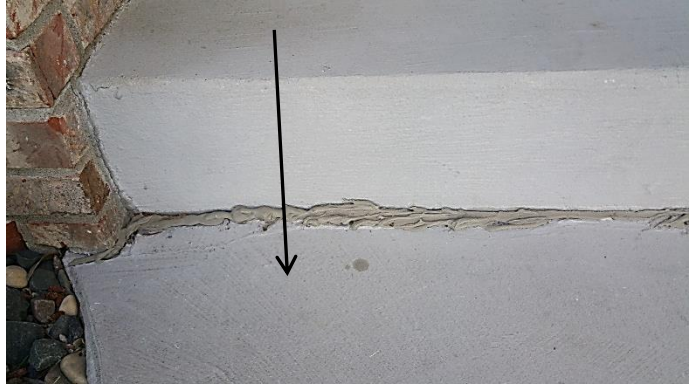
Settled front section walk

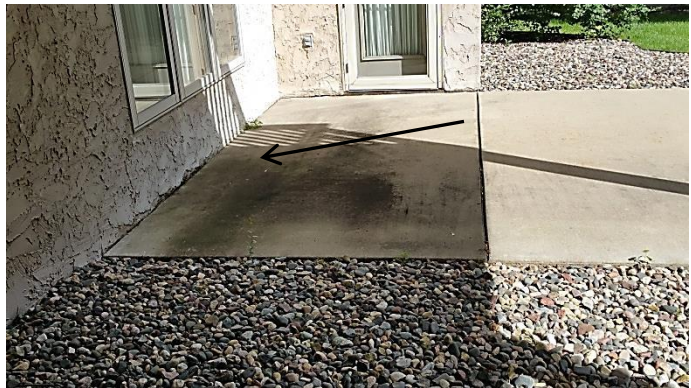
- steps \_\_\_\_\_ ⊗.... top coated
- walks \_\_\_\_\_ ⊗.... top coated / settled section at steps
- patio \_\_\_\_\_ ⊗.... settled concrete / negative slope / ponding water
- driveway \_\_\_\_\_ ⊗.... top coated / pitted concrete

Patio

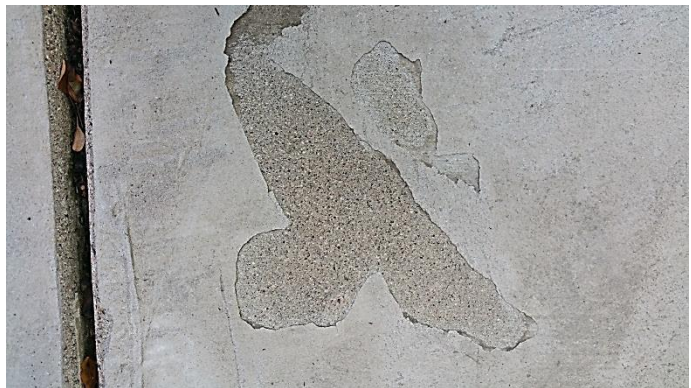
Top coated concrete

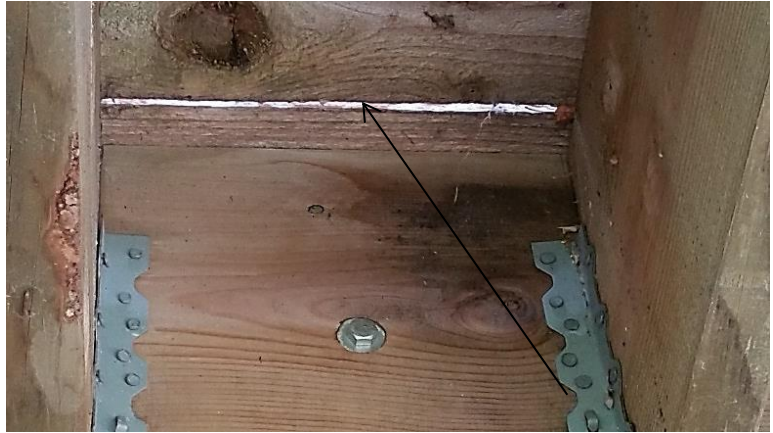
deck \_\_\_\_\_ ✗.... no ledger board flashing / decayed floor boards / guardrail  
embedded in stucco

No ledger flashing

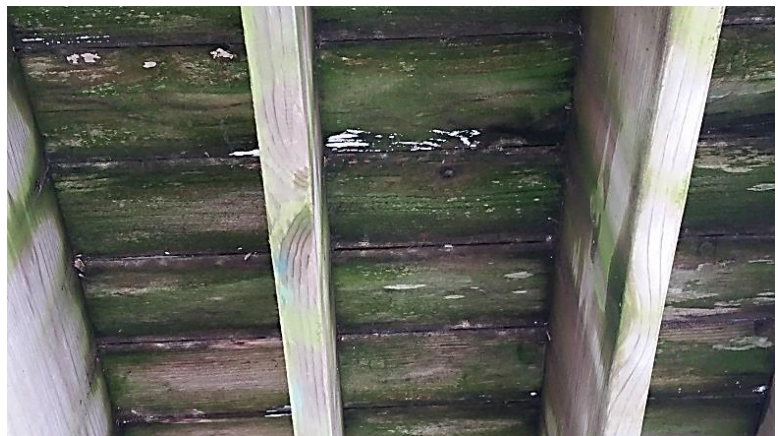
Decayed floor boards

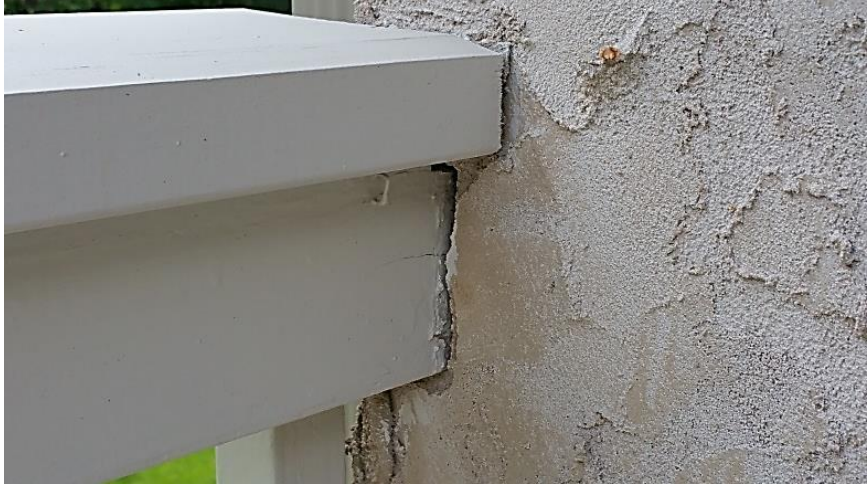
Guardrail in stucco (moisture intrusion)

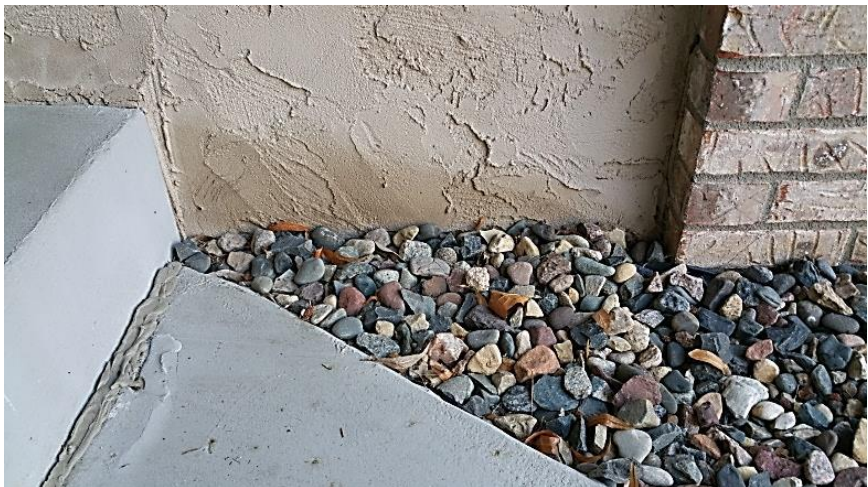
Stucco contacting earth

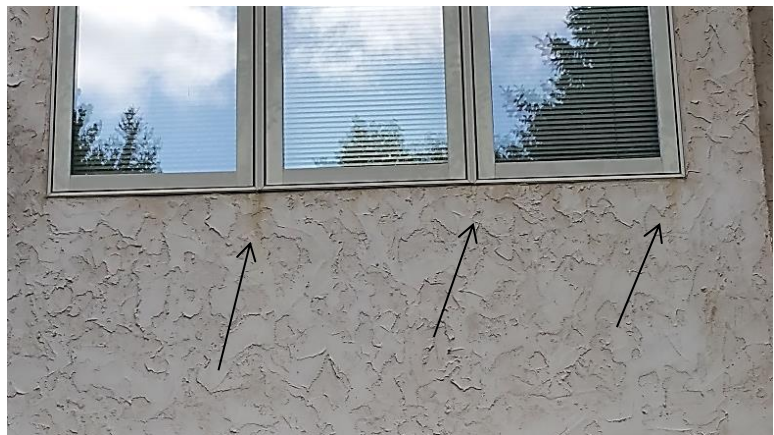
Water stains

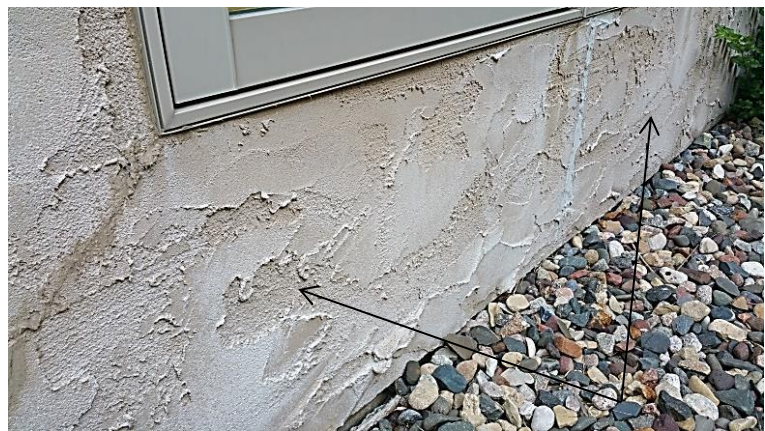
Loose stucco

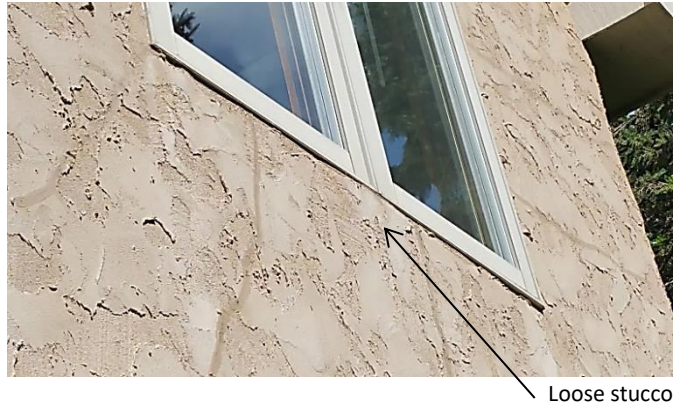
Loose stucco

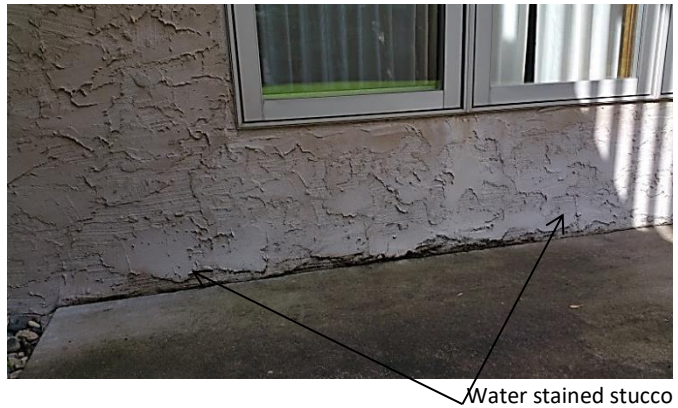
Water stained stucco

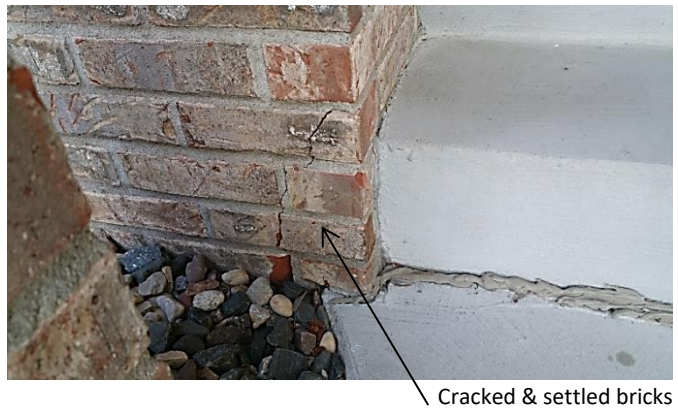
Cracked & settled bricks

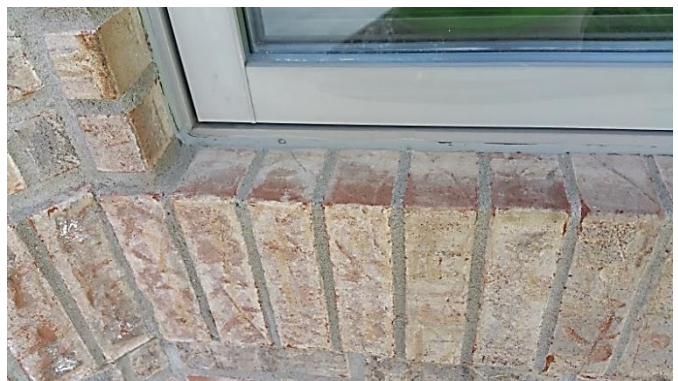
Flat window sill

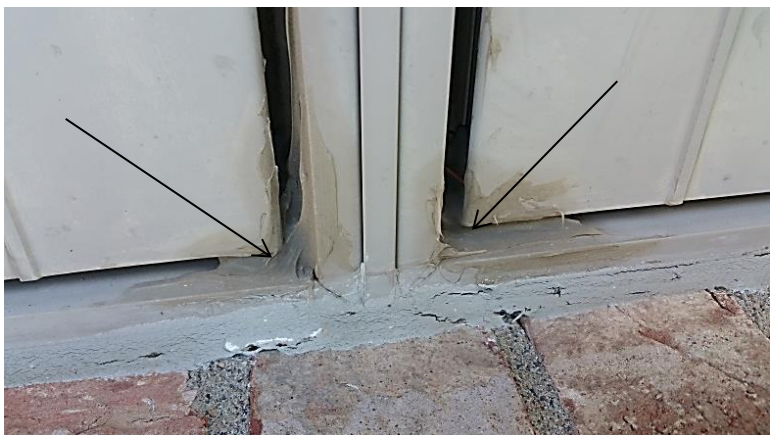
Excessive corner caulking (front only)

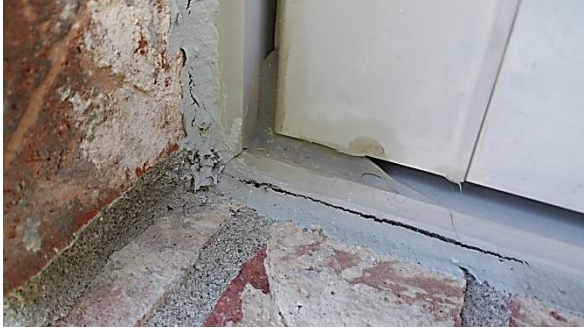
Excessive corner joint caulking (front only)

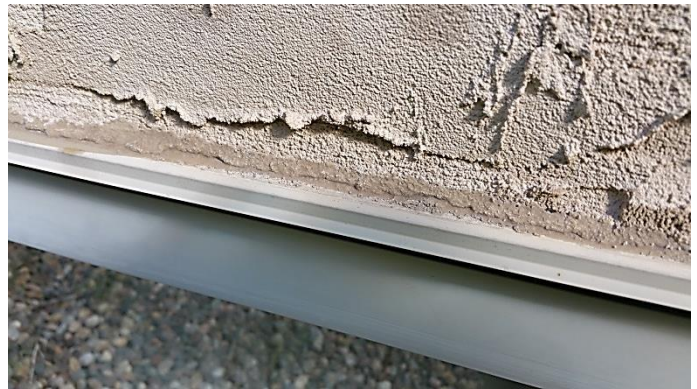
Caulked window top (traps moisture)

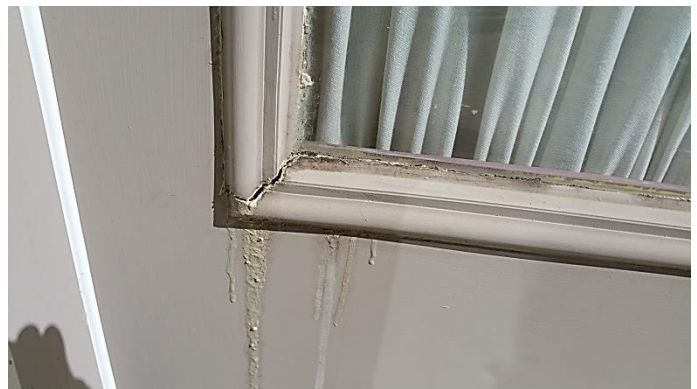
Cracked door trim

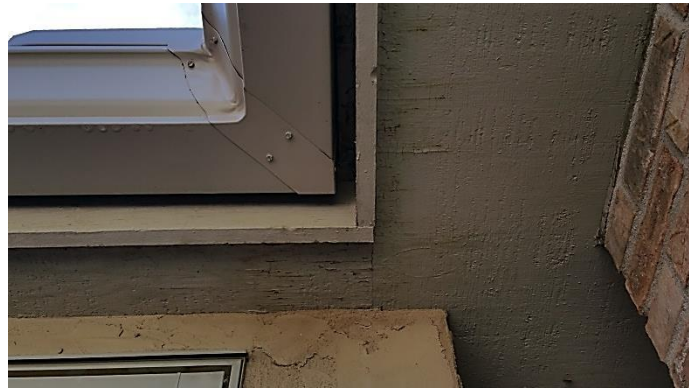
Water damaged soffit (front)

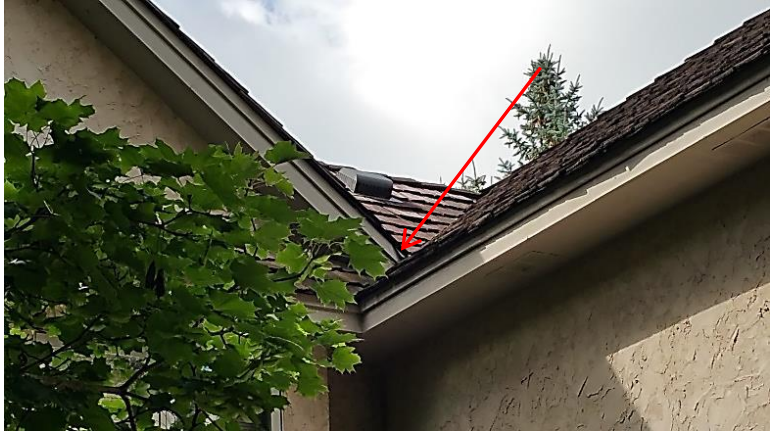
Restricted drainage (ice dam)

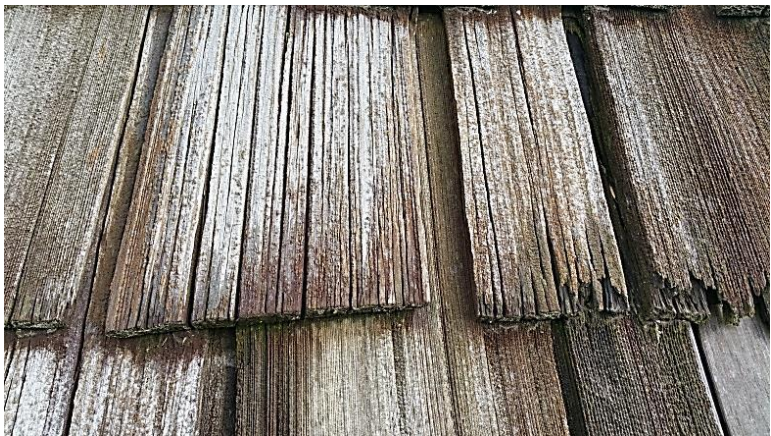
Split shakes

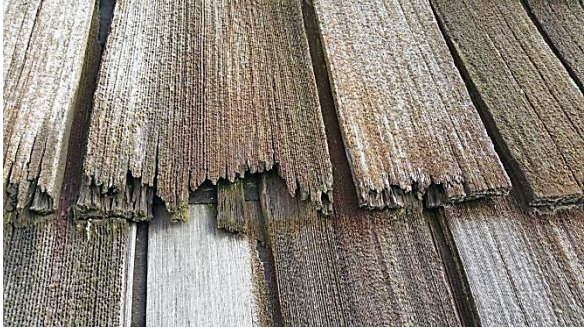
Decayed shakes

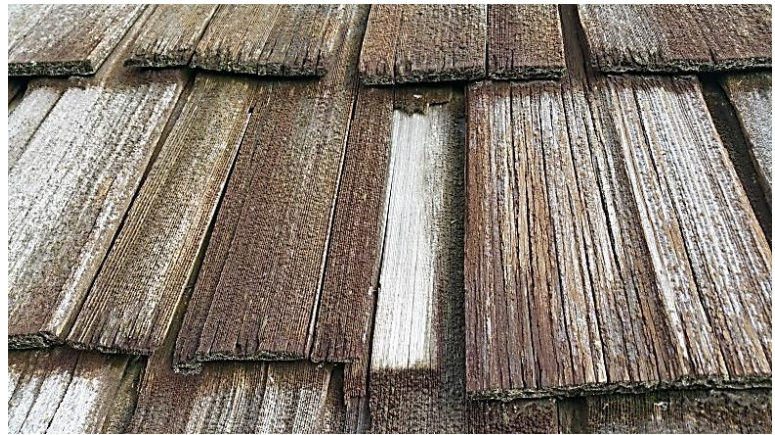
Missing shakes

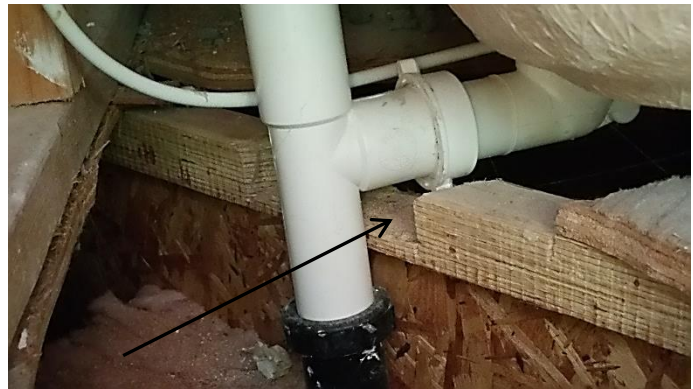
Cut flange

- ✓ Cut I joist top flange supporting master bathtub.
- ✓ There is a probability of moisture intrusion into the wood wall and floor framing; professional testing and certification is required (recommend Allen Powel CMT testing 651-272-5552)

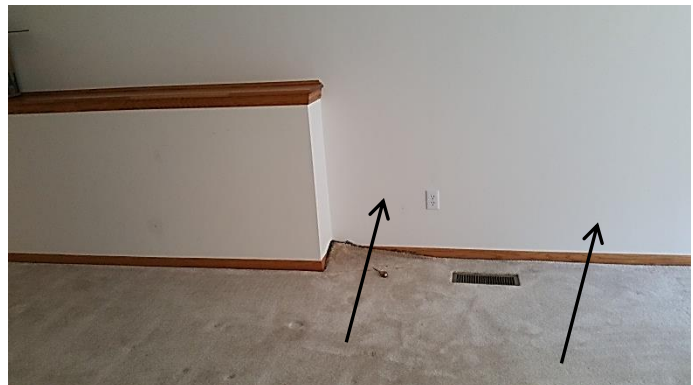
wood framing \_\_\_\_\_ ⚠ not visible / recommend moisture test / buried wood frame in family room

Buried wall
