On 8/14/2019, Cities' Inspection Service, Inc. completed a home inspection of the property located at XXXXXXX, XXXXXXX, Minnesota for you. Doug Hastings did all the fieldwork related to this project. Doug used the national home inspection protocol; the American Society of Home Inspectors (ASHI) Standards of Practice.

Exterior

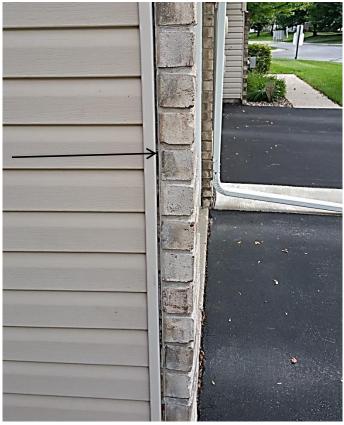
siding	⊗ loose bricks / loose siding / hole in siding / blocked vent
windows	⊗ leaking transom glass
doors	⊙ torn patio door screen / screen off track
overhangs

- ✓ Loose brick wall veneer.
- ✓ Leaking window glass air seals.

- ✓ Cracked & settled front patio slab.
- ✓ Tipped fence posts.
- ✓ Loose vinyl wall siding. Hole in siding. Blocked wall vent.
- ✓ Torn patio door screen. Screen off its track.

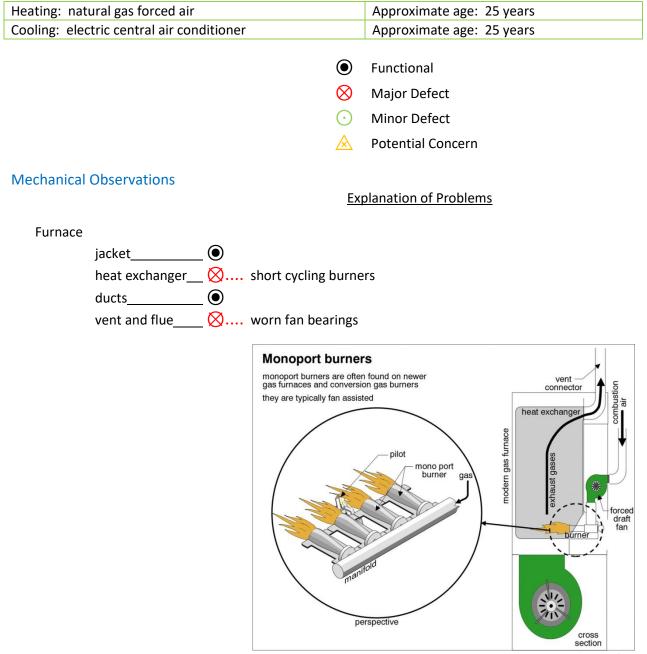
Short cycling

- ✓ Furnace and air conditioner are short cycling.
- ✓ Air conditioner cooling temperature is too high.
