Technical Notes on Brick Construction: **STAINS: Identification & Prevention**

Presented by the Brick Industry Association

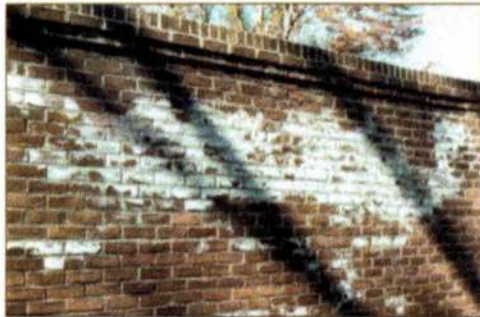
Photo 1, Efflorescence

less deposit of water soluble, white salt crystals, as shown in Photo 1. In some instances, efflorescence may appear on mortar joints as shown in Photo 2. Efflorescence may appear in limited areas on the surface of brickwork as shown in Photo 3 or, in extreme cases, cover the entire brickwork surface.

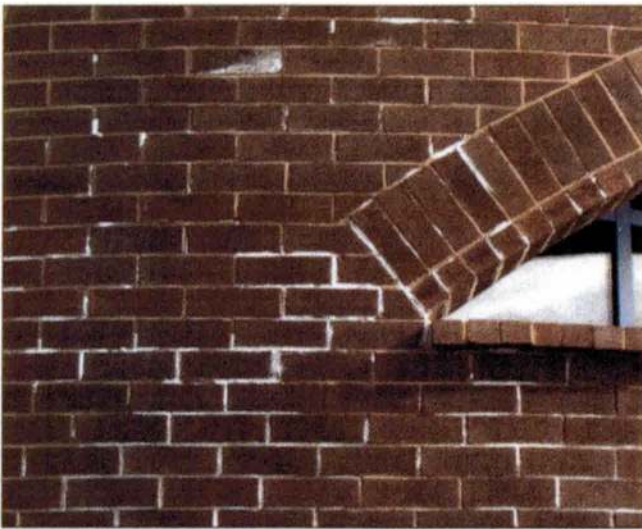
Photo 2, Efflorescence on mortar joints

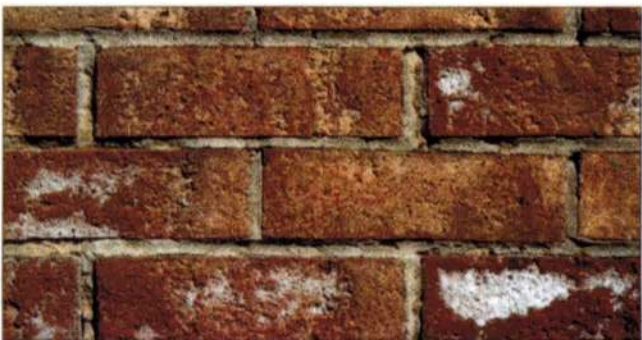
Photo 3, Efflorescence in limited areas

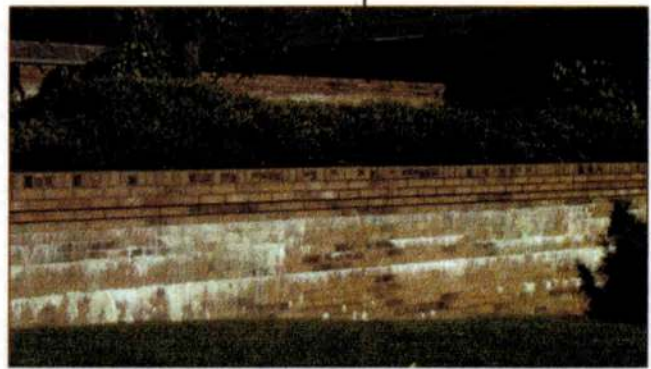
Calcium carbonate deposits, sometimes referred to as "lime run," usually appear as white or gray, crusty formations originating from a spot and running down the face of the wall, as shown in Photo 4. However, the term "lime run" is misleading since the stain is not a direct result of the lime component in the mortar. In fact, hydrated lime actually helps to reduce the risk of lime run. Lime run nearly always occurs at a small hole or opening or hairline crack in the face of the brick masonry, as shown in Photo 5.

The source of the calcium compounds that contribute to lime run can be trim, mortar, backing, or other construction materials. Lime run requires large quantities of water that follow the same path over an extended period of time, similar to the formation of stalactites in limestone caves. The water takes any of several calcium compounds into solution and brings them to the surface of the masonry through an opening. At the surface, the solution reacts with carbon dioxide in the air, thus forming the crusty calcium carbonate deposit.

Photo 4, Lime run

Materials containing cement are sources of calcium compounds and are an integral component of, or may be in contact with, the brickwork. To reduce the possibility of lime run, excess water must be eliminated or the path must be disrupted. Once lime run begins, it is likely to continue until the water source is stopped. ▶▶▶

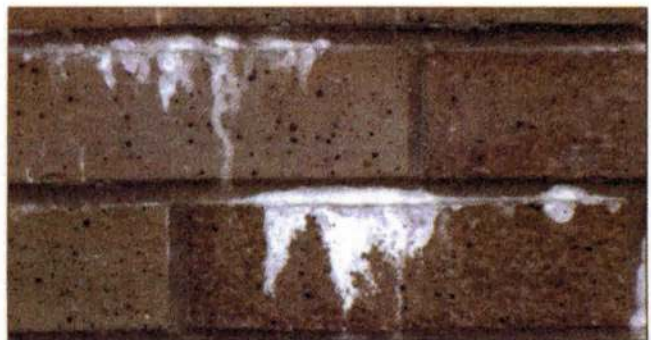
Photo 5, Lime run

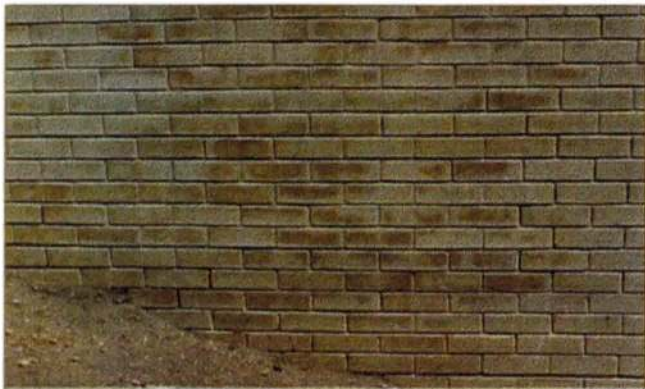
Some bricks develop yellow or green salt deposits as shown in Photos 7 (yellow) and 8 (green) when they come in contact with water or unbuffered hydrochloric (muriatic) acid. These stains are usually vanadium salts. They may be found on red, buff or white brick; however, they are more conspicuous on lighter-colored brick. The vanadium salts responsible for these stains originate in the raw materials used for

Photo 7, Yellow vanadium stain

Vanadium stains occur in a manner similar to efflorescence, except that vanadium oxide and sulfates are dissolved and result in a solution that may be quite acidic. As water evaporates from this solution at the surface of the brickwork, vanadyl salts are deposited. The chloride salts of vanadium, such as vanadyl chloride, may form as a result of washing with unbuffered hydrochloric (muriatic) acid or excessive moisture exposure. [Ref. 2]

Preventing vanadium stains is important since they can be difficult to remove and improper cleaning efforts may result in a brown, insoluble deposit. To minimize the potential for vanadium stains, the following steps are recommended:

- Store brick off the ground and under nonstaining protective covers.
- Never use or permit the use of highly-concentrated, unbuffered hydrochloric (muriatic) acid solutions to clean light-colored brick.
- Seek and follow the cleaning recommendations of the brick manufacturer.

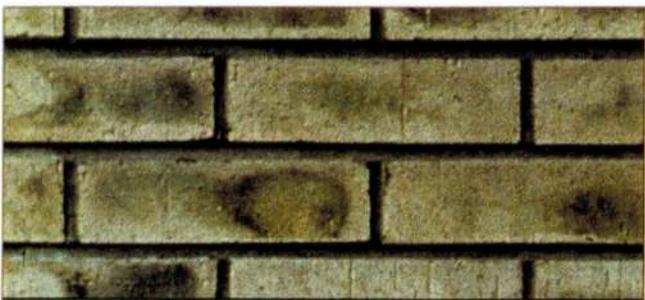
Photo 8, Green vanadium stain

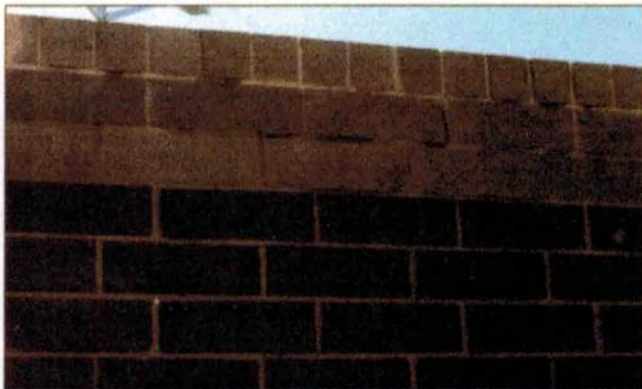
Under certain conditions, tan, brown, or occasionally gray staining may occur on the mortar joints of brickwork as shown in Photo 9. Occasionally, a brown stain will streak down onto the faces of the brick, as shown in Photo 10. This type of stain is the result of having a manganese oxide as a coloring agent in tan, brown, black or gray brick and its reaction to an acid.

Photo 9, Manganese stain

Manganese staining is closely related to efflorescence since it is the sulfate and chloride salts of manganese that travel to the surface of the brickwork. When the solution reaches the mortar joints, the salts are neutralized by the cement or lime in the mortar, producing insoluble manganese hydroxide. The manganese hydroxide precipitate is deposited on the mortar joint and, when dry, converts to brown manganese tetroxide resulting in the stain. [Ref. 2]

Unbuffered hydrochloric (muriatic) acid should not be used to clean tan, brown, black or gray brick. Proprietary cleaning compounds are available for cleaning brick containing manganese. Test for effectiveness and follow the advice of the brick manufacturer.

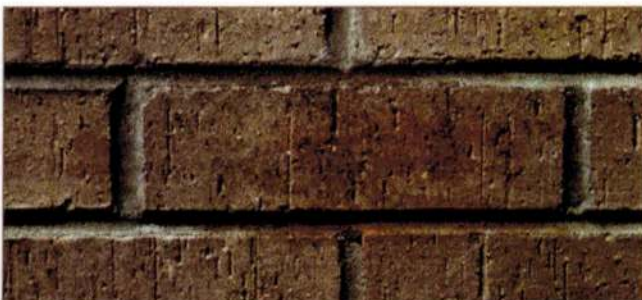
Photo 10, Manganese stain

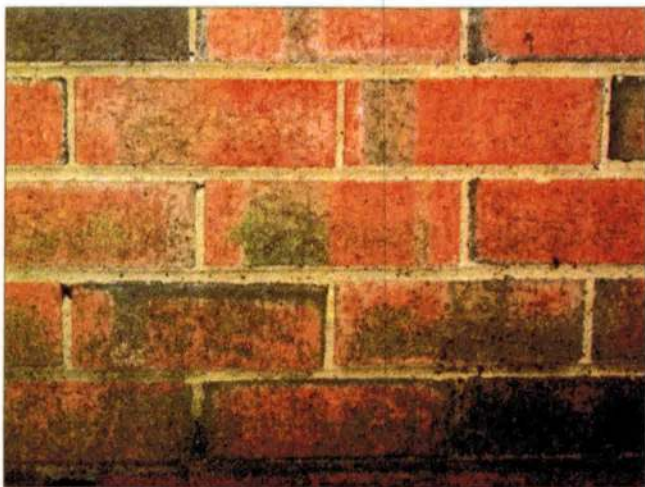
Photo 11, Organic stain

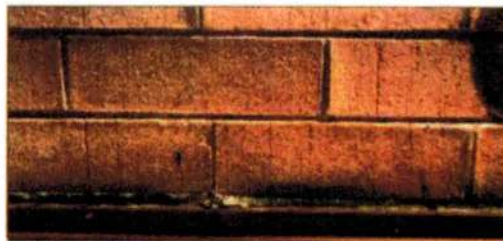
Photo 12, Stain from copper

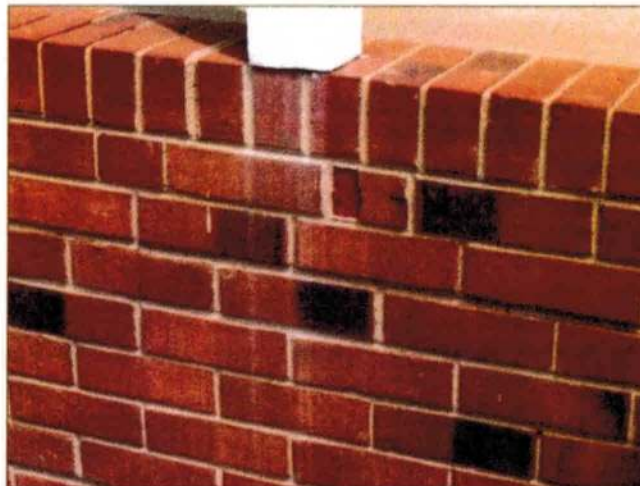
Photo 13, Runoff stain from paint

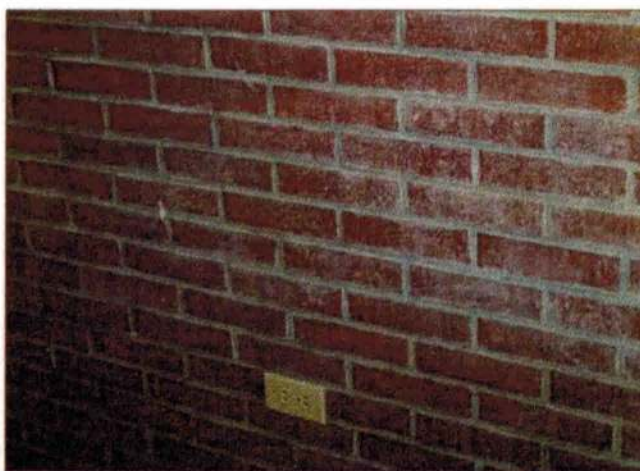
Photo 14, Hard water stain
