# VERMICULITE in the Attic

By DAVID GRUDZINKSI, ACI

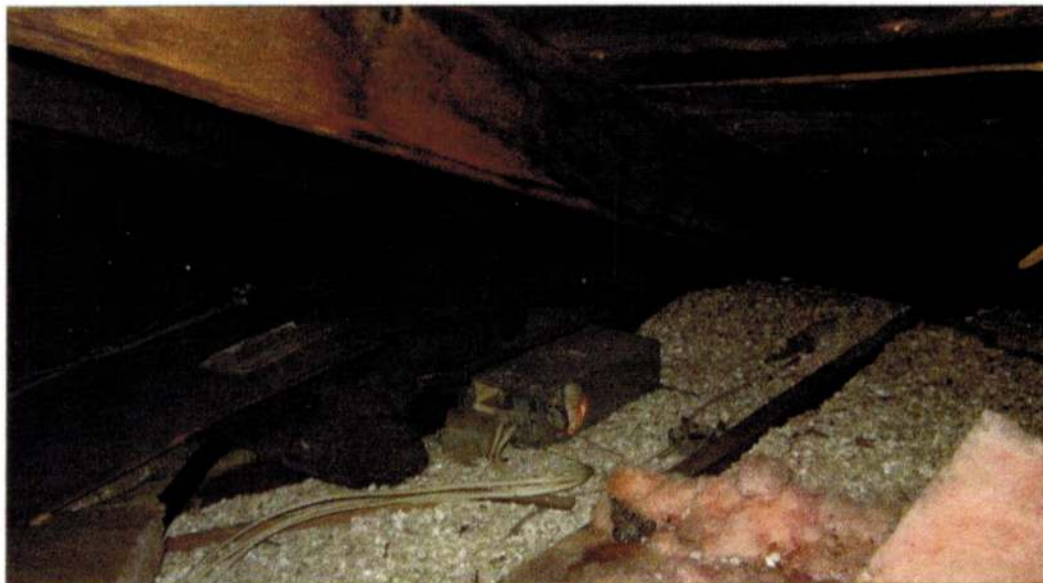
From the attic hatch's pull-down stairs, I photographed the bath fan (see photo at right), which had been blowing the product around the attic for years. Knowing how poorly hatches with pull-down stairs seal, I identified this as one path for asbestos being released into the living space.

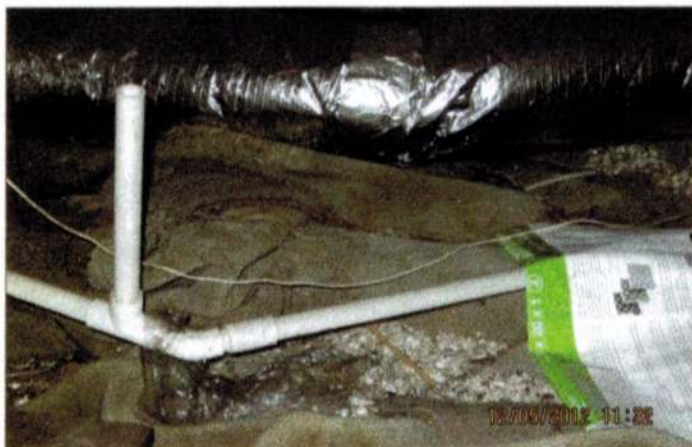
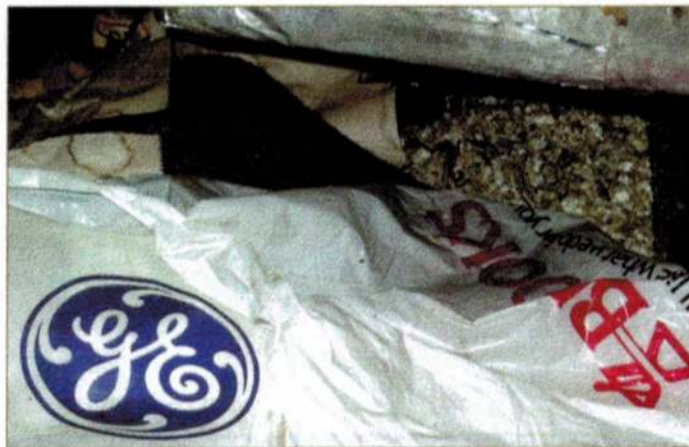
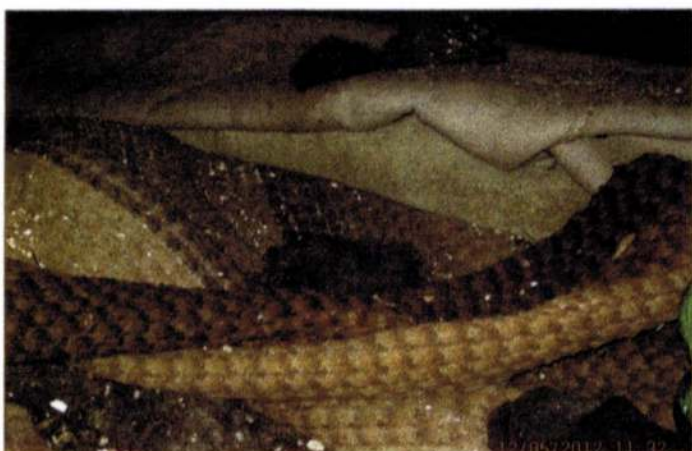
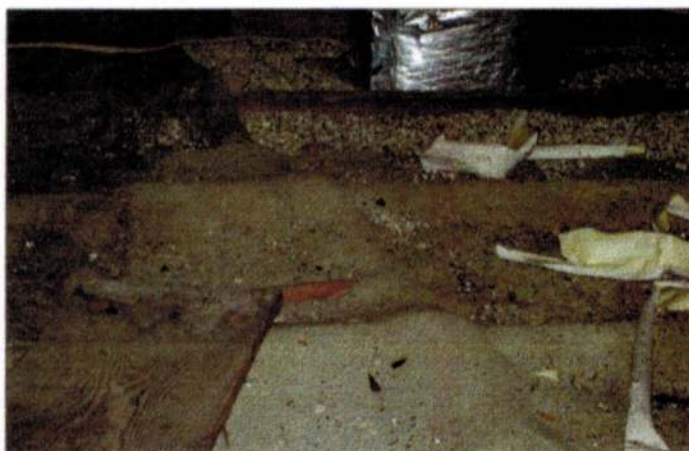
To make matters worse, fabric and carpets had been tossed in the attic, as you can see in the four photos above. Vermiculite can be seen under and on top of the debris. It will have to be disturbed further to remove the fabric and debris. ▶▶

I assume the homeowner and the contractor had been equally unaware of the health risks presented by vermiculite and of how it should be handled. Because my client still was interested in the property, I advised him to consult a professional remediation contractor. Nevertheless, even when informed, the owner did not want to address the issues, so my client moved on. ■

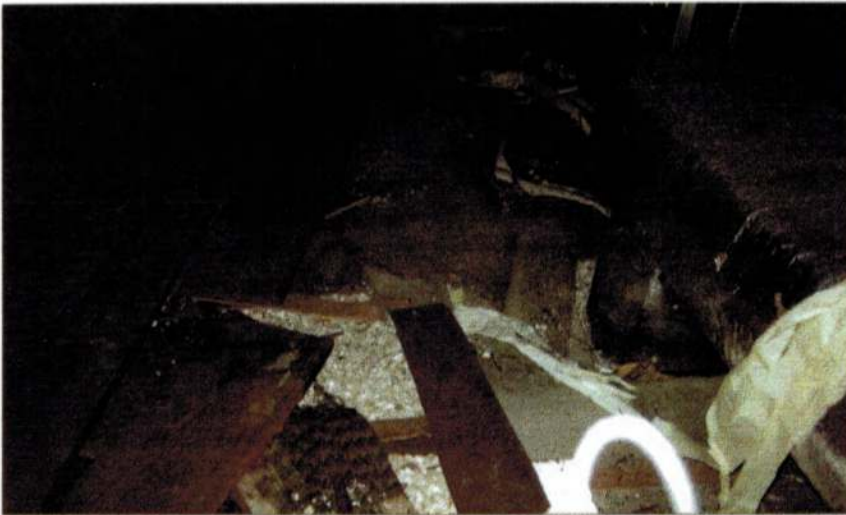
The air conditioning duct (on the right in the photo at left) was installed through the ceiling and down into a closet. No measures were taken to contain the vermiculite, and it has spilled into the living space — another path for contamination.

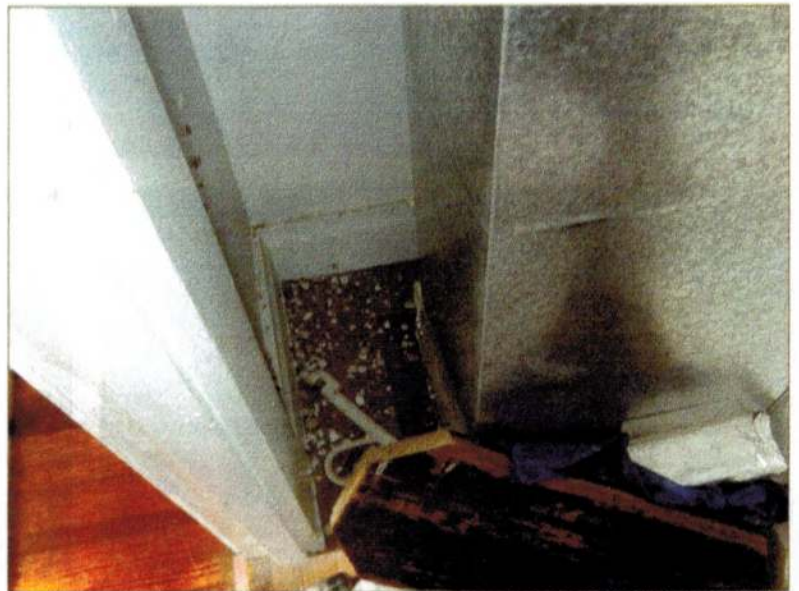
In the photo at the right, you can see where vermiculite has fallen out of the ceiling because an AC duct was installed.

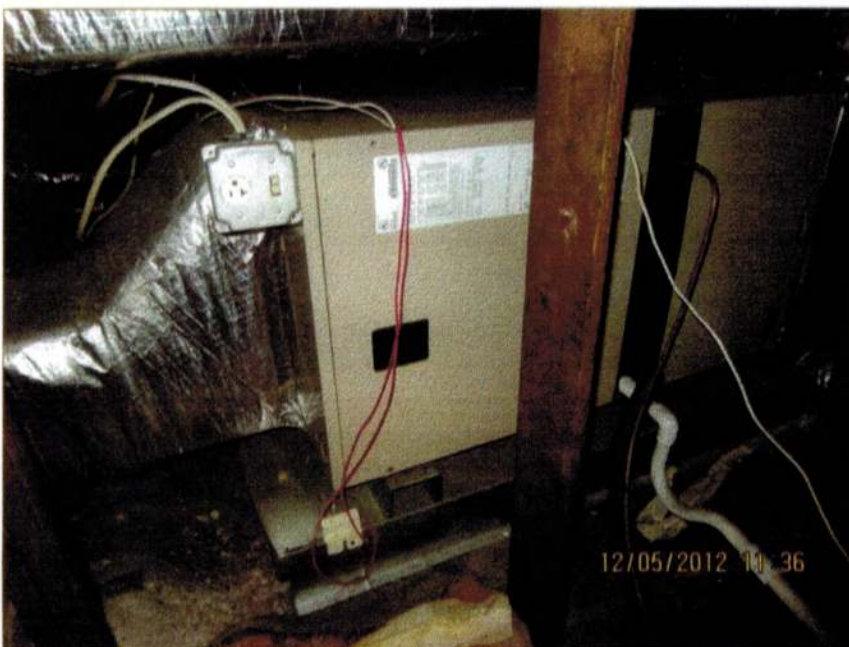
And, what may be the worst in this worse-case scenario, the air handler in the attic is sitting in and on vermiculite. I observed vermiculite inside the return duct, leading me to believe that asbestos probably is being blown through the air into the house every time the blower runs — yet another path.
