## A "Sweeper's Dozen": Advice From a Chimney Sweep

# 13 Chimney System Issues Home Inspectors Can Detect

### Without Exceeding Their Standard of Practice

By Ashley Eldridge and Robert Priesing, Chimney Safety Institute of America

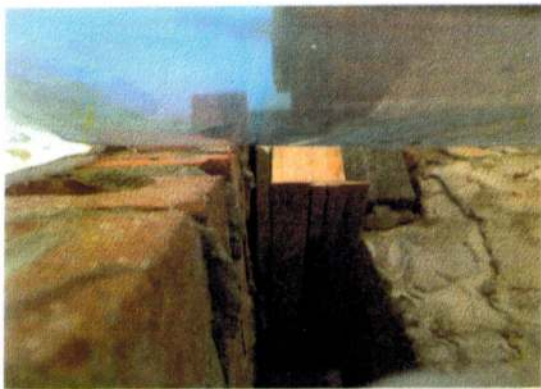
Measure from the top of the chimney on the high side (the right most corner). Do not include the rain cap in the measurement.

The brick veneer and sheetrock (left) and the chimney (on the right) has an embedded header between them. This picture—used for instructional purposes—shows a properly installed embedded header. While it may not be visible, it frequently lacks proper clearances.

For home inspectors not keen on climbing on a steep roof, one good trick is to measure the height of a single brick and then count the number of those bricks (this counting technique also works with uniform-cut siding). Remember: The three-foot

measurement should be from the point of the chimney where its high side penetrates the roofline.

Inadequate clearances are common at the header supporting the stud wall above the fireplace opening; at points of passage through floors, ceiling and attic; and where exterior chimneys run up the outside wall of the house. Combustible materials frequently are sandwiched between the chimney masonry and building insulation, which increases the fire hazard enormously. The NFPA calls for a two-inch airspace between combustibles and interior chimneys or smoke chambers. The NFPA also calls for sheathing to be one inch from exterior chimneys. CSIA experts believe that although the clearance requirements have been in place for many years, virtually every fireplace and chimney contains at least one serious clearance deviation. You may even see this wood from the basement if the ceiling is unfinished (this applies to the outer and inner hearth). There is an exception in the IRC for exterior sheathing.

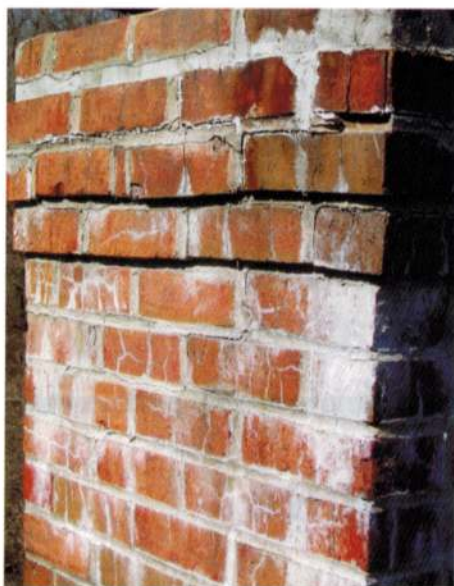
Here's an example of exterior colorization changes. This is efflorescence, which can be an indicator of moisture issues.

On the exterior, colorization changes can relate to damage from water entry and freeze thaw. Dark staining near the top of the chimney, often thought to be smoke staining, may be mildew growing as a result of water penetrating the masonry. Interior staining can be the result of water, but if the staining is near the appliance connection or above the fireplace, the issue could relate to the spillage of flue gas. Many newly constructed American homes simply do not have sufficient available combustion air to operate the fireplace. Proper air exchange rates create better indoor air quality. The fireplace acts like an exhaust device and may pull fresh air into the home to replace what is being exhausted up the chimney.

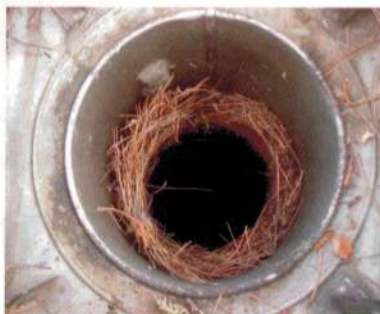
The simplest of obstructions, such as a bird's nest, can be a big issue for an unsuspecting home-owner who can't see what the home inspector can.

If the chimney is blocked with animals, leaves or other debris, deadly carbon monoxide gases and smoke can back up into the home, threatening the health of the occupants. In addition, if the inside of the chimney is wet, it may be because a highly efficient appliance was introduced into an

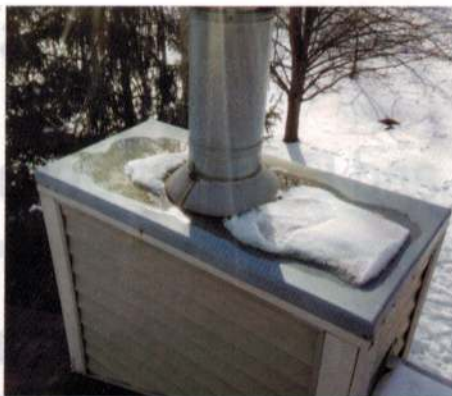
Snow, ice or water standing atop a chase cover, instead of draining, is an indicator of a poorly designed cover.

Instead of a masonry crown, a prefabricated chimney chase has a sheet metal top called the "chase cover." Many of these covers are field-fabricated and perform poorly; some are even concave in the middle. They retain moisture and are prone to water leakage, water pooling and rust, particularly from

snow that accumulates and melts. Water can show up at ceiling lines, in the firebox and behind the louvers of the prefabricated fireplace. Rust running down the exterior chase siding indicates a significant problem.

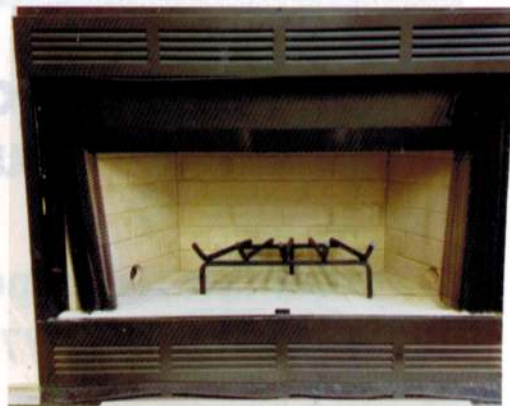
This is an example of an ideal grate size.

**Improperly sized grate:** Fireplace grates keep firewood or wax logs from rolling during burning and allow air to flow beneath the solid fuel. Grates also allow for a central ash pile. Many people like these hearth accessories for the traditional look they lend to their fireplaces and fireplace inserts. Most people tend to purchase the largest grate that will fit into the fireplace instead of the recommended size, which is two-thirds the width and one-half the depth of the fireplace. As a result, they'll usually load their fireplace with too much firewood. Lastly, ashes should never build up as high as the grate.
