Decks

By Bruce Barker, ACI

Deck Stairs

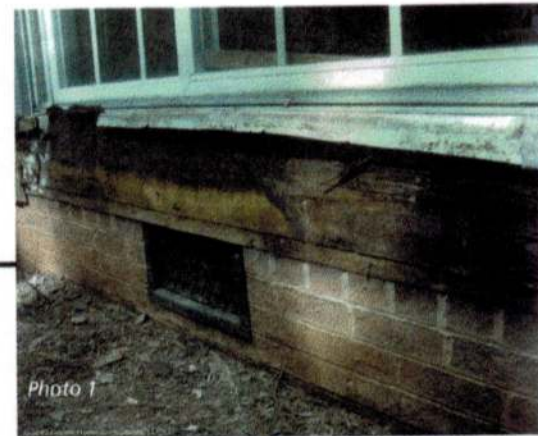
Improper deck flashing enables the ledger detachment demon by letting water into the building. Water deteriorates the band board/rim joist to which the deck ledger is usually attached. If the band board/rim joist fails, it does not matter how many fasteners are used; the ledger connection may fail, causing a deck collapse (**Photo 1**).

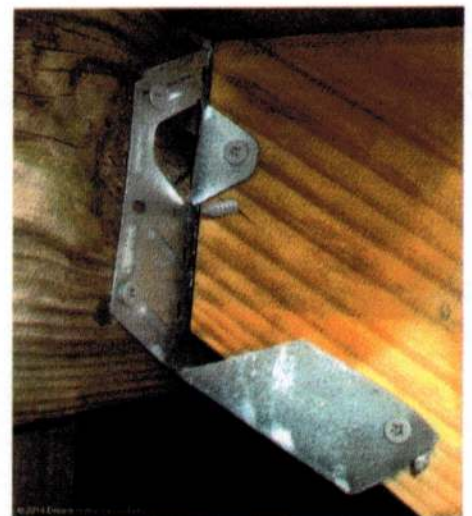
Photo 1

a connector, such as a Simpson LSC or LSSU, installed according to manufacturer's instructions, including using the recommended fasteners. Connectors provide both the vertical and lateral support for the stringer. **Photo 1** shows an attempt to attach a stringer using a connector. Good try, but there are still problems. The stringer should fully bear on the connector seat. Screws are not allowed unless specifically allowed by manufacturer's instructions, and then, only manufacturer-supplied screws may be used. Deck screws and drywall screws are not allowed.

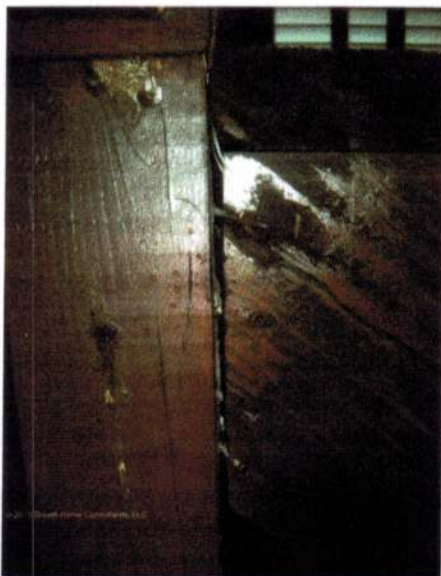
Photo 2

This is always wrong. Nails are subject to withdrawal unless the stringer is secured somewhere against lateral movement. If the stringers are bearing on a landing with no attachment to the landing and no other attachment that resists lateral loads, then the nails are subject to withdrawal. If the stringers are bearing on the ground, that is even worse. **Photo 2** shows a stringer that is pulling away from the rim joist after less than one year.

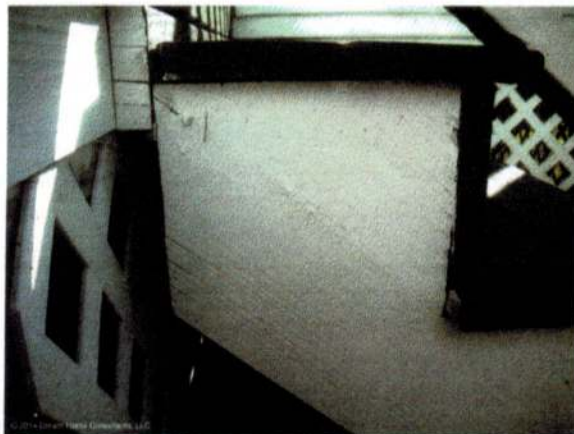
Photo 3

The best place to position a stringer, from a stringer attachment perspective, is to place the top tread even with the deck flooring. This allows the stringer plumb cut to fully bear on the rim joist or beam, and it provides the maximum fastening area. Carpenters do not like this method because they claim it makes installing the stair guards and handrails more difficult. A common stringer placement, therefore, is to place the top tread one riser below the deck flooring. There are two common ways to accomplish this. **Photo 3** shows one method, which is clearly a job for Obviousman. The other method is to use a drop header.

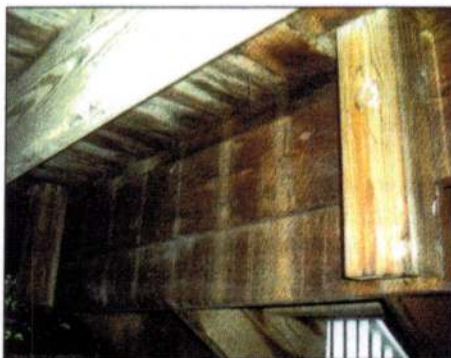
Photo 4

to withdrawal over time. **Photo 4** shows a drop header secured using only nails. Proper attachment of the drop header to the rim joist or beam involves installing bolts through lumber to connect the drop header and rim joist or beam.

or beam. The following is a common detail that is accepted in some areas. Use at least two 2x4s. Install at least a 3/8-inch diameter bolt through the drop header and through the rim joist or beam. The bolts should be located as close as possible to the center of the 2x4, horizontally, so there is enough wood between the bolt and edge of the wood to resist wood splitting and shearing. 2 inches is a safe distance in this case.

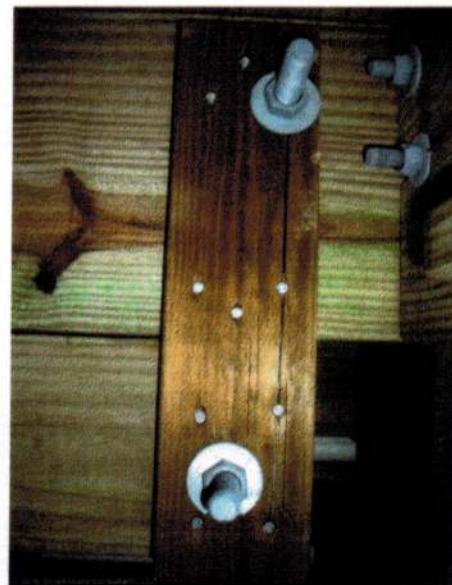
Photo 5 shows a bolted drop header. The top bolt is too close to the right edge of the 2x4; if you look closely, the 2x4 is split. Otherwise, it is a decent effort at a drop header installation.

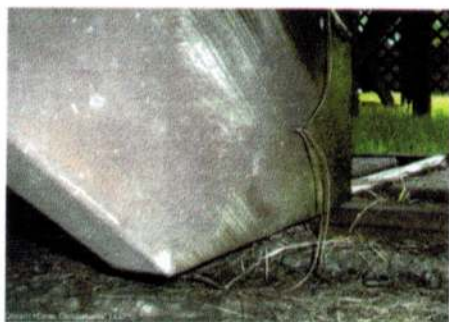
Photo 6

bearing surface. At a minimum, 1½ inches of the seat cut heel should bear on support. The seat cut toe should not be the only part of the stringer bearing on support. We should report configurations such as shown in **Photo 6** as significant deficiencies requiring correction. These configurations can allow the stringer to shear along the wood grain, resulting in stair collapse.
