EIFS (Exterior Insulation and Finish Systems) *A Simple Approach to a Complex Issue*

By Alan Carson, Carson Dunlop, www.carsondunlop.com

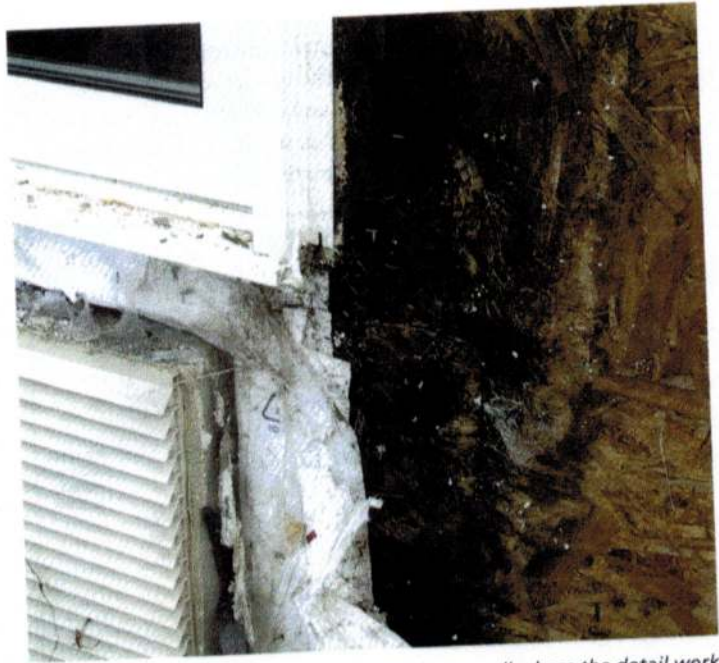
Here's what it looked like when we opened up a wall where the detail work was not so good.

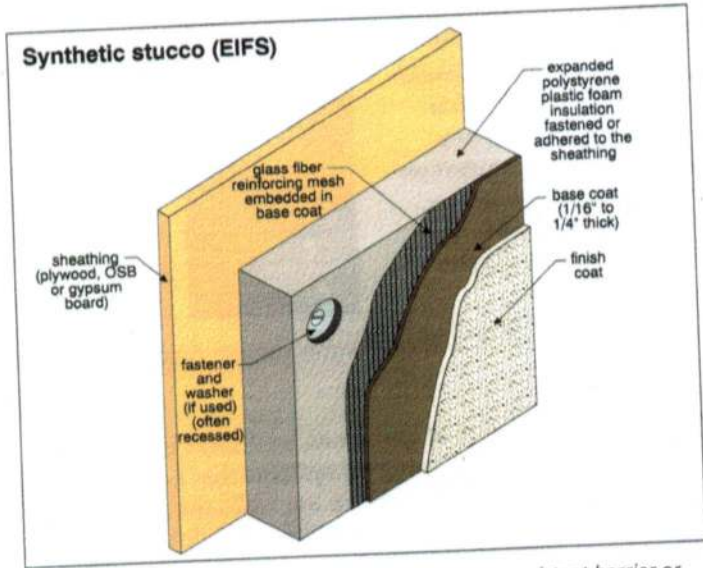
This illustration shows an older system with no water-resistant barrier or drainage plane.

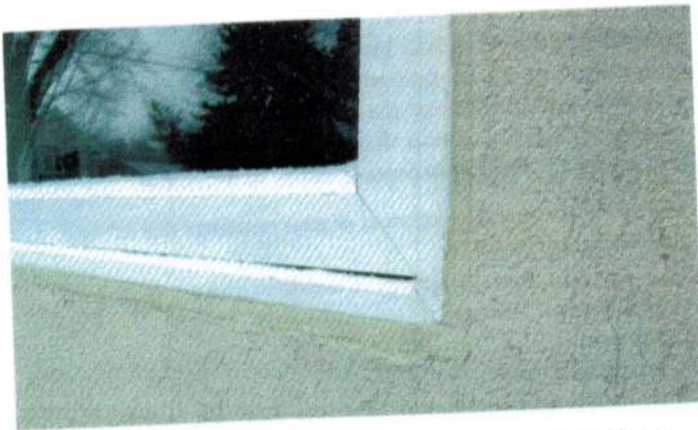
The joint between the synthetic stucco and windows is a vulnerable area. This system appears to be in good condition with a well-caulked joint.

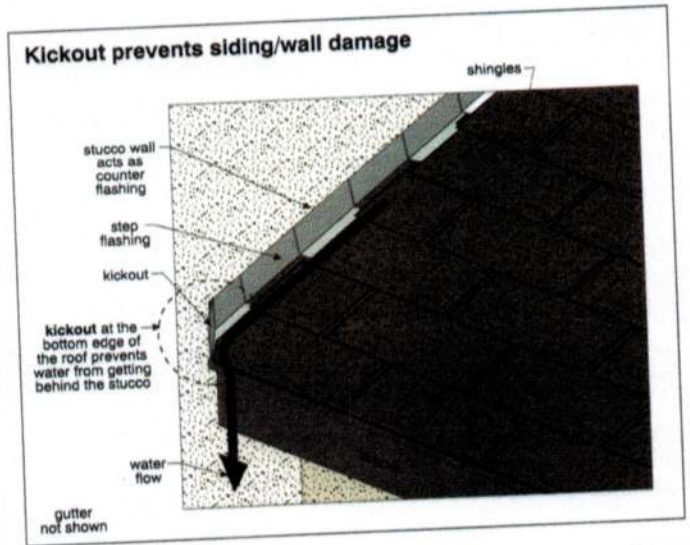
Kickout flashings prevent water from getting behind stucco at the bottom of adjacent roofs.

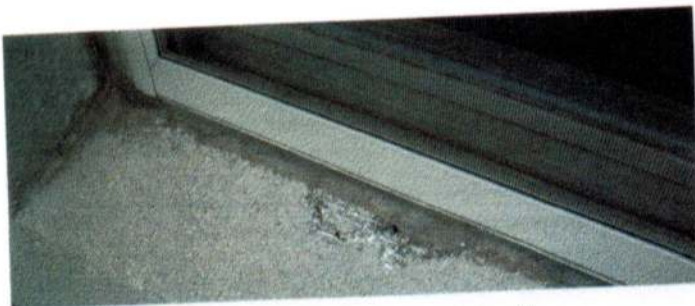
Workmanship is often an issue, as seen on this windowsill.

You may be able to see the fiber mesh reinforcement at openings or surfaces, as we saw on the windowsill in the photo at the bottom right on Page 11. You may be able to see the wall detail at the bottom with a mirror, for example. You may be able to see the insulation, fiberglass mesh or the thick (approximately 2-inch) wall system projection typical of synthetic stucco. By the way, you should not be able to see the insulation or the mesh.

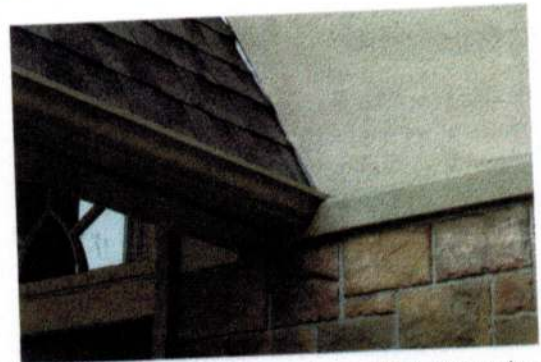
There is no kickout flashing on this new home. This is likely to be a problem area.

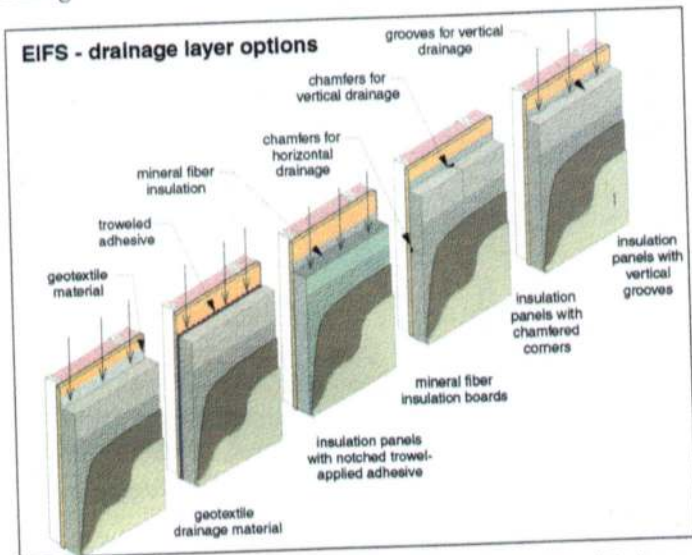
This illustration shows a more modern approach with a series of drainage strategies.

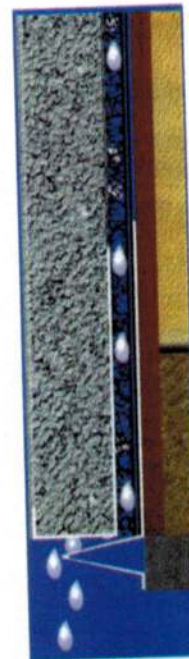
Illustration courtesy of STUC-O-FLEX International. Here we can see the drainage layer behind the stucco. The drip screed/weep screed at the bottom directs water out through the bottom of the wall. In a true vented rain screen, the cavity behind the stucco becomes pressurized by the force of the wind. This reduces the pressure differential across the stucco and reduces the amount of water driving through the siding. We don't get to see walls and cross-sections, so you won't often know how the stucco assembly was put together.

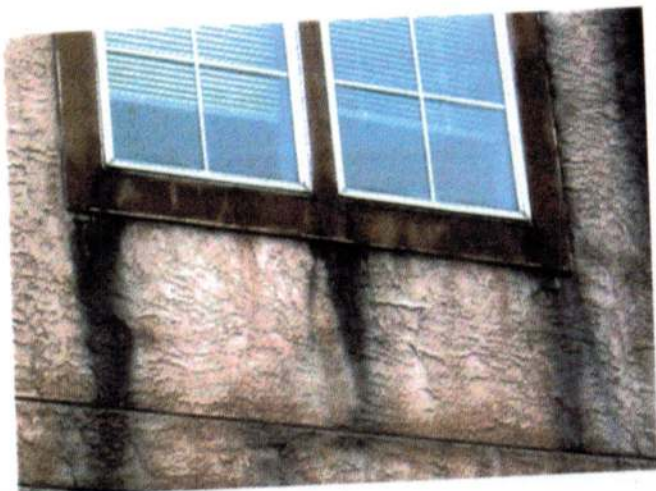
It's rarely this dramatic, but watch below windows!

Problems around windows are more common than any other. Pay close attention around and below windows, inside and out.
