September 1, 2019

On 5/19/2018, Cities' Inspection Service, Inc. completed a building inspection of the property located at XXXXXXX, XXXXXX, Minnesota for you. Doug Hastings did all the fieldwork related to this project. Doug used the commercial inspection protocol; the Standard Guide for Property Condition Assessment – ASTM Standard E2018-01.

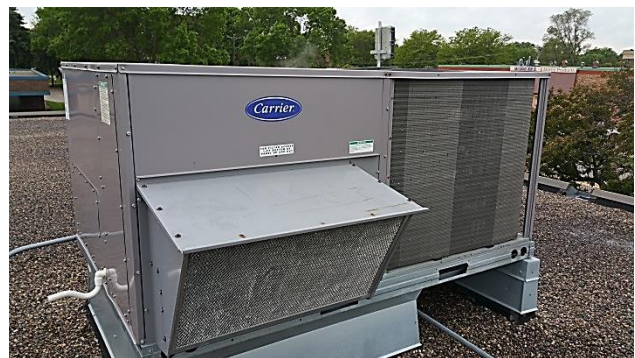
Main HVAC

- jacket_____ ⦿
- heat exchanger__ ⦿
- distribution_____ ⦿
- vent_____ ⦿
- condenser_____ ⦿
- compressors_____ ⚠.... too cold & not viewed operating
- wiring_____ ⦿

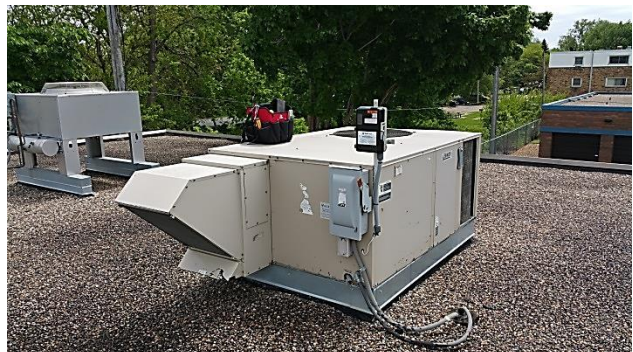
Dock AC

- condenser_____●
- compressors_____⚠.... cold weather & not viewed operating
- wiring_____●

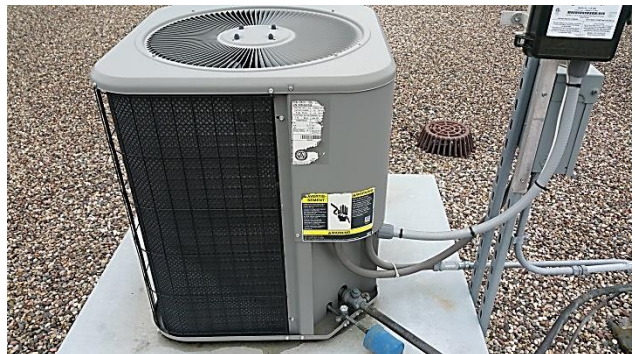
Interior AC (located on rooftop)

- condenser_____●
- compressor_____⚠️.... cold weather & not viewed operating
- pipng_____●
- wiring_____●

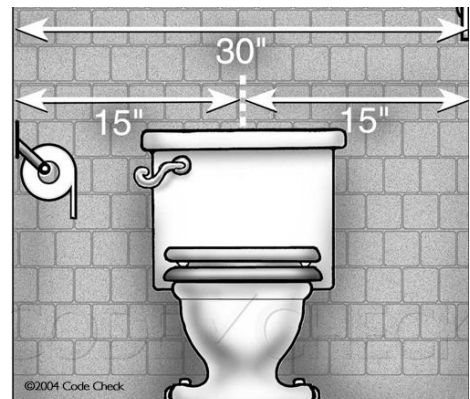
Restroom #1

- wall, ceiling, floor___●
- fan and door___☒.... disconnected vent pipe
- outlet and fixture___☒.... no outlet
- heat_____●
- plumbing___☒.... corroded sink drain pipe / inadequate width
- cabinet and top_____●
