September 1, 2019

On 8/27/2019, Cities' Inspection Service, Inc. completed a home inspection of the property located at XXXXX, XXXXXXXX, Minnesota for you. Doug Hastings did all the fieldwork related to this project. Doug used the national home inspection protocol; the American Society of Home Inspectors (ASHI) Standards of Practice.

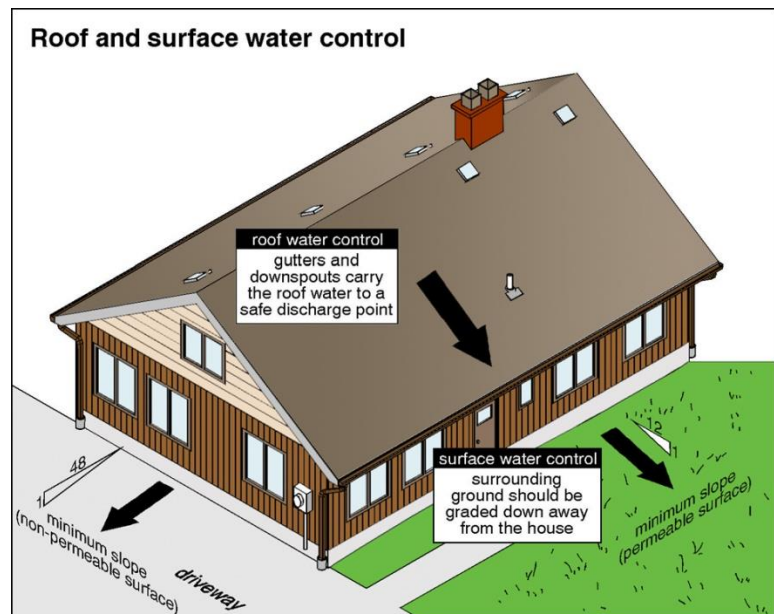
- front \_\_\_\_\_ ●
- left side \_\_\_\_\_ ⊗ .... negative slope
- right side \_\_\_\_\_ ●
- rear \_\_\_\_\_ ⊗ .... ponding water on foundation

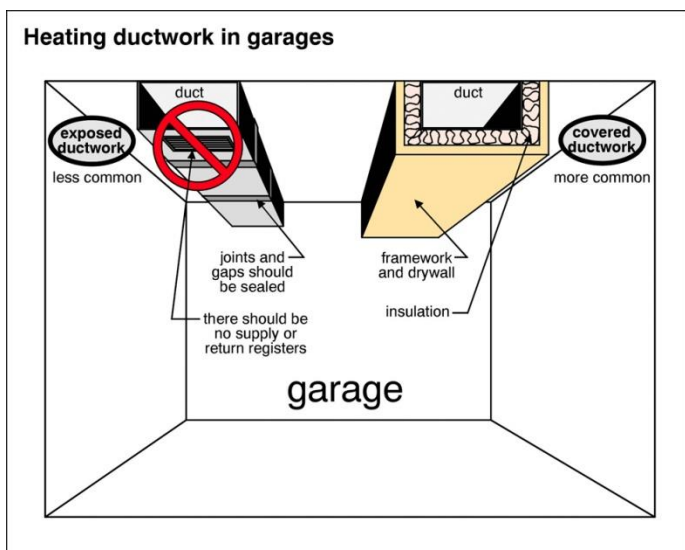
Water stained ceiling

- ✓ Water damaged foundation blocks and water stained wood paneling.
- ✓ Unprotected heat duct (not fire rated). Wood wall paneling is not fire rated.
- ✓ Water stained ceiling below upper bath.

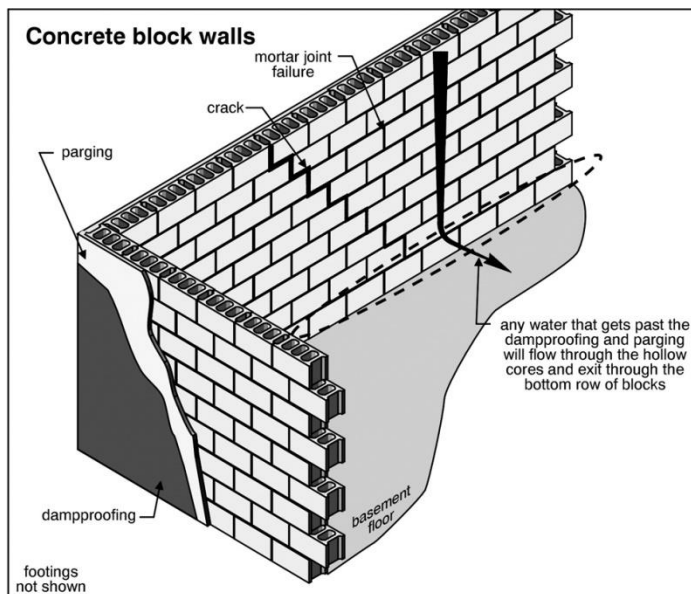
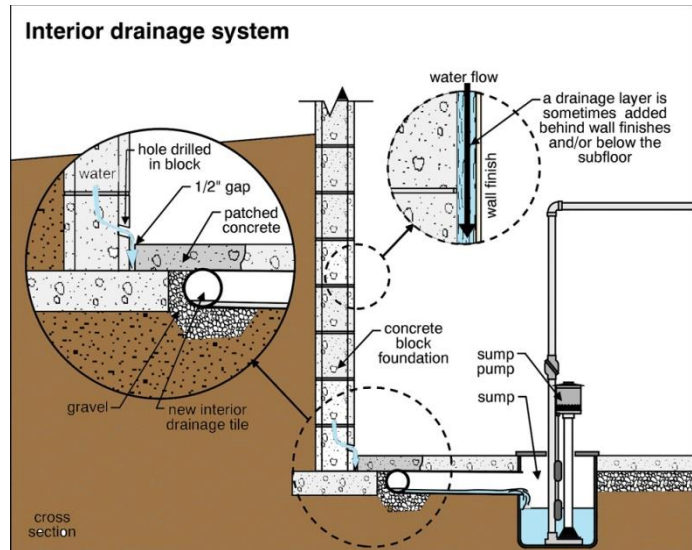
sump/drain tile \_\_\_\_\_ △ .... sump pump not viewed operating / no battery backup pump / lower level bedroom not drain tiled / installed by Standard Water Control

radon mitigation \_\_\_\_\_ △ .... none / test in process

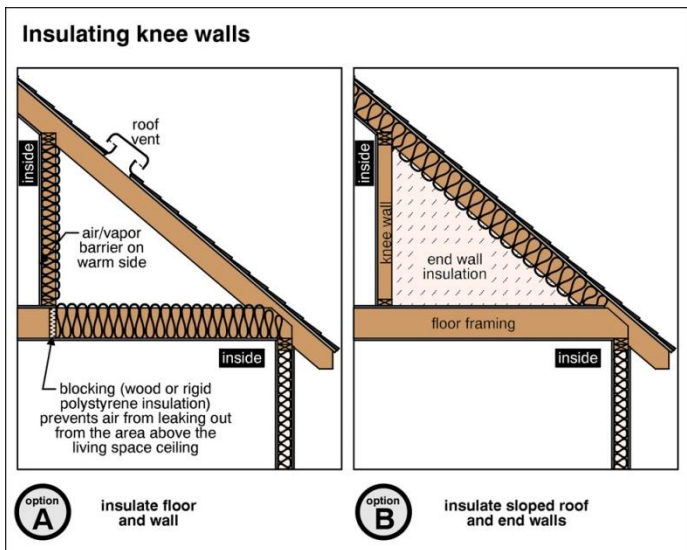
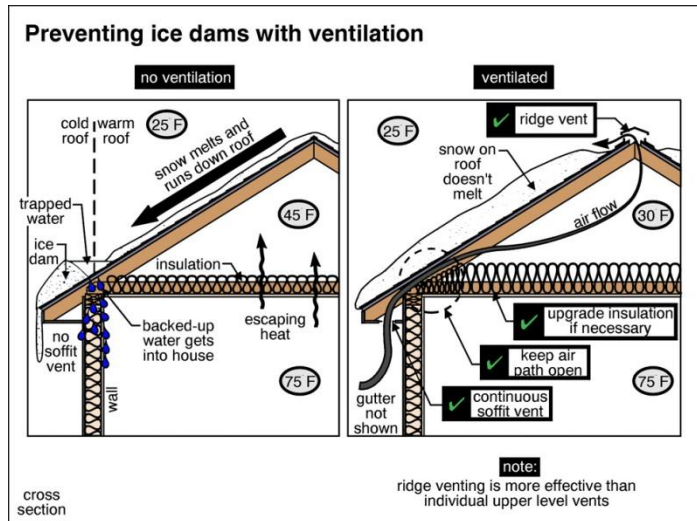
attic \_\_\_\_\_ ✖ inadequate amount insulation & ventilation / restricted access to improve insulation / poorly installed insulation improvement / ice dams

- ✓ Inadequate amount attic insulation and ventilation (ice dams and moisture intrusion). The existing improvements are poor. A good portion of the attic is inaccessible and will be difficult to correct.

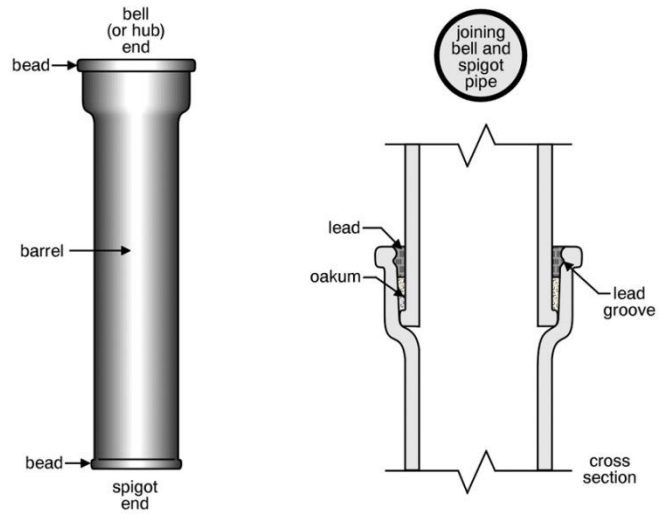
Loose lead connection

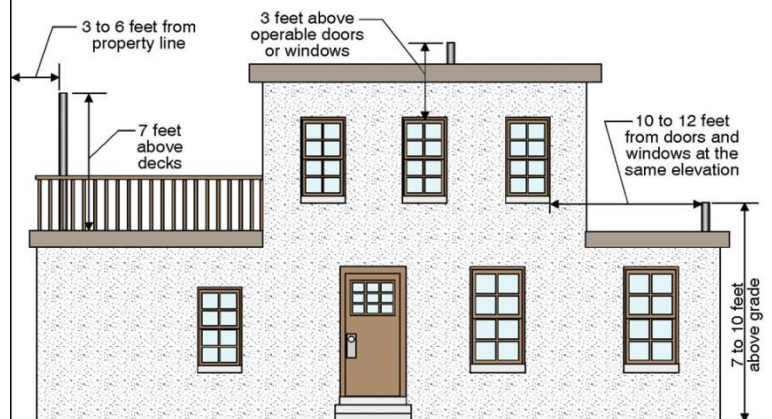
Too close to window

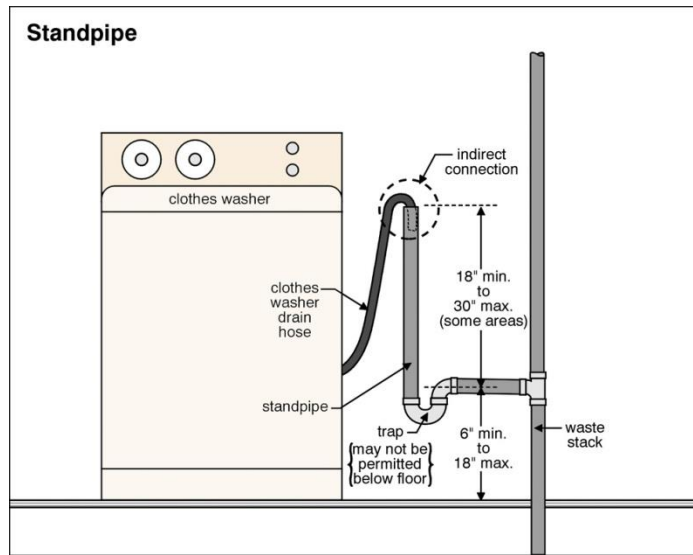
Standpipe too high

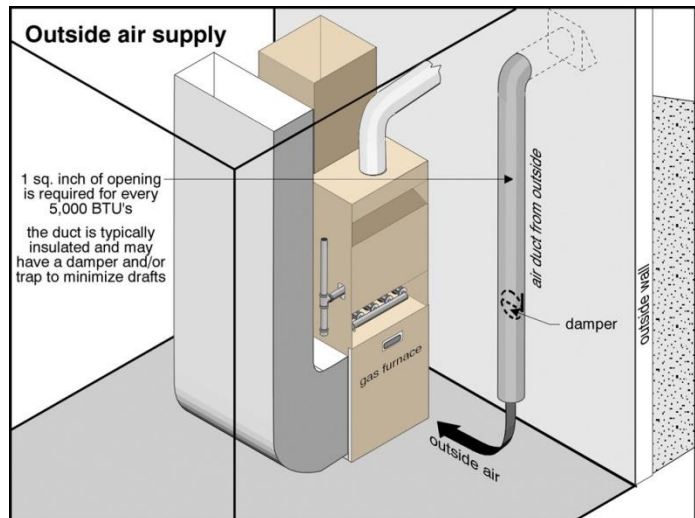
Too close to ground

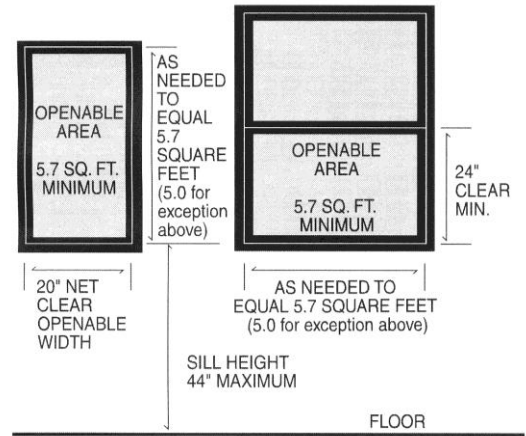
wall, ceiling, floor\_\_\_\_\_●  
 window and door\_\_\_\_\_✗.... no egress window  
 outlet and fixture\_\_\_\_\_●  
 heat\_\_\_\_\_✗.... no supply air register (no AC) / abandoned thermostat  
 electric baseboard\_\_\_\_\_●

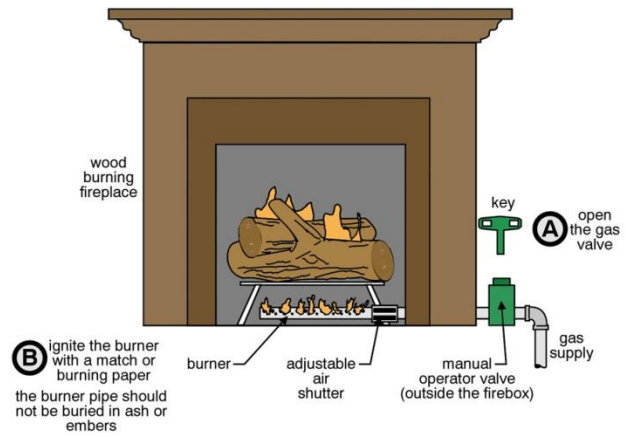
most gas igniters have few safety features and may not be permitted in some areas - find out if they are allowed in your area

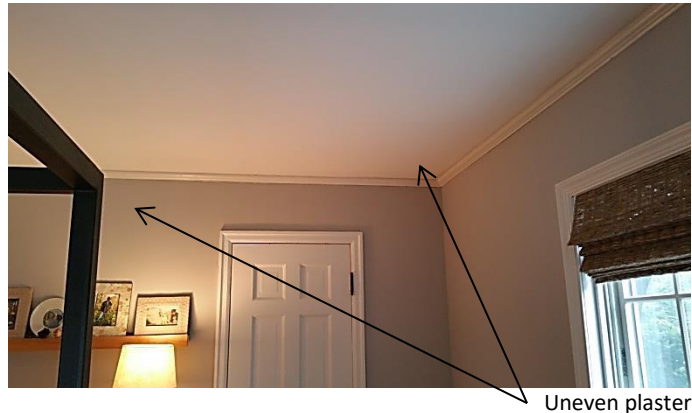
- wall, ceiling, floor\_\_\_ ⚠️.... uneven ceiling & wall plaster (below front & rear roof valleys) / ice dams
- window and door\_\_\_ ●
- outlet and fixture\_\_\_ ●
- sink\_\_\_ ●
- heat\_\_\_ ●
