September 1, 2019

On 10/15/2018, Cities' Inspection Service, Inc. completed a second stage new construction inspection of the property located at XXXXXXXX, XXXXXX, Minnesota for you. Doug Hastings did all the fieldwork related to this project. Doug used the 2015 Minnesota State Building Code as the minimum construction standard.

Structure, Mechanical, Plumbing, and Electrical Rough-In Inspection

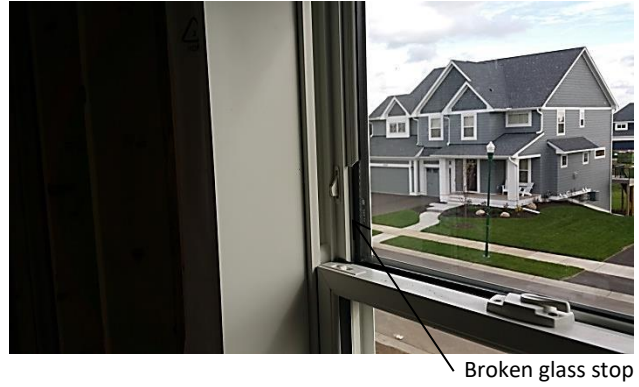
- Barriers and flashing_ ☒.... loose pieces of housewrap / not extended & taped on roof flashing & foundation insulation
- Siding and trim_____ ☐.... not completed
- Veneers_____ ☐.... not completed
- Doors_____ ☐.... not completed
- Windows_____ ☒.... gathering room lower awning windows not tempered (not marked) / upper level front bedroom broken window glass stop

- ✓ Loose housewrap and not seam taped at foundation and roof flashing.
- ✓ Gathering room awning windows not tempered glass (not marked).
- ✓ Upper front bedroom broken top sash window glass stop.

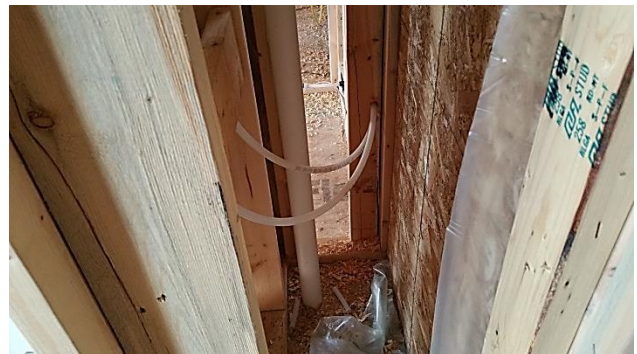
- Electrical _____ (○).... not completed
- Plumbing _____ (⊗).... upper level bathtub water pipes may be located in unheated & confined space
- Heating _____ (●)
- Radon pipe _____ (●) passive system / recommend active

- ✓ Recommend adding an active fan on the passive radon pipe.
