On 12/13/2018, Cities' Inspection Service, Inc. completed the final stage new construction inspection of the property located at XXXXXXX, XXXXXXX, Minnesota for you. Doug Hastings did all the fieldwork related to this project. Doug used the 2015 Minnesota State Building Code as the minimum construction standard.

## Final Inspection

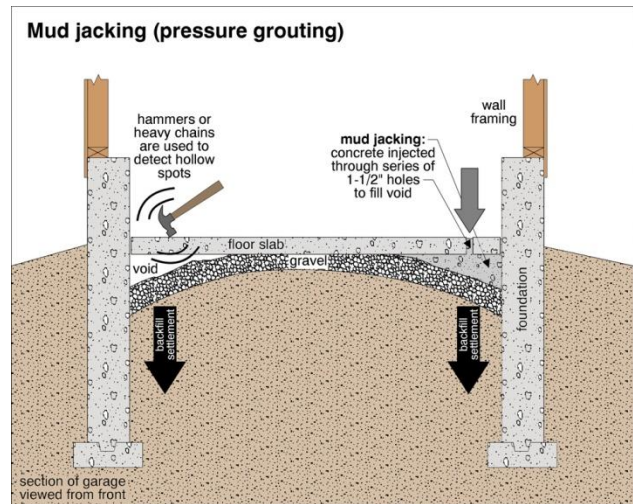
- Footing\_\_\_\_\_●  
Walls\_\_\_\_\_●  
Drain tile\_\_\_\_\_●.... covered & installation not visible  
Passive radon pipe\_\_\_\_\_●  
Floor slabs\_\_\_\_\_⊗.... unstable basement & garage backfill (not compacted)

- Unstable (not compacted) exterior, interior, and garage soil backfill material (recommend making floor slabs and hardscaping a part of 10 year structural warranty).

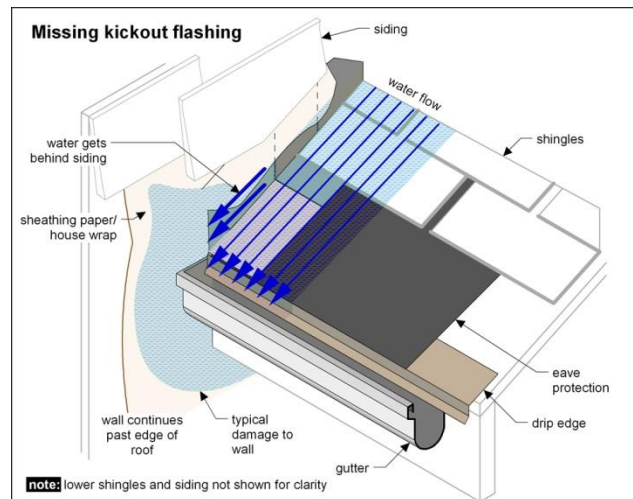
- Shingles\_\_\_\_\_ ☒.... uneven, buckled, ridged, lifted shingles
- Flashing\_\_\_\_\_ ☒.... missing kickout flashing
- Gutters\_\_\_\_\_ ☉.... incomplete (winter escrow)

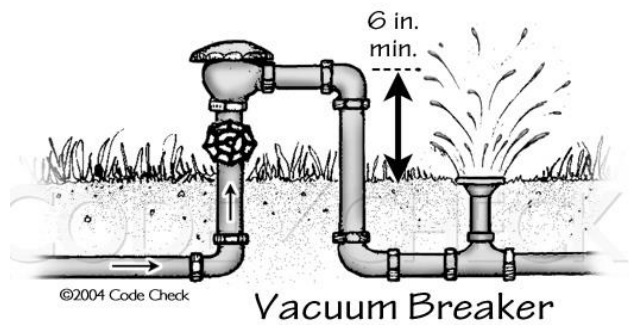
- Water supply\_\_\_\_\_●
- Interior water pipes\_\_\_☒.... UL bathtub located on exterior wall (no ventilation)
- Water heater (50g)\_\_\_●
- Waste pipes\_\_\_\_\_●
- Drain and vent pipes\_●
- Floor drain\_\_\_\_\_●
- Kitchen fixtures\_\_\_\_\_☒.... unsupported & poorly finished sink water piping
- Laundry fixtures\_\_\_\_\_☒.... unsupported & poorly finished sink water piping
- Bath fixtures\_\_\_\_\_☒.... unsupported & poorly finished sink & toilet water piping
- Bath rough in\_\_\_\_\_●
- Yard sprinkler\_\_\_\_\_☒.... incomplete (winter escrow) / poorly located vacuum breaker)
- Gas pipes\_\_\_\_\_●

- Poorly located and extended yard sprinkler vacuum breaker.
- Missing furnace humidifier damper knob.
- Noisy ML bath exhaust fan.
- Unvented (should be vented) kitchen exhaust fan.

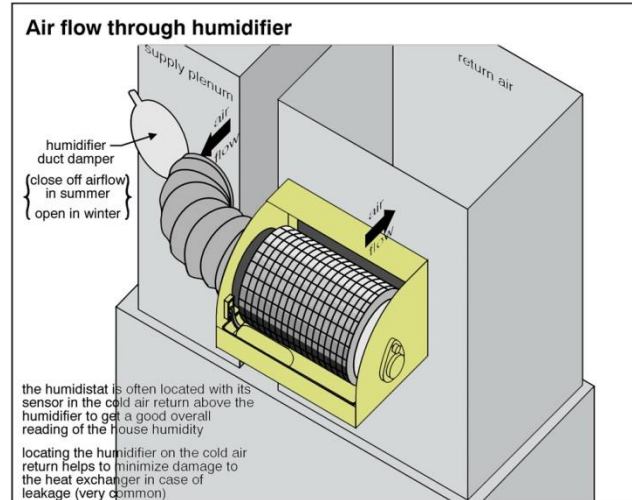
- Furnace ☒
- Vent and flue ☒
- Humidifier ☒ .... missing damper knob
- Air filter ☒
- Ventilation (HRV) ☒
- Bath fans ☒ .... noisy ML fan
- Kitchen fan ☒ .... unvented fan
