On 8/14/2019, Cities' Inspection Service, Inc. completed a home inspection of the property located at XXXXXXX, XXXXXXX, Minnesota for you. Doug Hastings did all the fieldwork related to this project. Doug used the national home inspection protocol; the American Society of Home Inspectors (ASHI) Standards of Practice.

Exterior

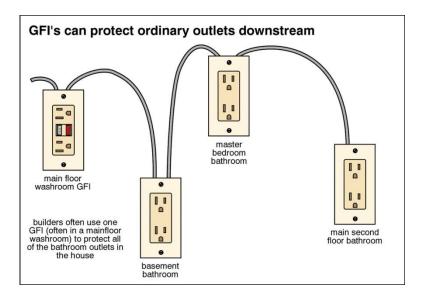
Loft

wall, ceiling, floor	
door	
outlet and fixture	
clothes washer	_ 🔆 no overflow tray / no emergency water shutoff
clothes dryer	
Hallway and entry	
wall, ceiling, floor	
outlet and fixture	
Probability of Moisture Intr	rusion
✓ ceiling low
