# FLAT-ROOF INSPECTION, *with a Focus on* Modified Bitumen

John Cranor, ASHI Certified Inspector

Part II of II

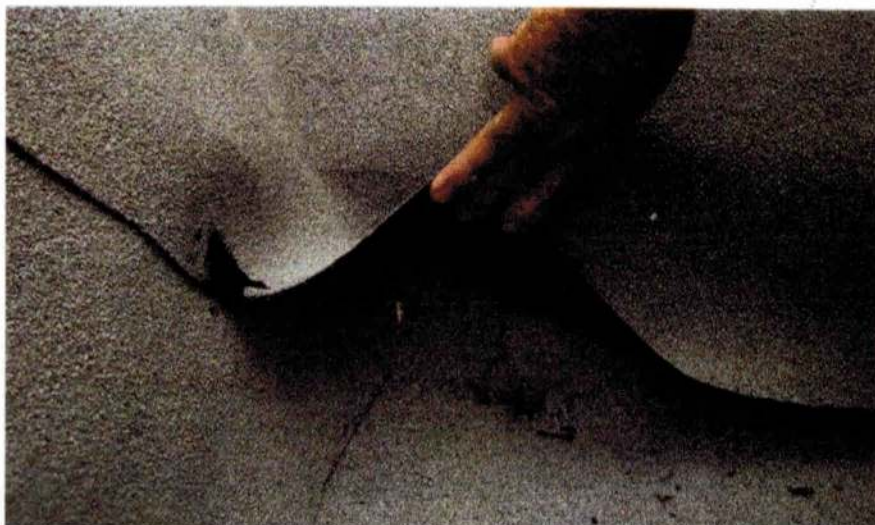
*This new roof is an example of poor workmanship. The base wall flashing was not adhered to the roof membrane.*

**1) Laps are critical on flat roofs** and should be examined for full and uniform adhesion. On an MB roof, you should see the following:

- a uniform flow-out of asphalt at the laps (ideally  $\frac{3}{8}$ " of asphalt flow-out at all laps, including base flashing);
- the bottom edge overlapping the adjacent row (a minimum 3");

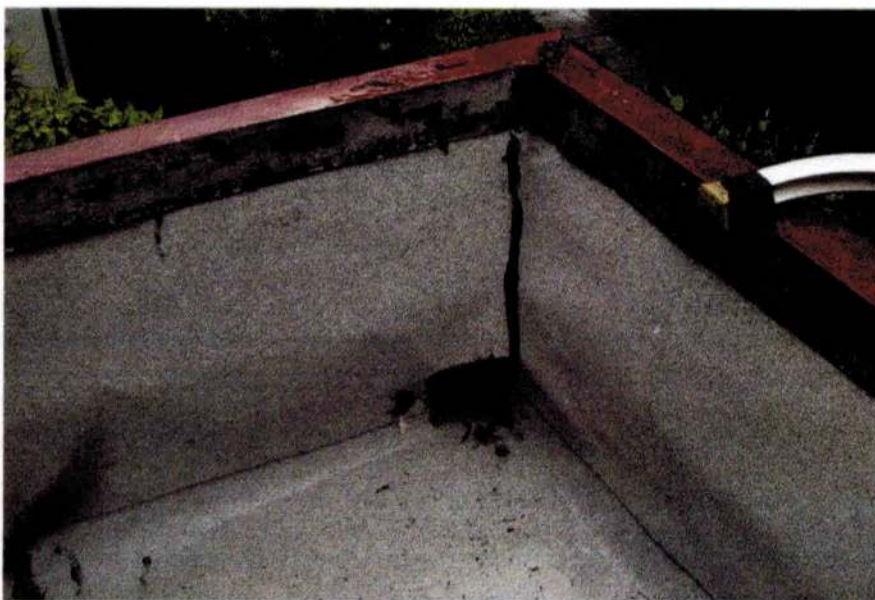
*Another example of poor workmanship on a new roof. A poorly adhered lap was improperly patched with roof cement and the scupper was improperly installed.*

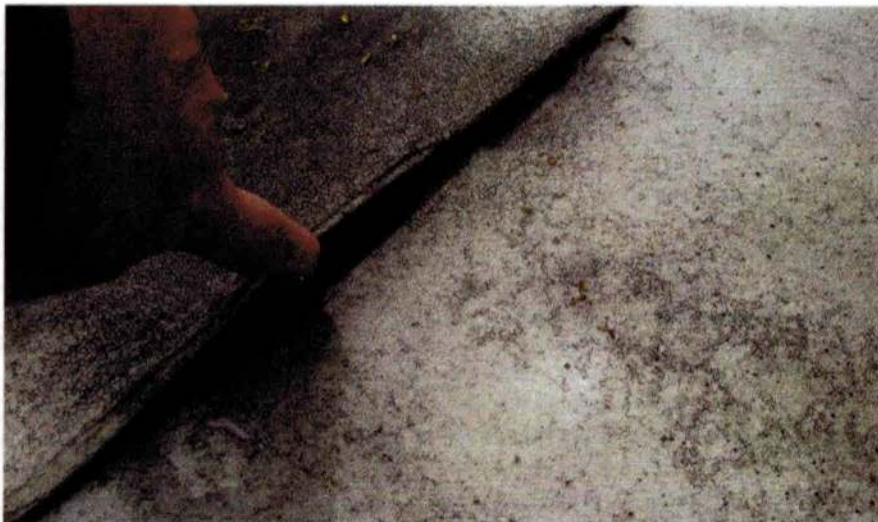
*This roof is no longer watertight because a lap has failed.*

Examine the laps for indications of short laps, overheating, voids and/or seal deficiencies.

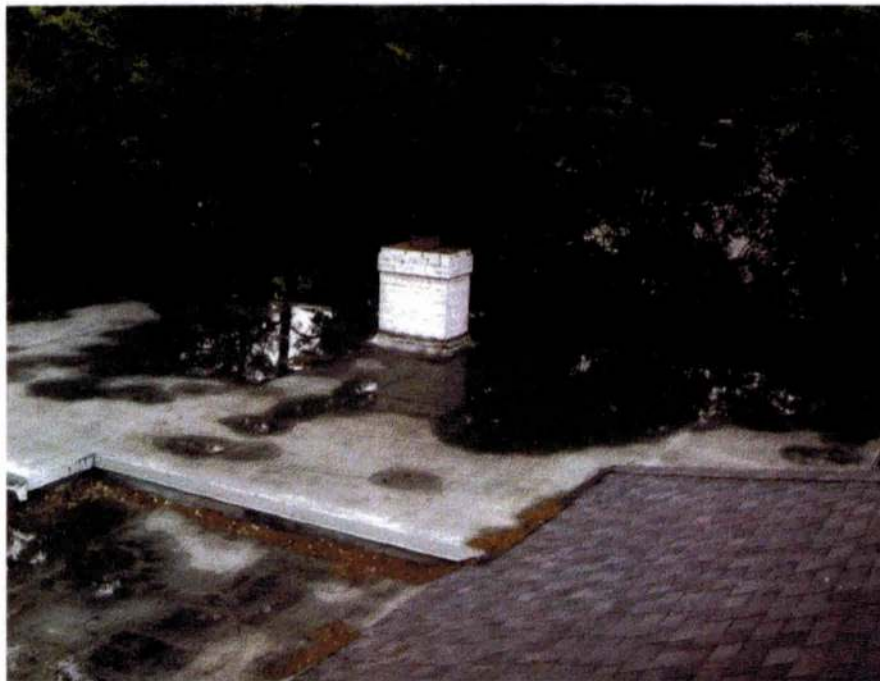
*Modified Bitumen membranes are especially not suited for ponding conditions.*

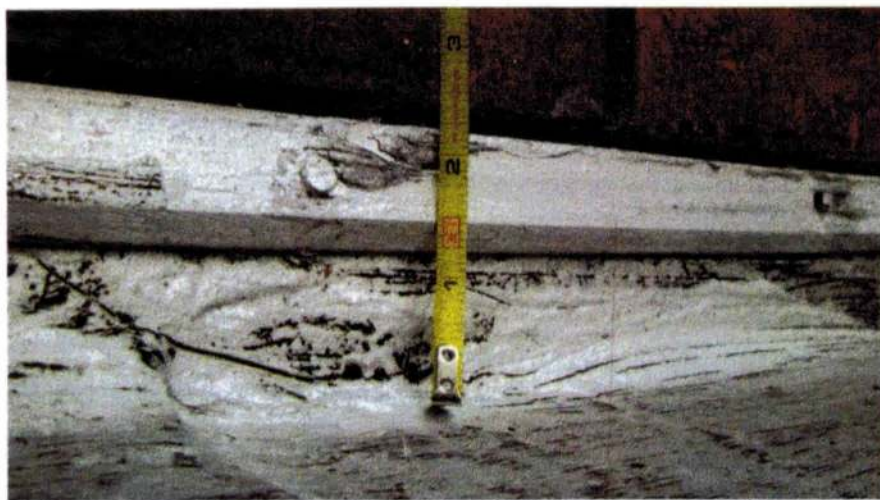
*At only slightly more than 2" high, this base flashing was improperly installed.*

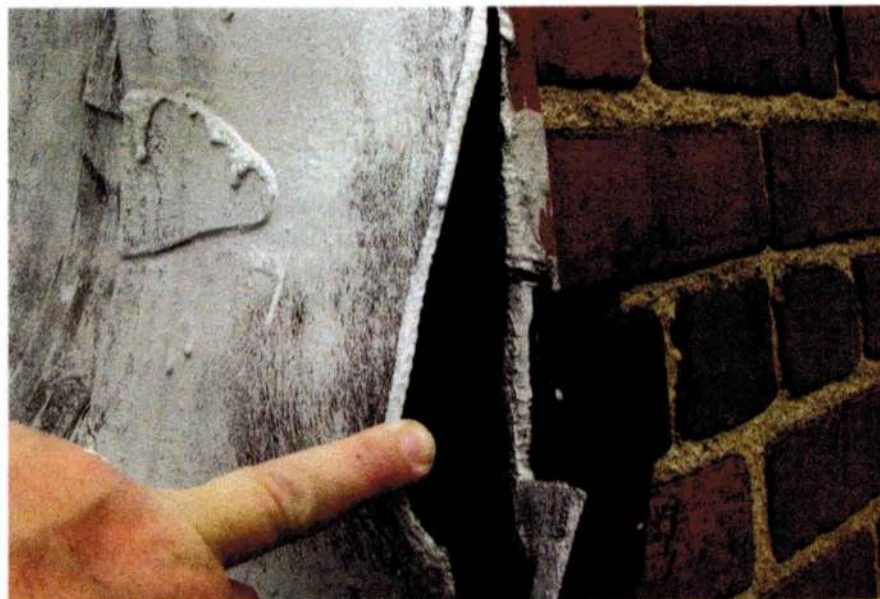
*This is a defect because the flashing is not adhered to the brick.*

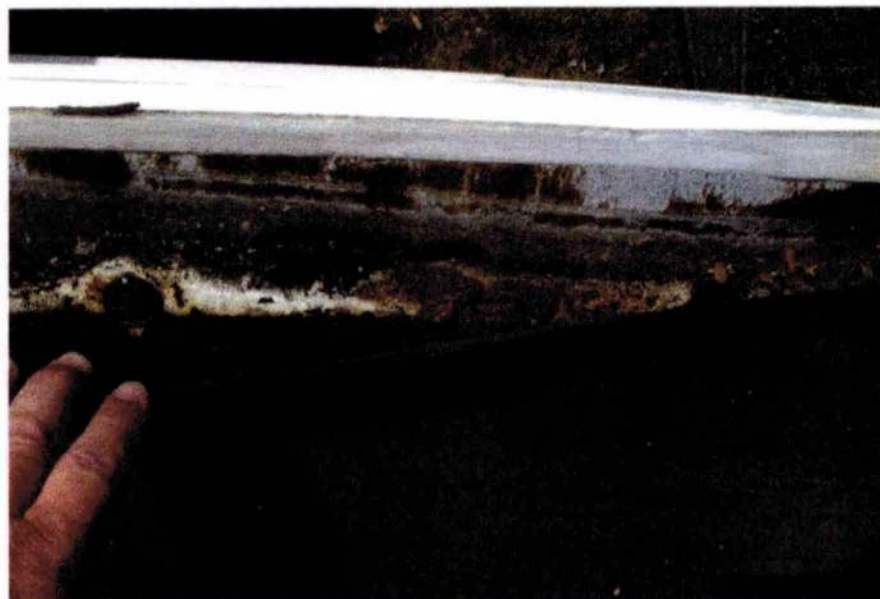
*The membrane has separated from the perimeter flashing. The flashing was not primed, possibly a contributing factor to the failure.*

In my experience, one of the most common defects and failure points on an MB roof occurs at the perimeter-edge flashing. Usually, the membrane loses its adhesion to the metal, often ►►►

because the metal-edge flashing was not cleaned and primed with an asphalt primer as required. All metal flashings must be secured (mechanically fastened down), cleaned and asphalt-primed so the membrane flashing will stick to it. When not primed, it holds for a while, but rarely functions long term.
